# Flexible solutions for **complex** wound reconstruction

# Table of contents

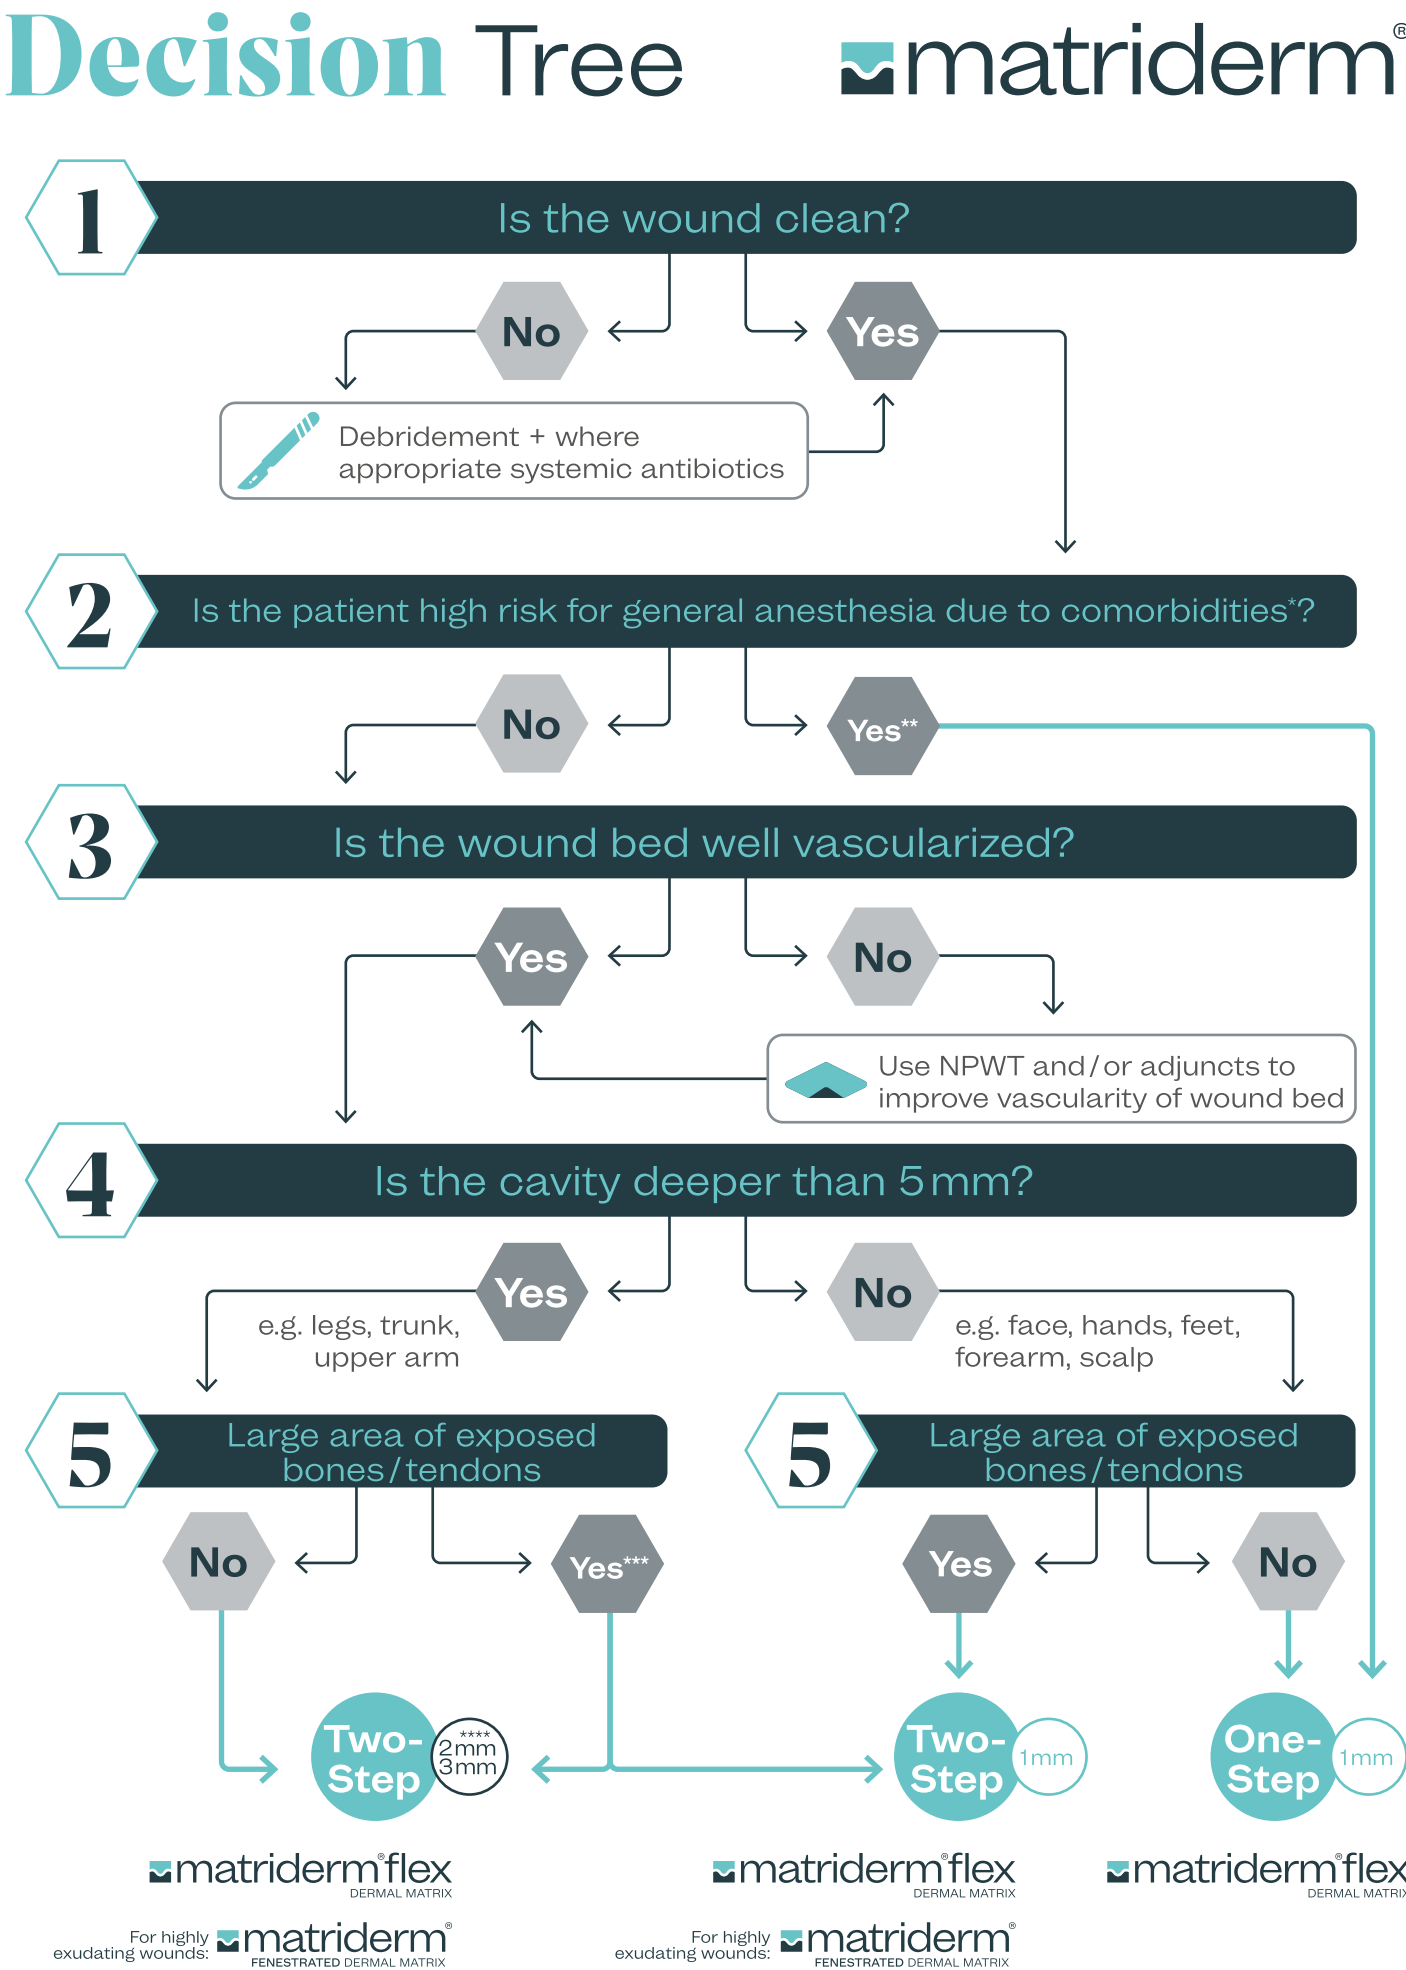
1 Panayi A. et al. Evidence based review of negative pressure wound therapy, World J Dermatol. Feb 2, 2017; 6(1): 1-16

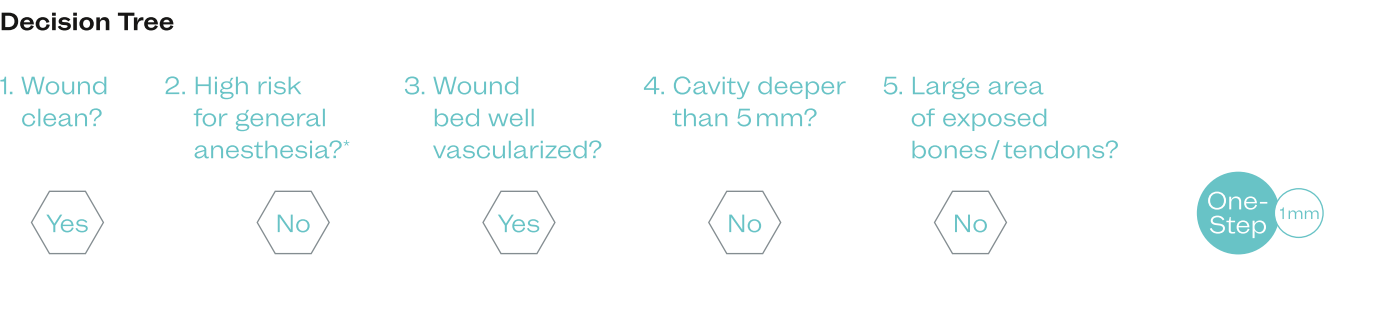
Pre-operative: Hyperextension of the MCP joint – function is considerably limited (Fig.1). Fist closure is not possible (Fig.2). Intra-operative: Complete excision of the scar tissue (Fig.3). Intra-operative: The scar tissue – laid back onto the wound bed for the photo – reveals the dimension of the scar contraction, the skin deficit and the substantial functional limitation (Fig.4). Long-term follow-up: Normal function of the hand without any limitations (Fig.5–7).

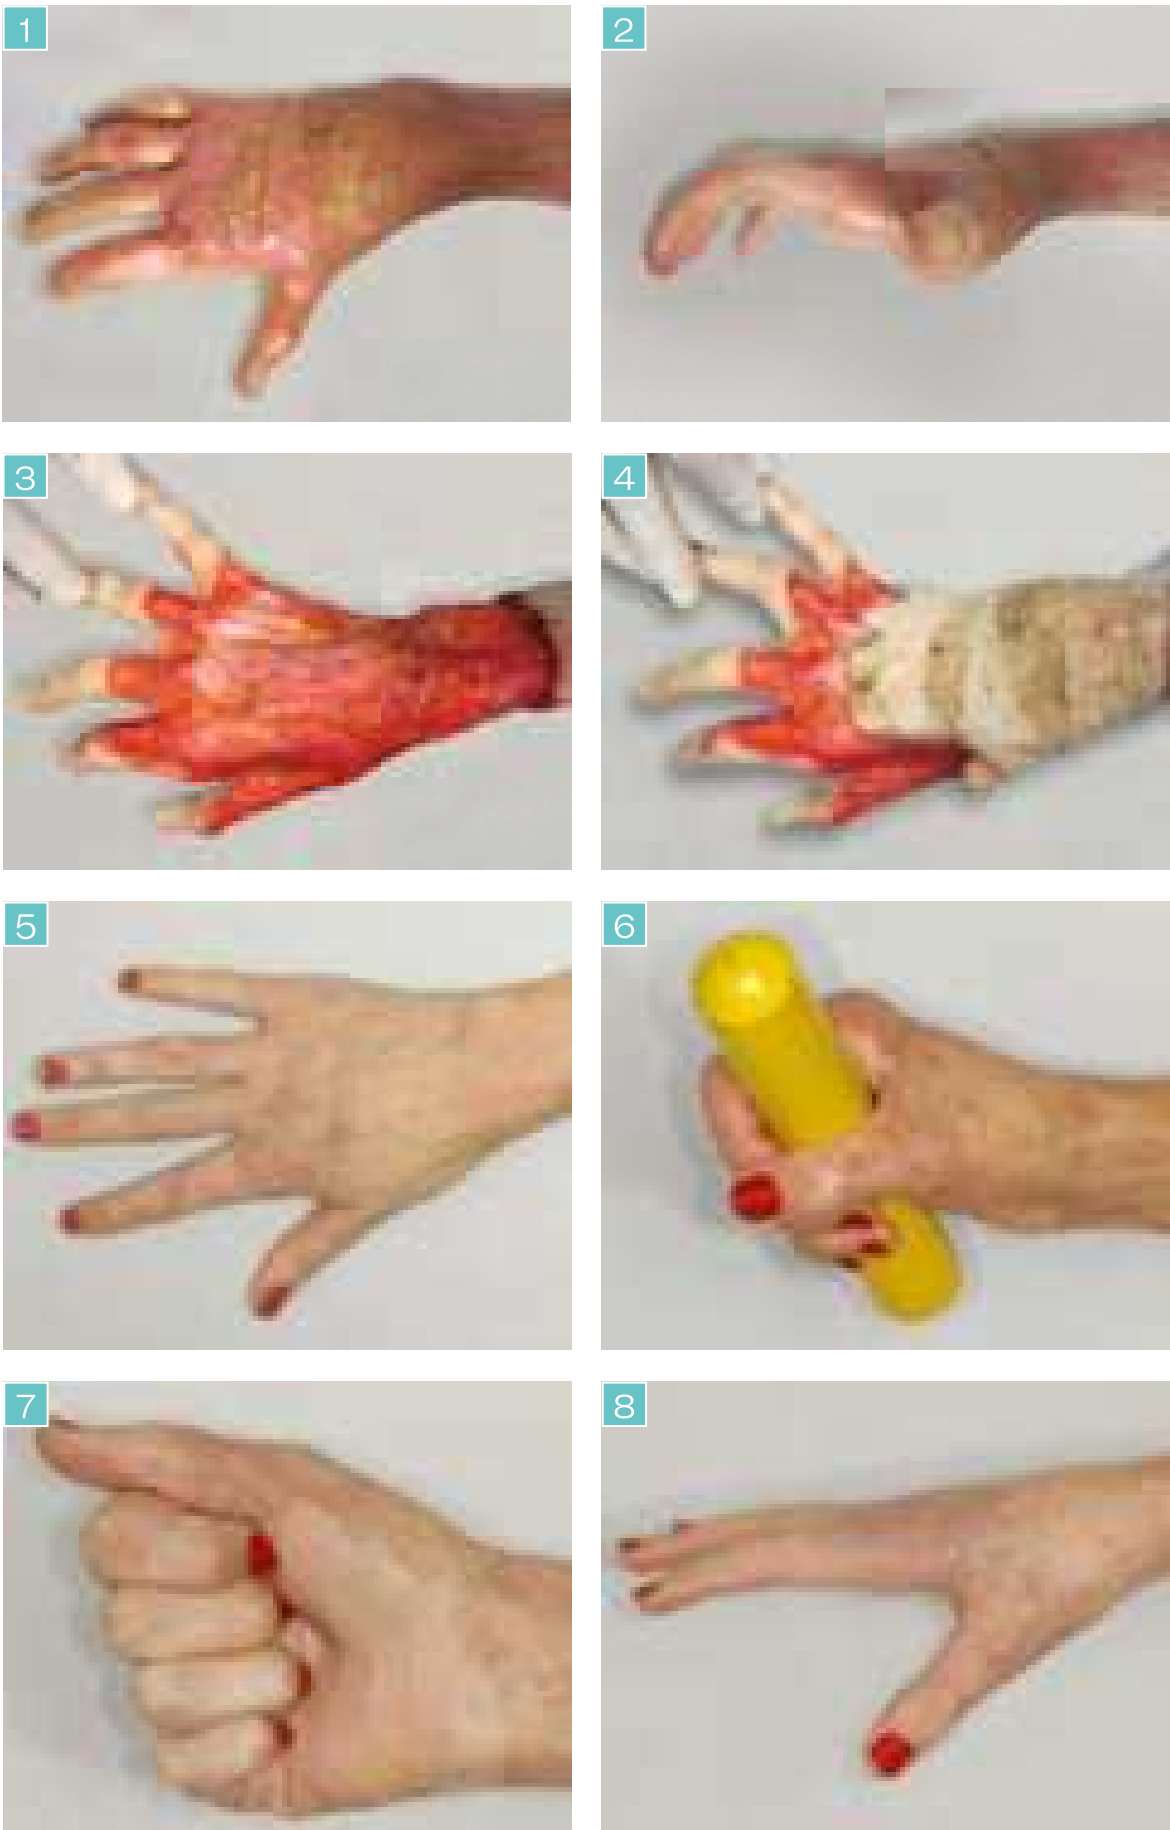
\* Courtesy of L. Kamolz, MD, Graz, Austria

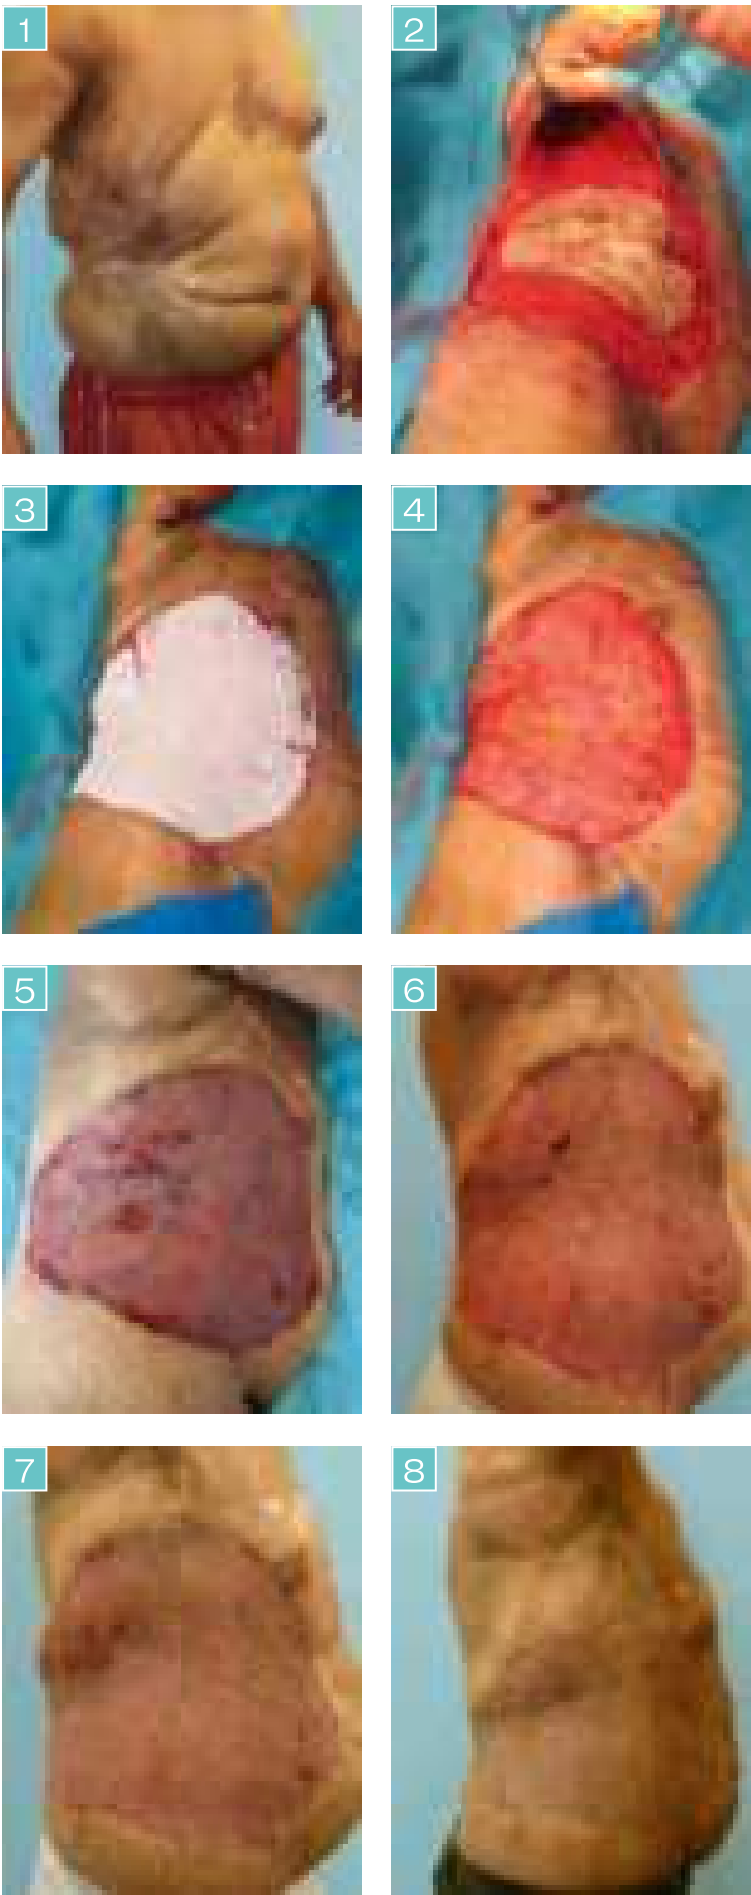
The patient presented with a large scar from a burn wound on the flank 20 years ago (Fig.1). Reason for his request of scar revision was the instability and aesthetic appearance of the scar and skin insensitivity. Comorbidities included a history of peripheral artery occlusive disease and arterial hypertonia.

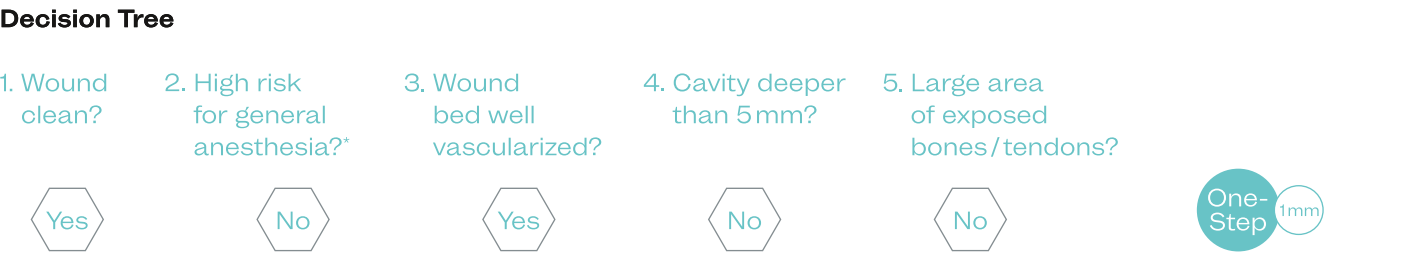
Aspect of the wound before operation (Fig.1,2). Pre-operative marking of the area to be excised (Fig.3). Aspect of the wound after scar resection with release of healthy tissue. In order to show the extend of contracture release the scar tissue was put back onto the wound bed for this photo (Fig.4). Application of MatriDerm® (Fig.5), covered with fenestrated split-thickness skin graft (Fig.6). Negative pressure wound therapy as dressing (Fig.7). Result after 2 weeks (Fig.8). Result after 3 months (Fig.9). Result 1 year later (Fig.10,11). Pleasing functional and aesthetic outcome with full pain release. Complete and stable healing of the wound.

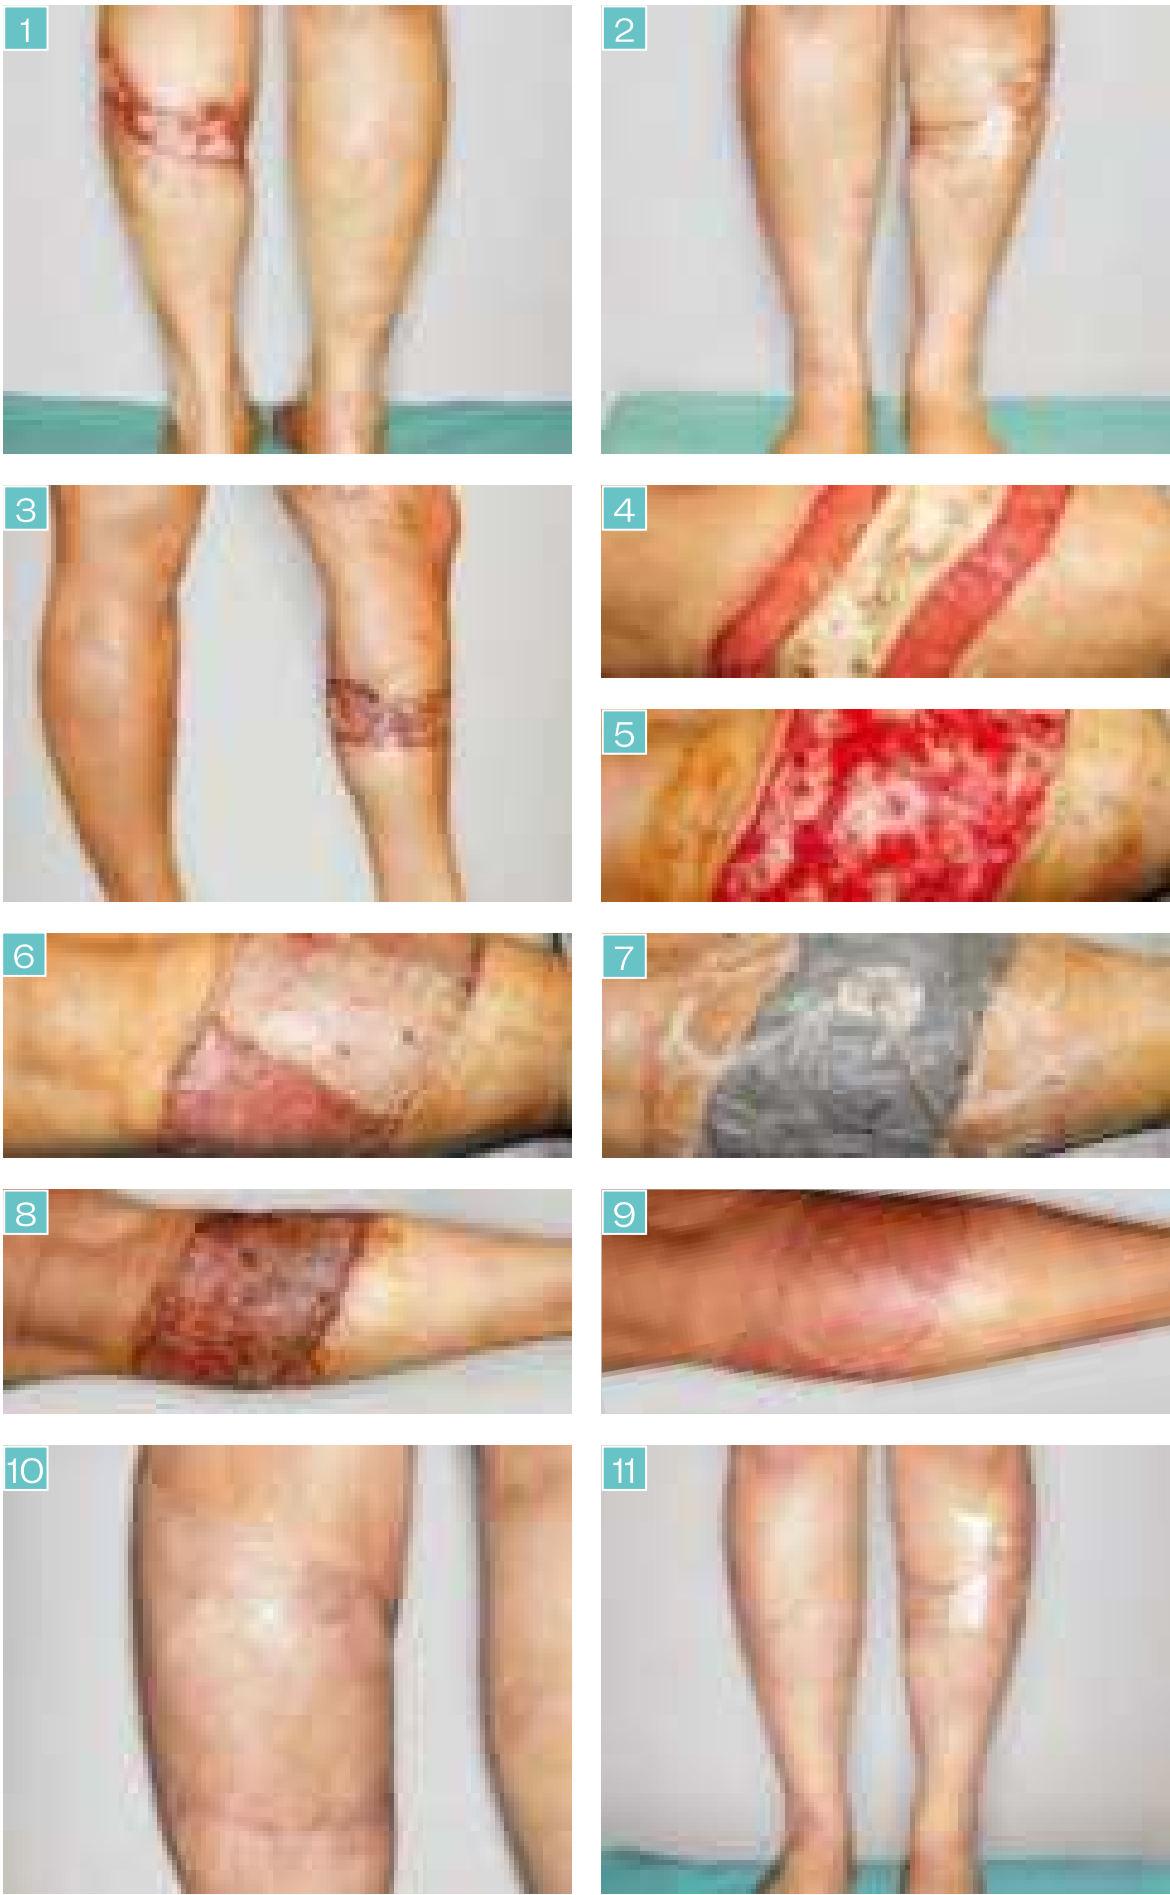
\* Courtesy of A. Modarressi, MD, Geneva, Switzerland

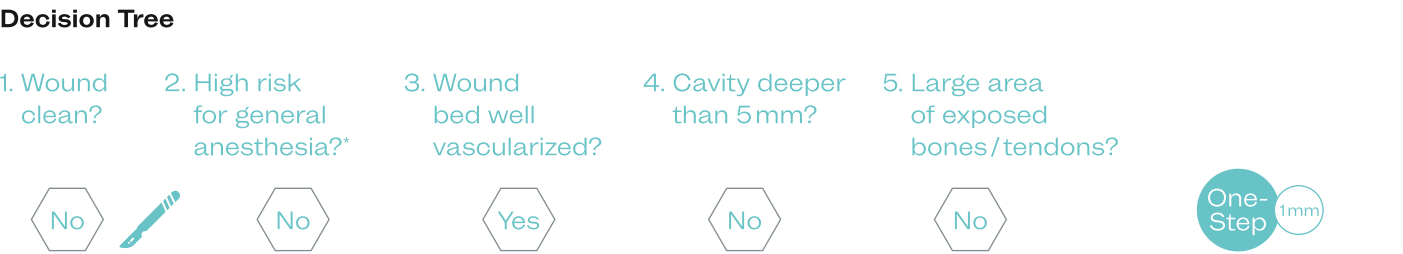
A 42-year old male presented with a flame burn on chest and neck (60% TBSA) (Fig.1). This is a challenging region due to high incidents of contractions, so high elasticity is very important.

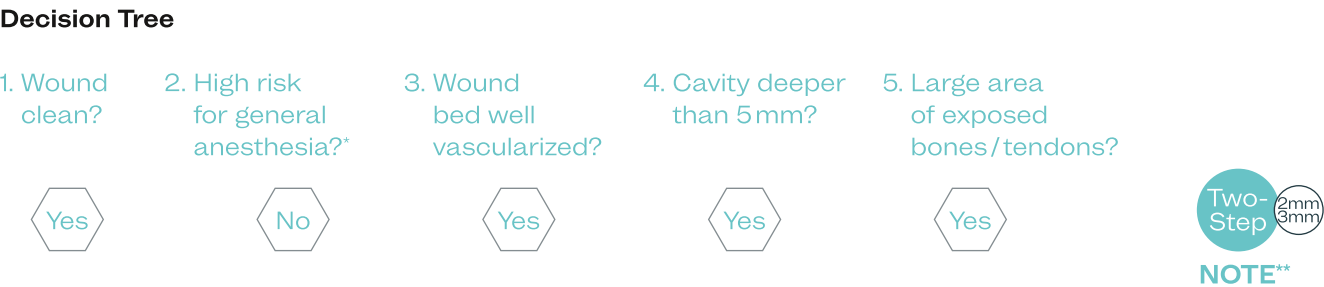
The patient suffered from a work accident where his arm was crushed into an industrial roller, which resulted in multiple bone fractures and degloving of his right arm (Fig.1).

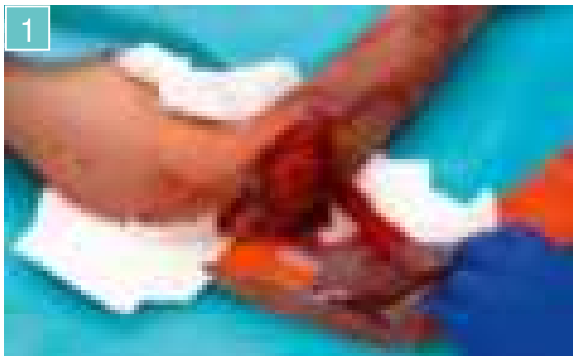
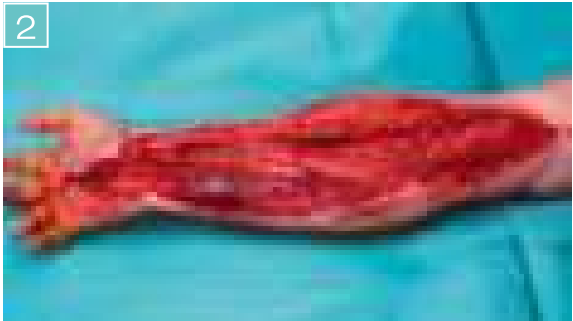
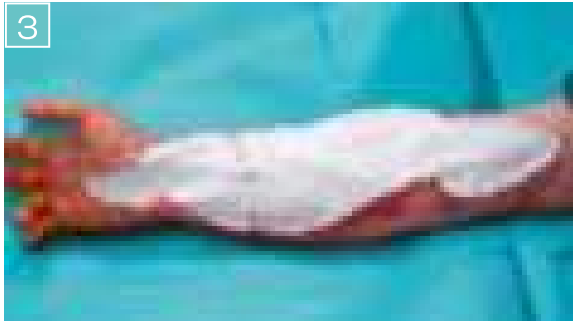
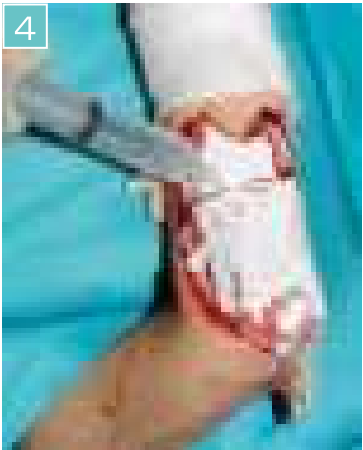
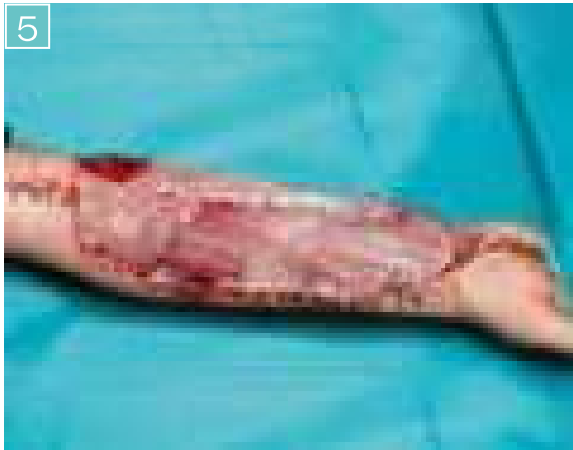
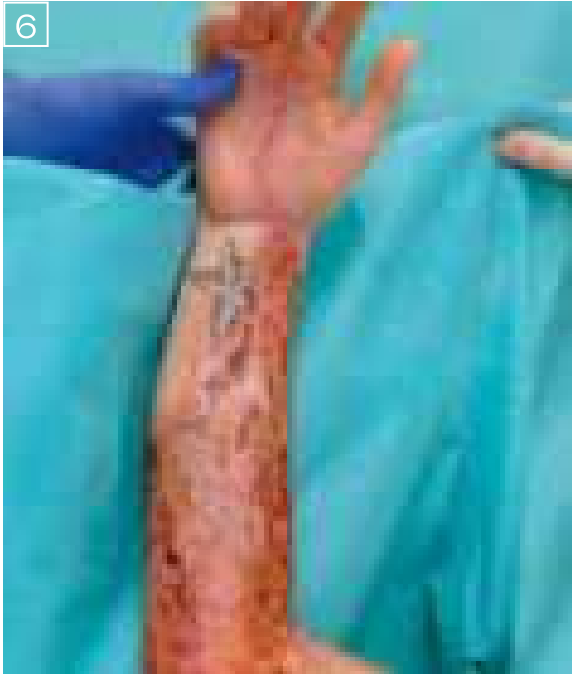
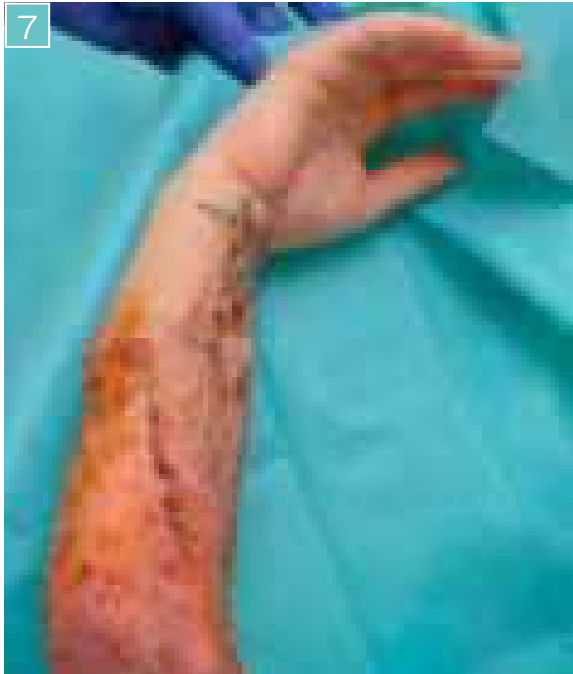
\* Courtesy of M. Kerl, MD, Graz, Austria  
Epigard by Biovision GmbH  
\*\* The surgeon used MatriDerm® in a One-Step procedure. Upon the discretion of the surgeon and his/her experience with dermal substitutes the procedure and thickness of MatriDerm® can differ from the recommended pathway of the decision tree.

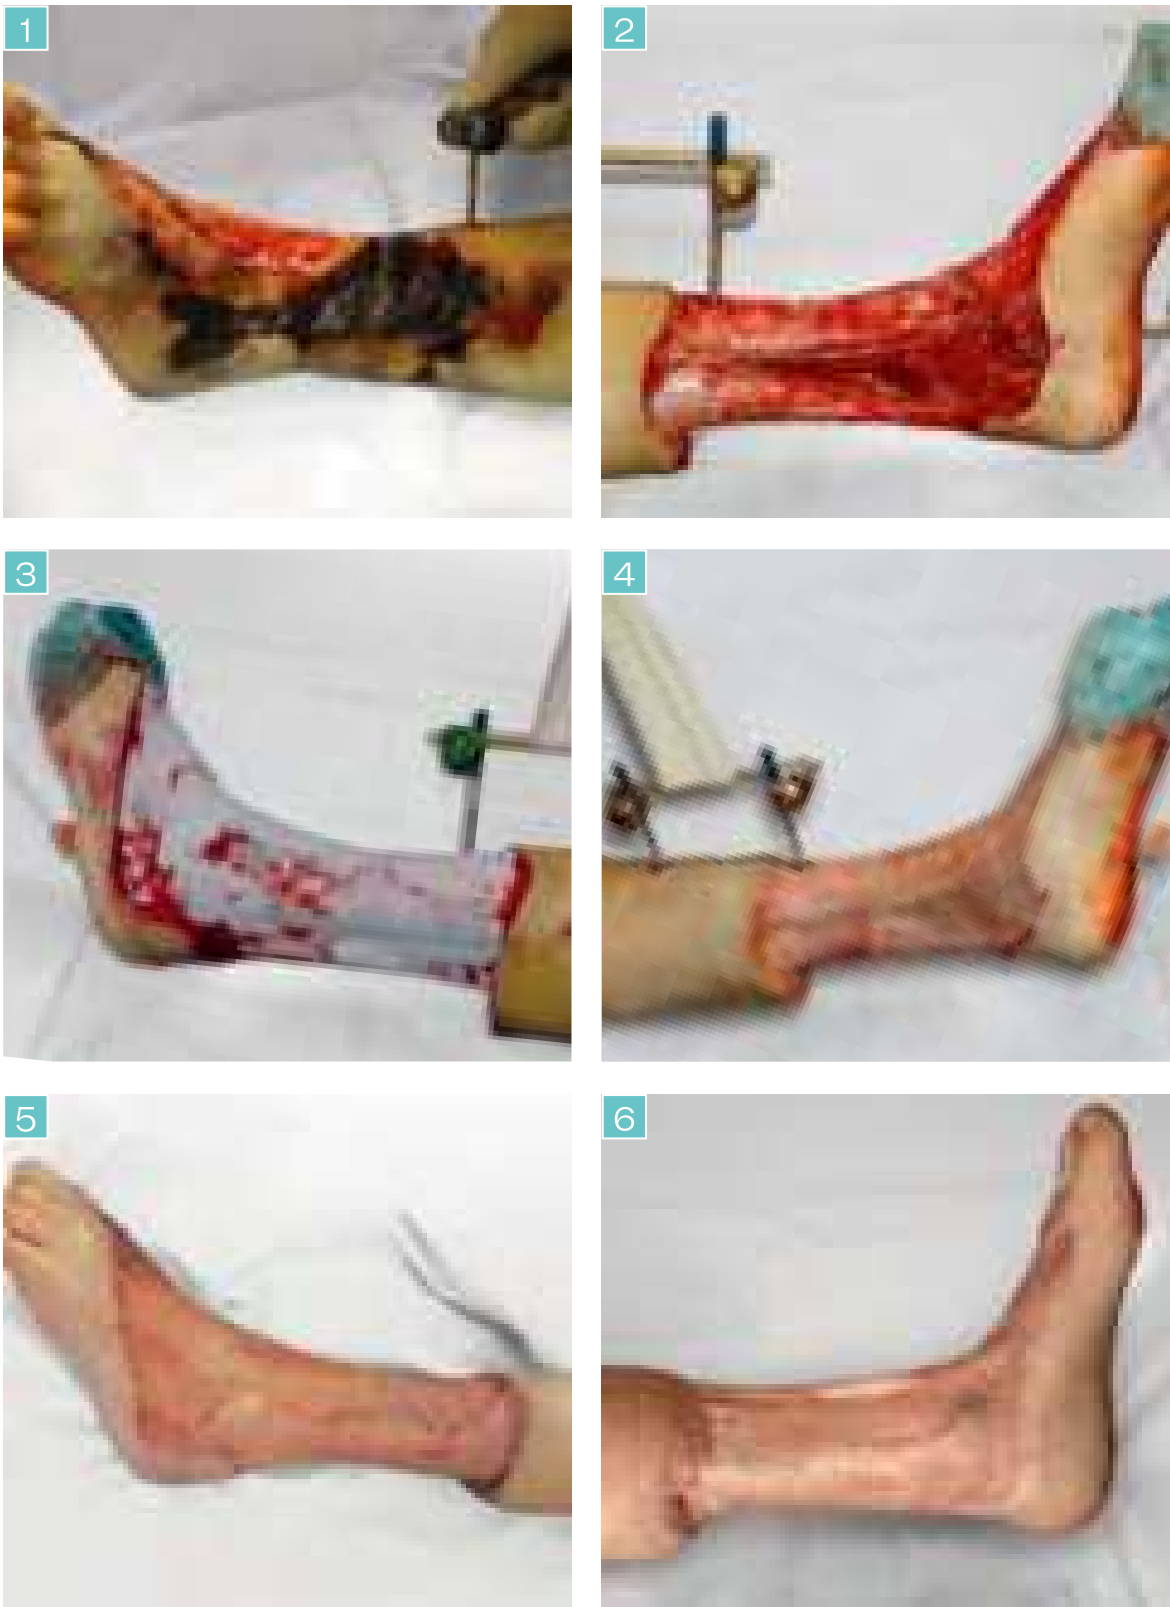
\* Courtesy of M. Öhlbauer, MD, Murnau, Germany

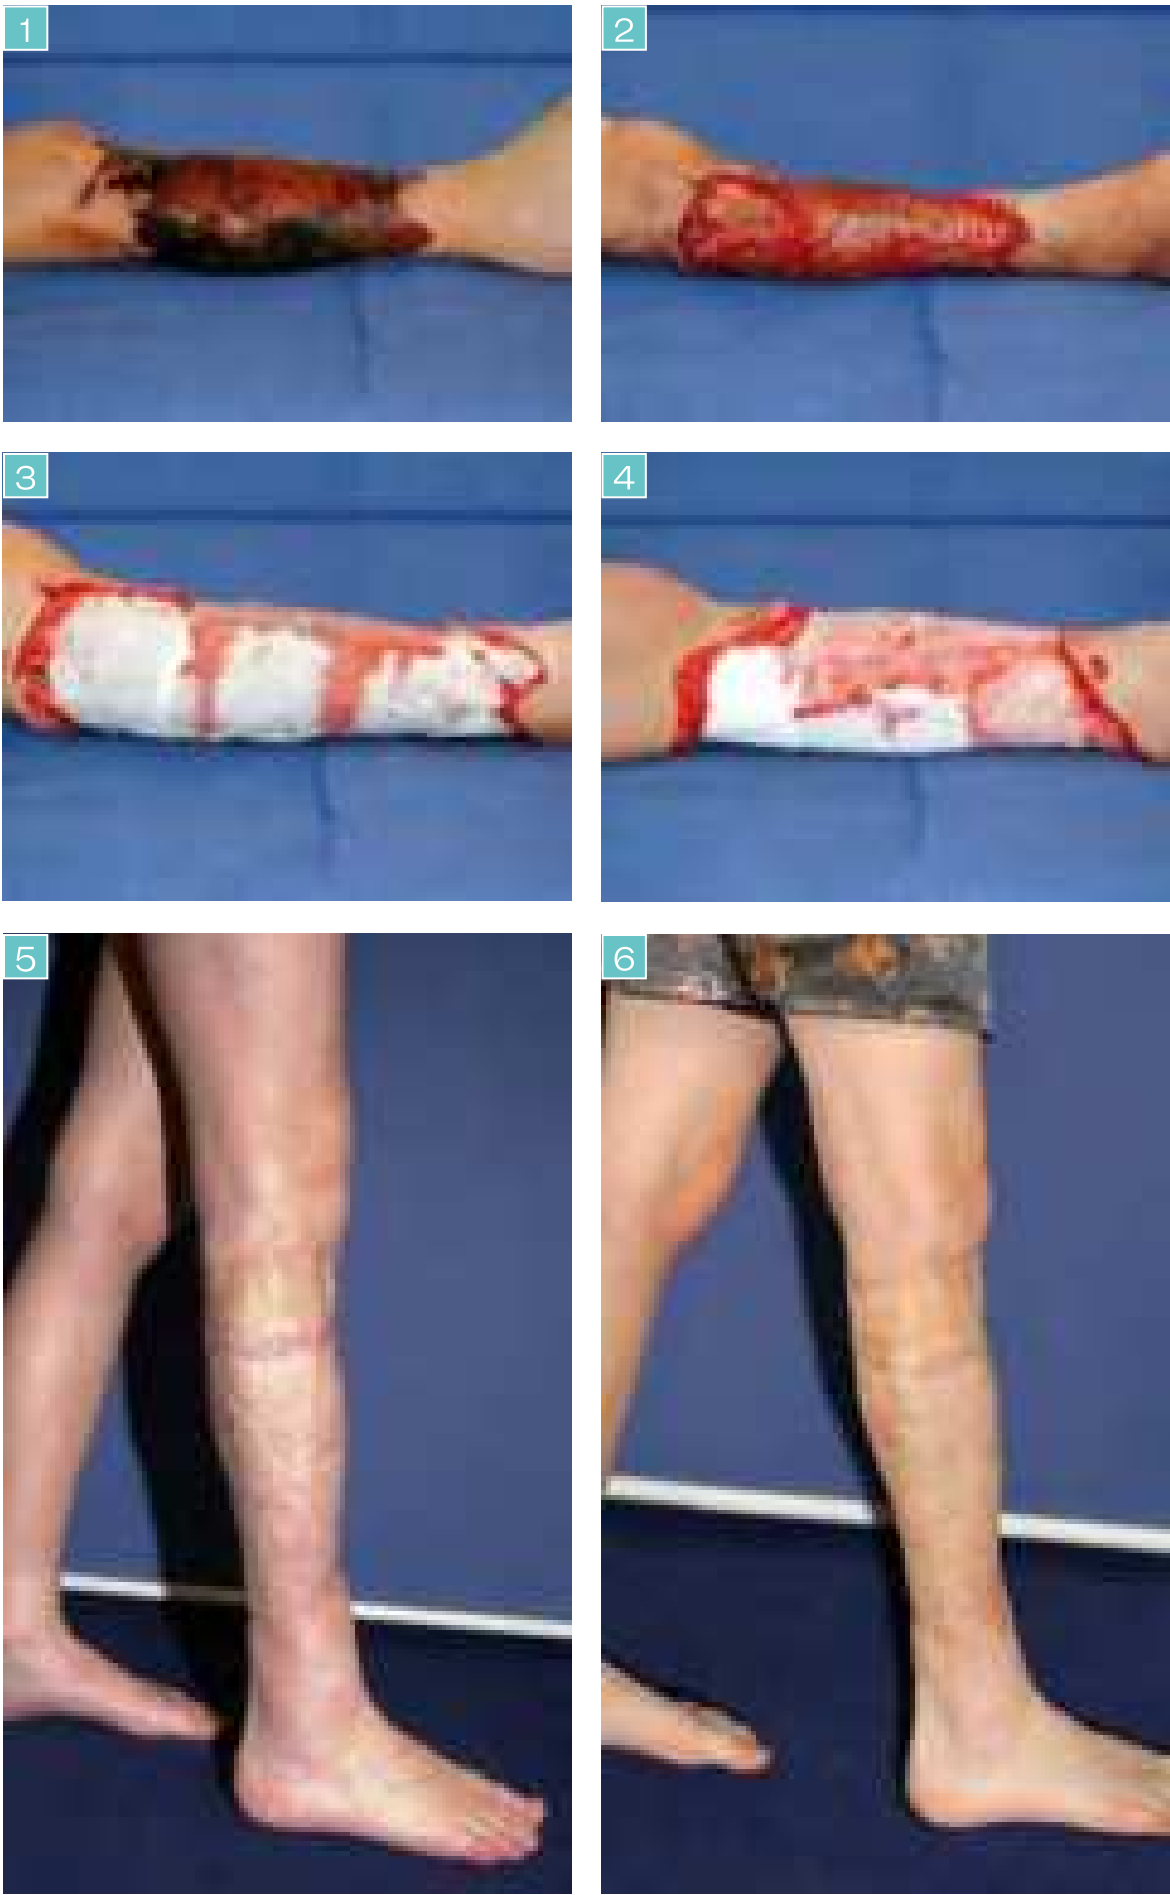
\* Courtesy of M. Öhlbauer, B. Wallner and M. Miltz, MD, Murnau, Germany

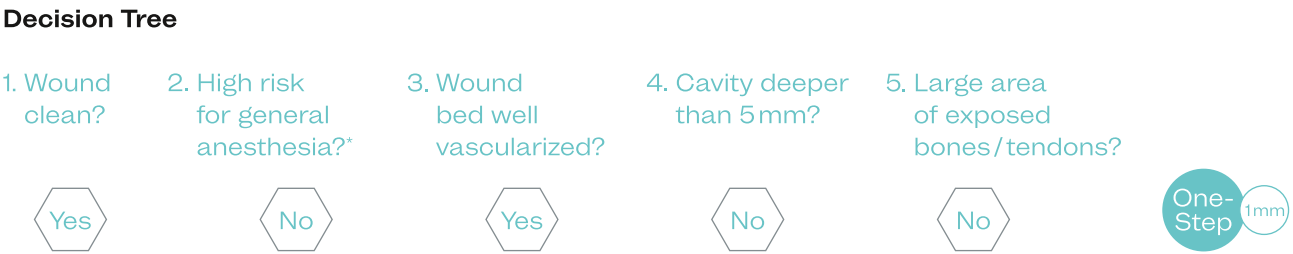
In this case a 60-year-old patient was hospitalized with an acute avulsion after motor-bike injury. The intra-operative view revealed a defect at the heel and a 2cm exposed Achilles tendon (Fig.1). The wound was treated with 1mm MatriDerm® and unmeshed split-thickness skin graft in a One-Step Procedure. 2.5 weeks later the wound area showed a closed skin with good tendency to heal (Fig.2). The physiotherapy started at this stage. A follow up of 5 weeks p. o. demonstrated a good development with a completely stable wound also over the Achilles tendon (Fig.3,4).

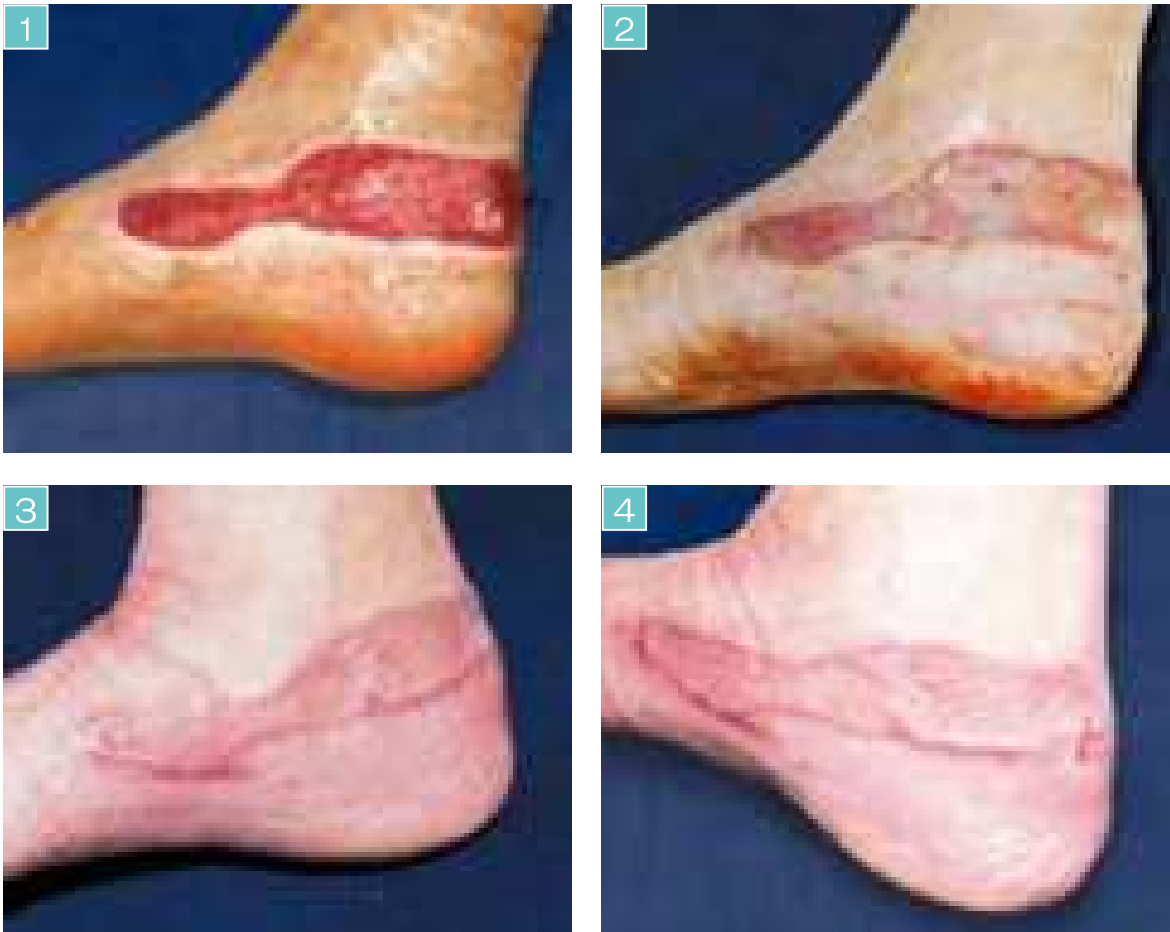
\* Courtesy of U. Graf, MD, Zurich, Switzerland

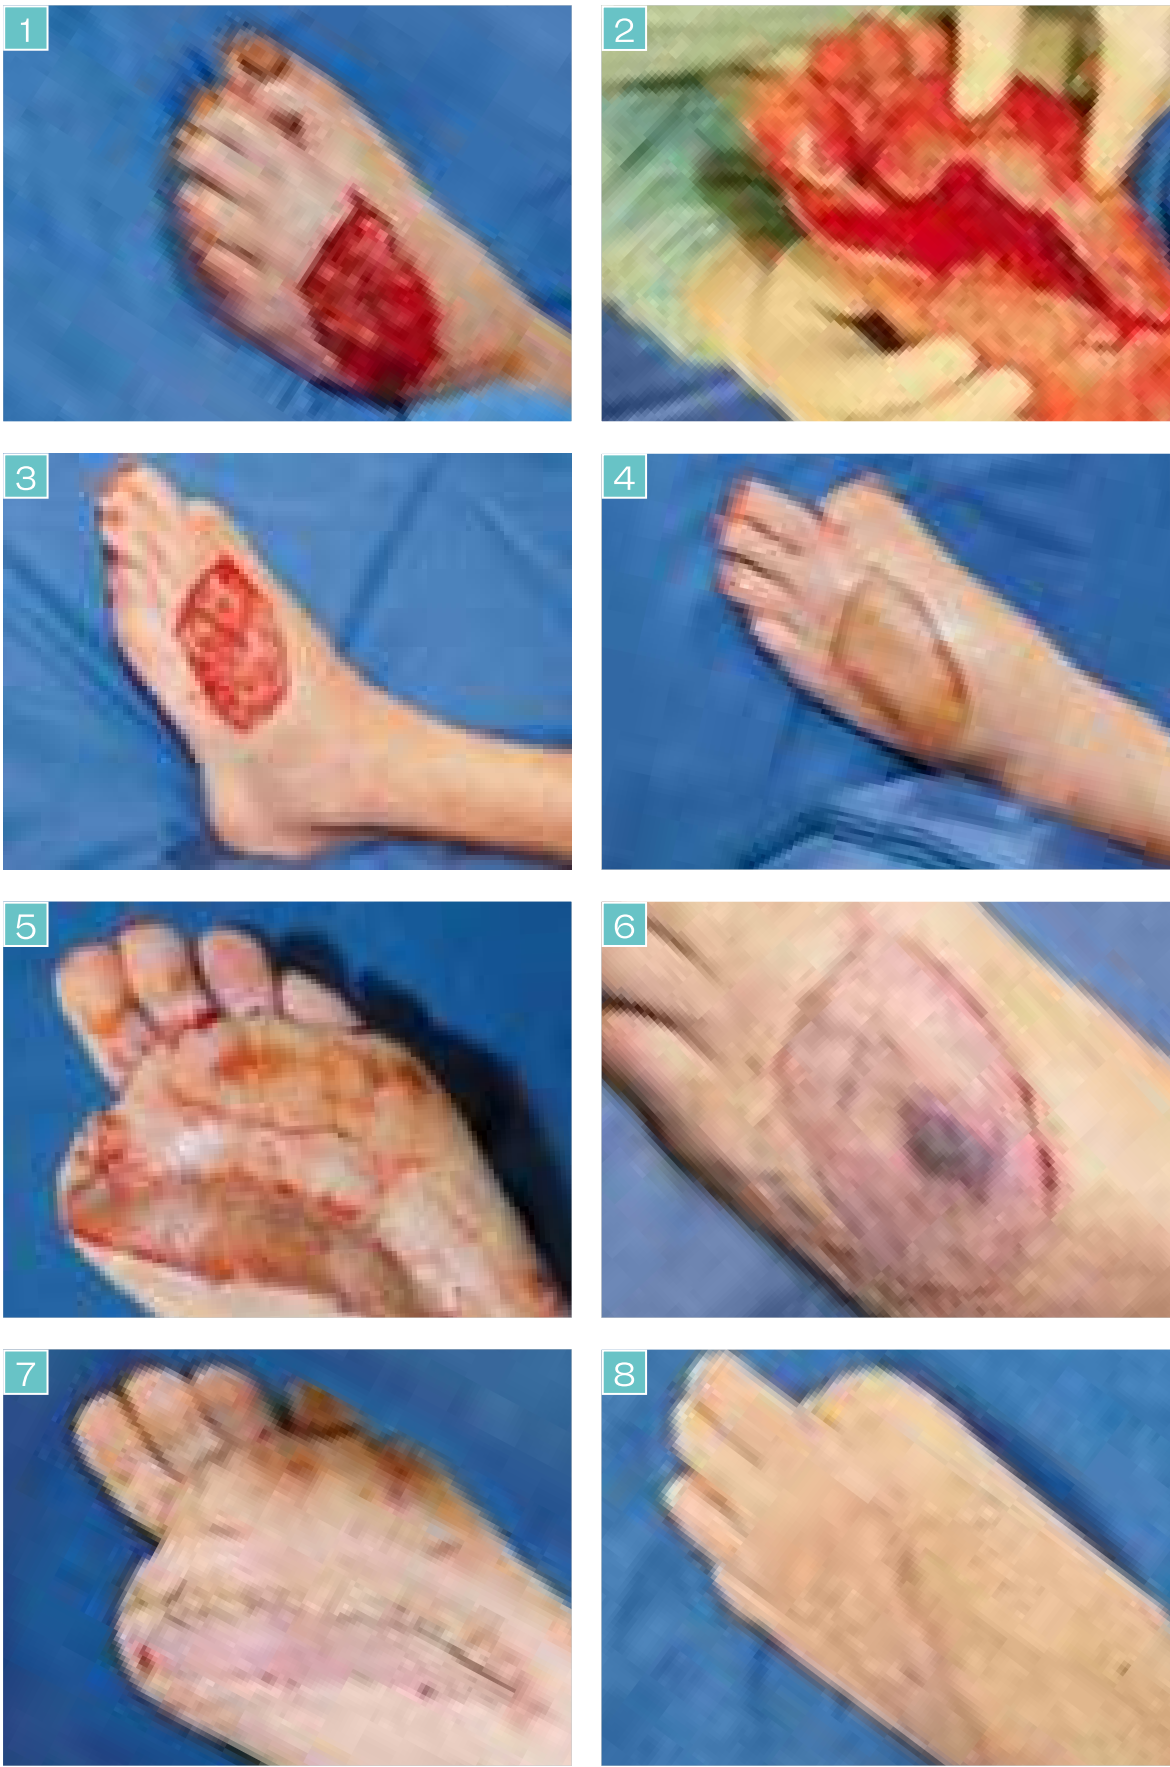
\* Courtesy of M. Öhlbauer, B. Wallner and M. Militz, MD, Murnau, Germany

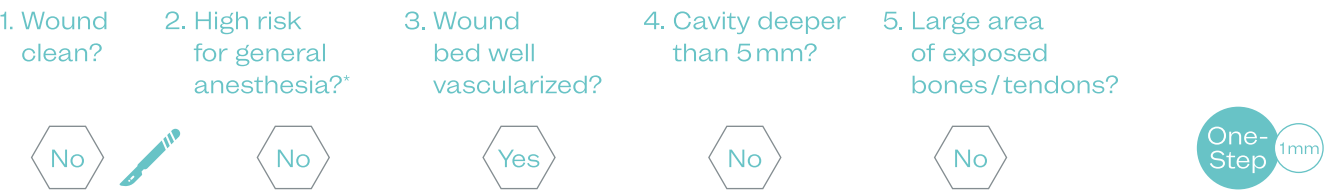
Initial view of the circular saw injury at the hand showing a deep soft tissue defect with involvement of the auricular and the annular finger (Fig.1). Based on the bone status a partial amputation to the mid-joint of the auricular finger was necessary. The wound closure was done with a retrograde pedicular forearm flap. Three days later the flap suffered from a necrosis caused by a septal vascular anomaly (Fig.2). 13 days after injury: Second surgery was required due to the flap loss.

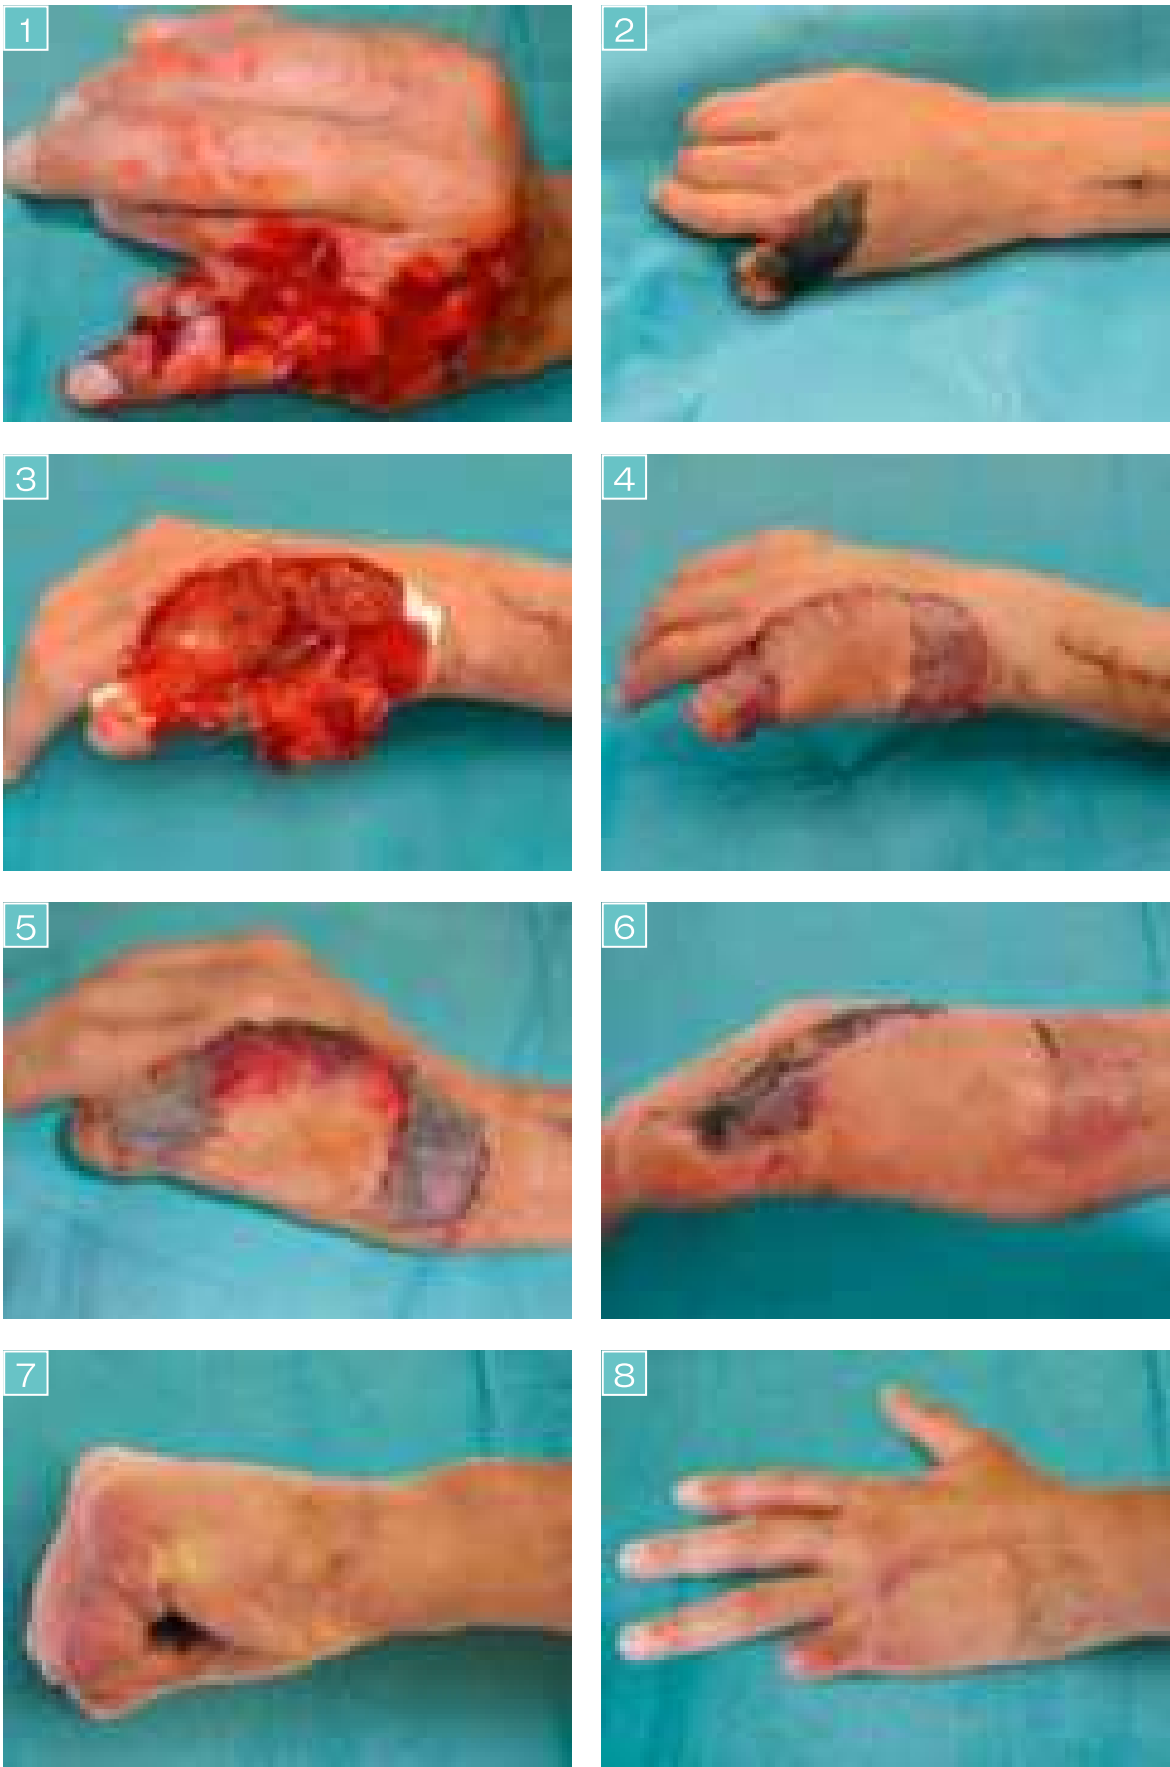
\* Courtesy of L. Mathys, MD, Bern, Switzerland

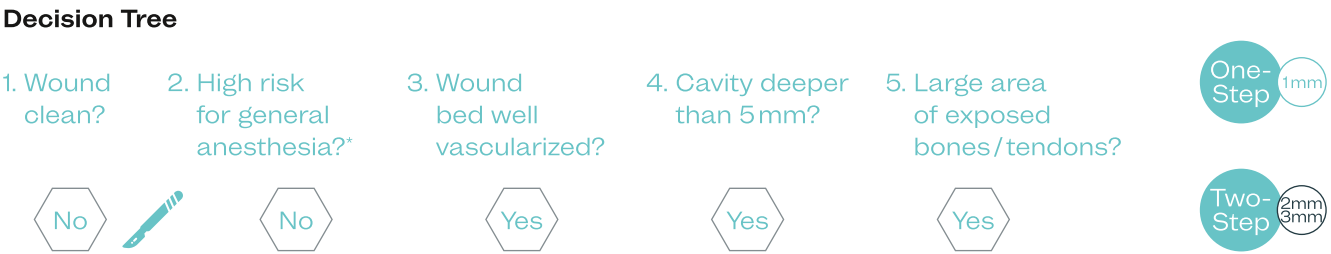
This 55-year-old patient suffered a laceration of the left lower leg and foot (Fig.1). After operative debridement, there was significant soft tissue loss (Fig.2). Defect coverage was performed with a free latissimus dorsi-serratus flap to replace the soft tissue loss. On top of the muscle flap a dry MatriDerm® (1mm) was placed (Fig.3) and rehydrated in situ. A meshed split-skin graft (meshed 1:1.5) was placed on top of the rehydrated MatriDerm® in a One-Step Procedure.
