# Flexible solutions for **complex** wound reconstruction

# Table of contents

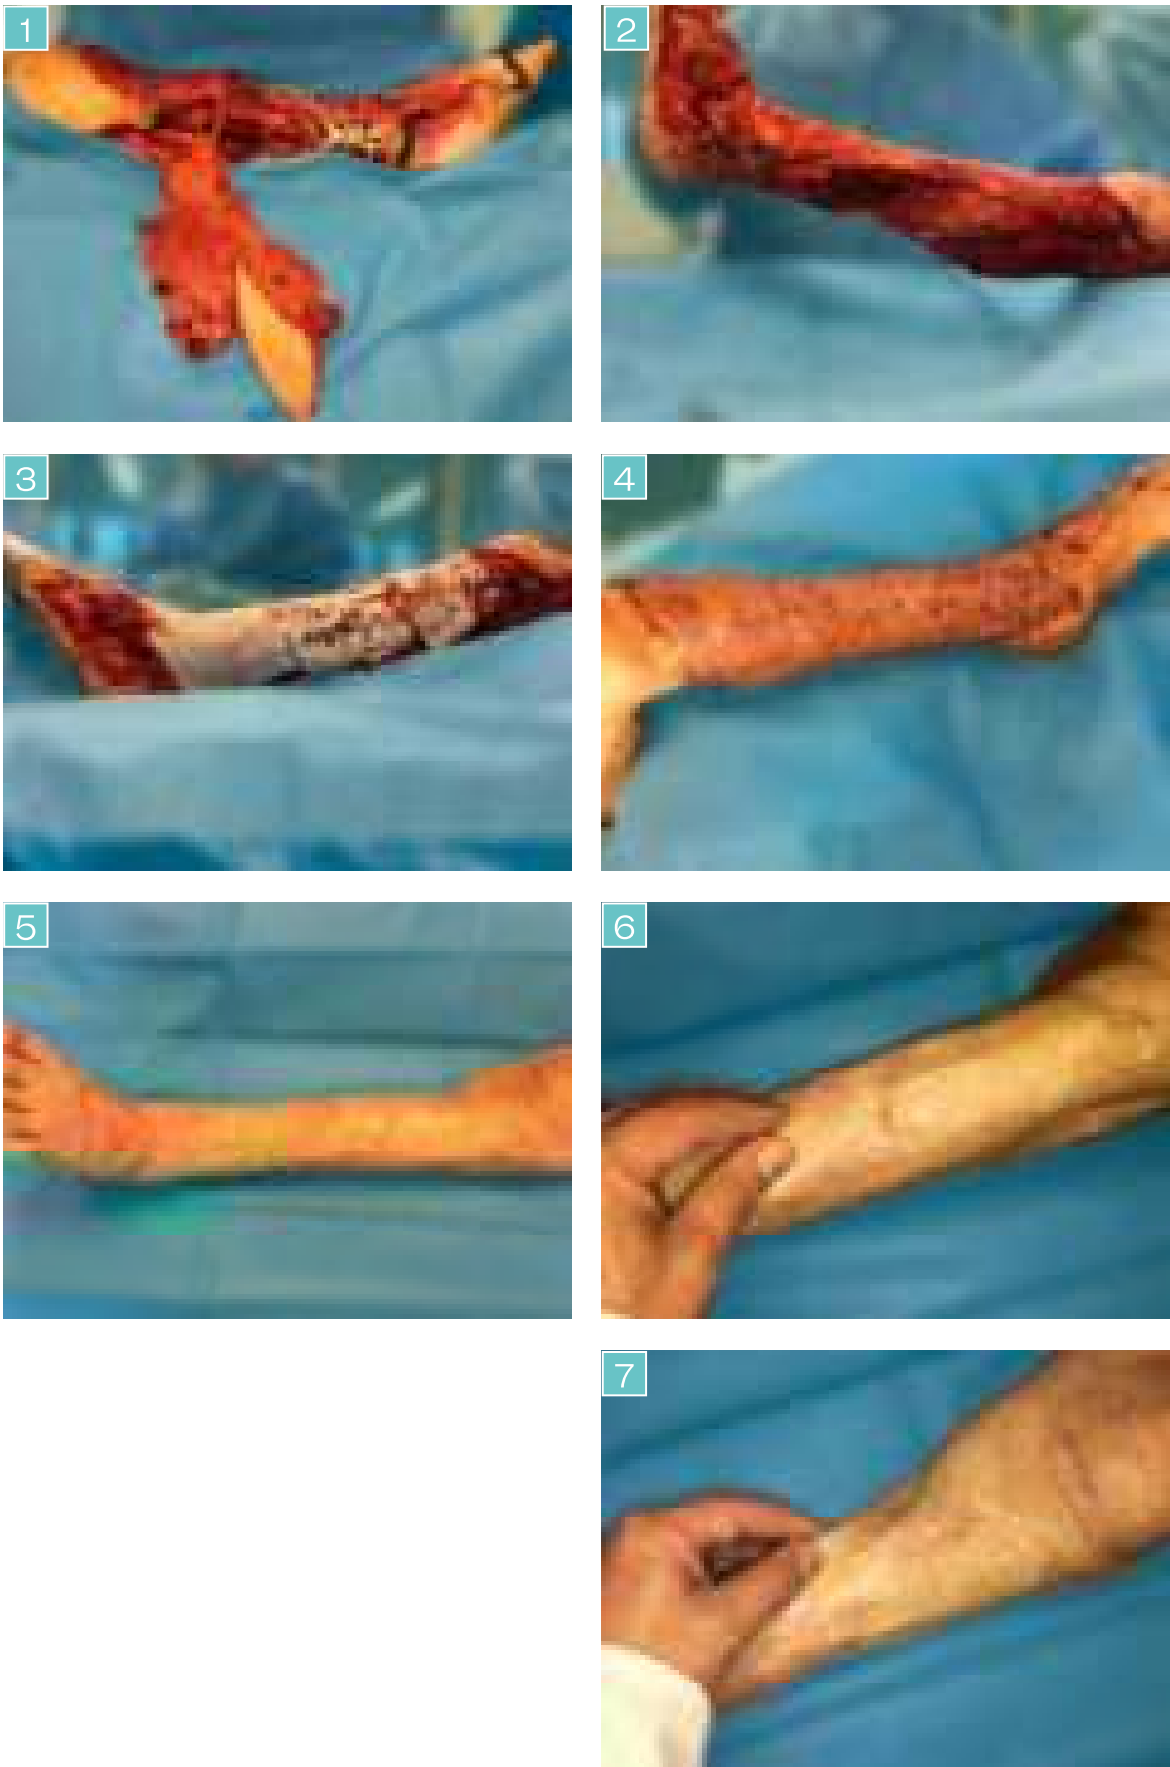
\* Courtesy of D. F. Kalbermatten, MD, Basel, Switzerland

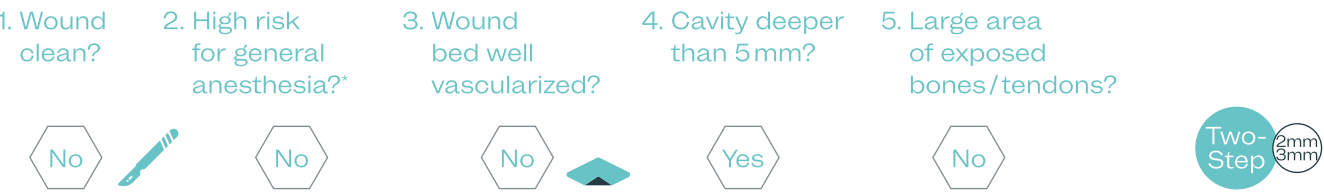
This patient required extensive life saving abdominal wall debridement after developing necrotizing fasciitis following ovarian cancer surgery. After debridement, she was admitted to the intensive care unit for several weeks with an ‘open abdomen’ measuring 34x33cm. There was exposed bowel covered by a fragile layer of granulation tissue and yellow slough with discharging cavities under the skin flaps laterally (Fig.1). The rectus muscles had retracted laterally and, therefore, it was inappropriate and unsafe to attempt an abdominal wall reconstruction using mesh and/or advancement techniques at that stage. The objective was to get the wound healed in a timely manner with as much protection and padding over the bowel so the patient could commence the rest of her oncologic treatment that included chemotherapy.

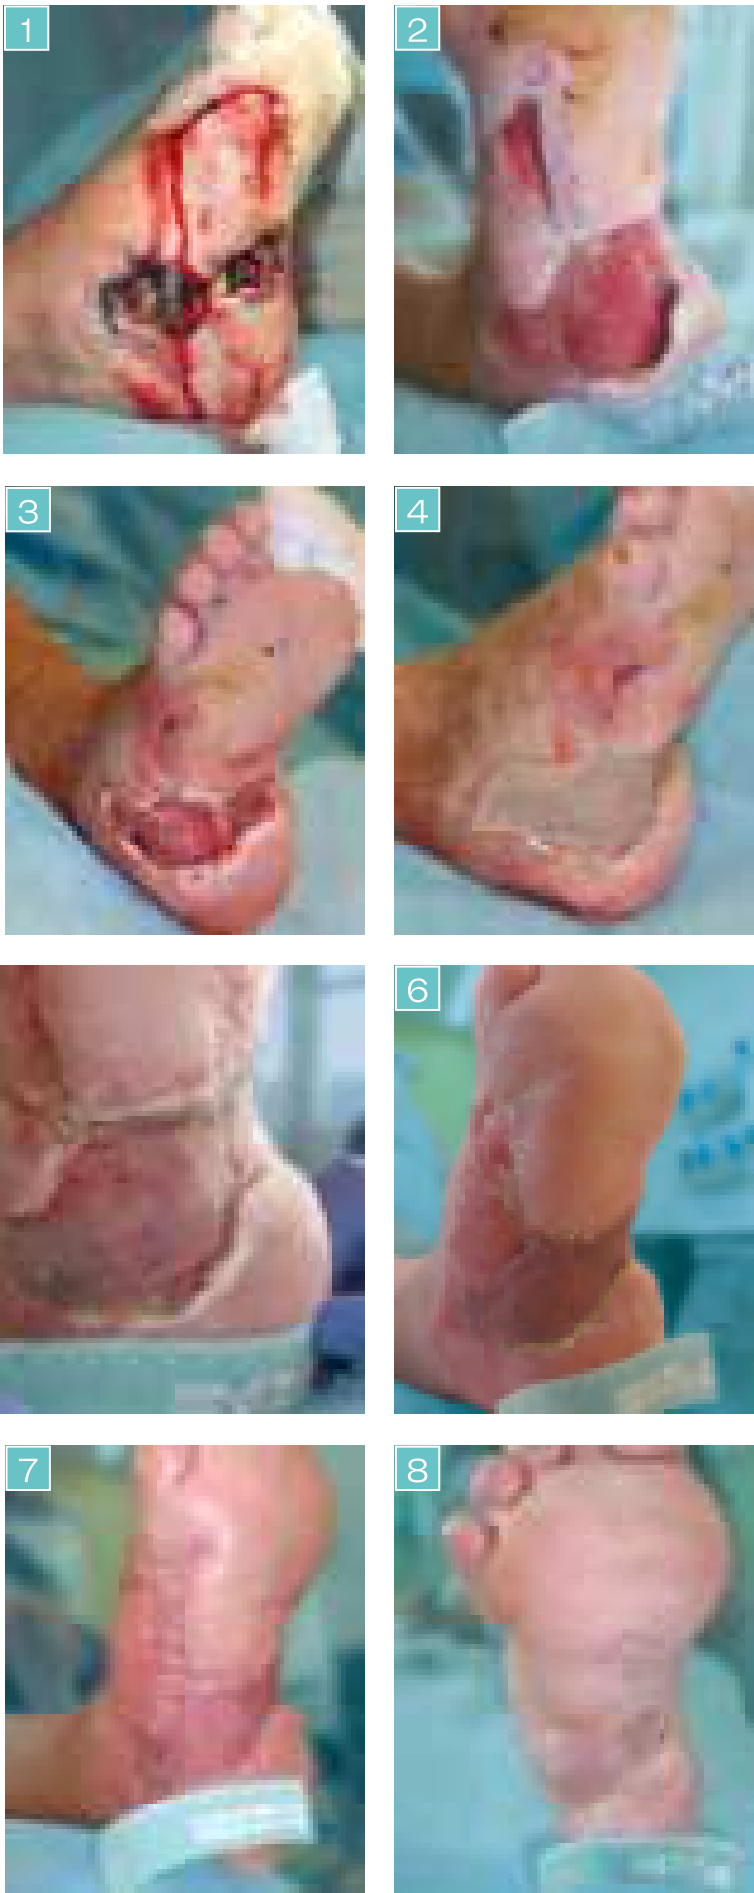
A 60-year-old male with diabetic foot syndrome and a history of obesity and coronary heart disease, presented with a gangrenous right foot (Fig.1). An emergency bedside debridement was performed and IV antibiotics were started. At the following surgical debridement, the 5<sup>th</sup> metatarsal bone was resected. The wound was further debrided with the use of maggots. The wound bed was prepared with gauze-based Negative Pressure Wound Therapy (NPWT), which was set at 120 mmHg (Fig.2).

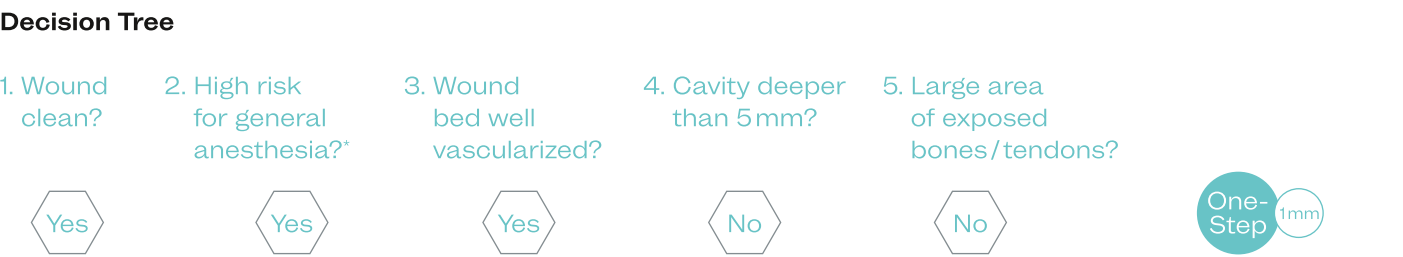
This patient with a neuropathic cavoid foot and an idiopathic clubfoot has a 4-year history of infected ulcerations on the plantar and lateral dorsal side of the foot. In the weeks prior to the reconstructive surgery, the Pseudomonas-infected ulcer was treated with MediHoney to control the infection. The wound bed was optimized with Hyiodine.

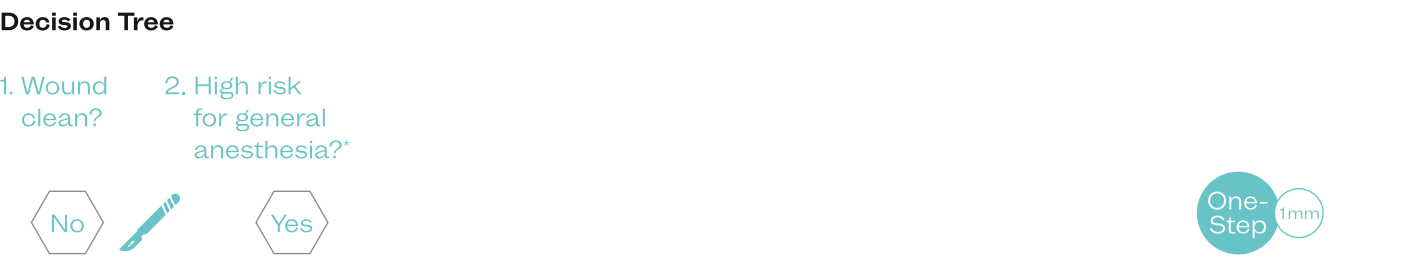
The 70-year-old patient suffers from a mixed chronic ulcers. The wound bed was debrided and conditioned for 2 – 3 weeks (Fig.1).

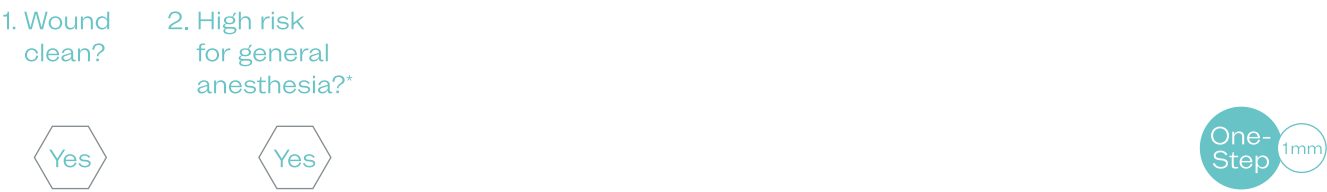
A 70-year-old patient suffered from an ischaemic stroke at home. He was found 4 days later lying on the floor unable to move and had developed large pressure ulcers of the left thorax and the lateral side of the left knee. After cardiopulmonary stabilisation at the intensive care unit, operative debridement of the necrotic tissue exposed both knee capsule and rib cartilage.

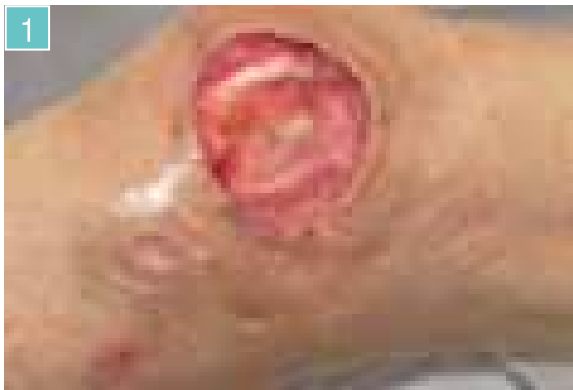
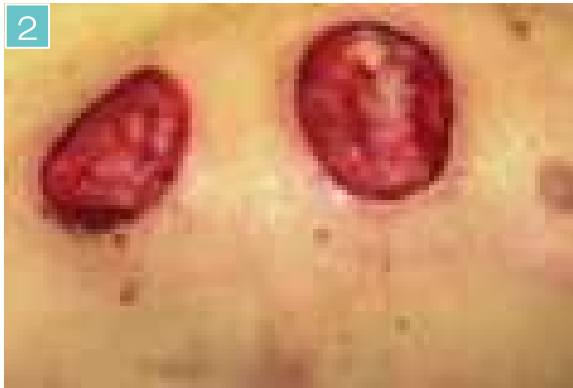
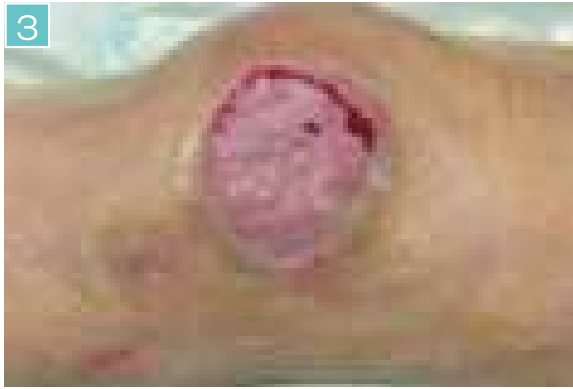
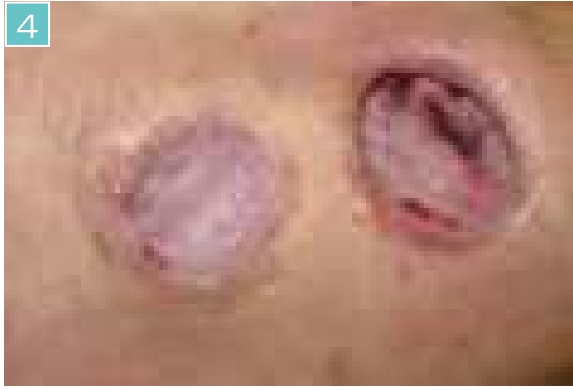
\* Courtesy of M. Öhlbauer, MD, Murnau, Germany

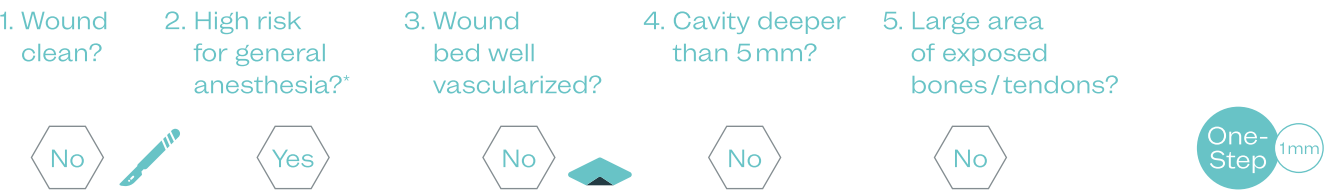
An 81-year-old male patient presented with a squamous cell carcinoma in the left popliteal fossa. The ulceration was growing already for 5 years.

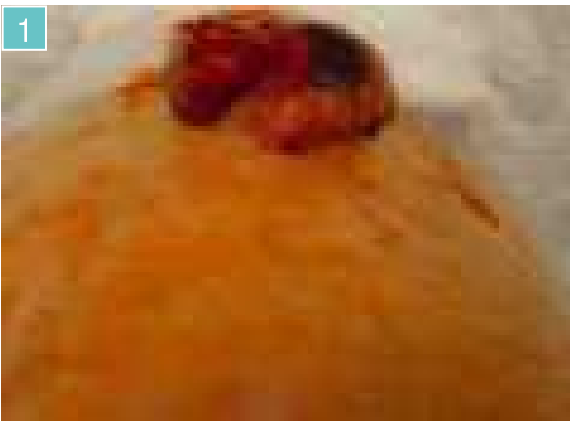
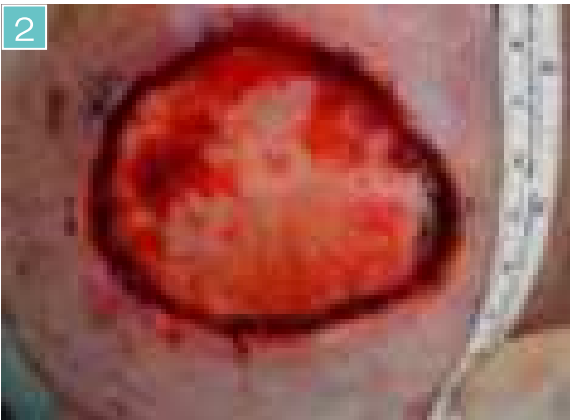
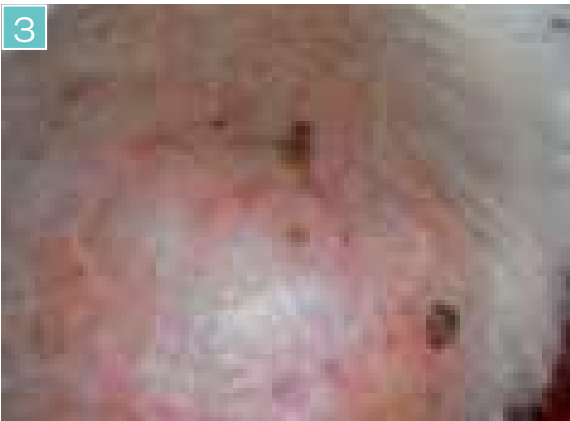
\* Courtesy of V. Wedler, MD, Frauenfeld, Switzerland

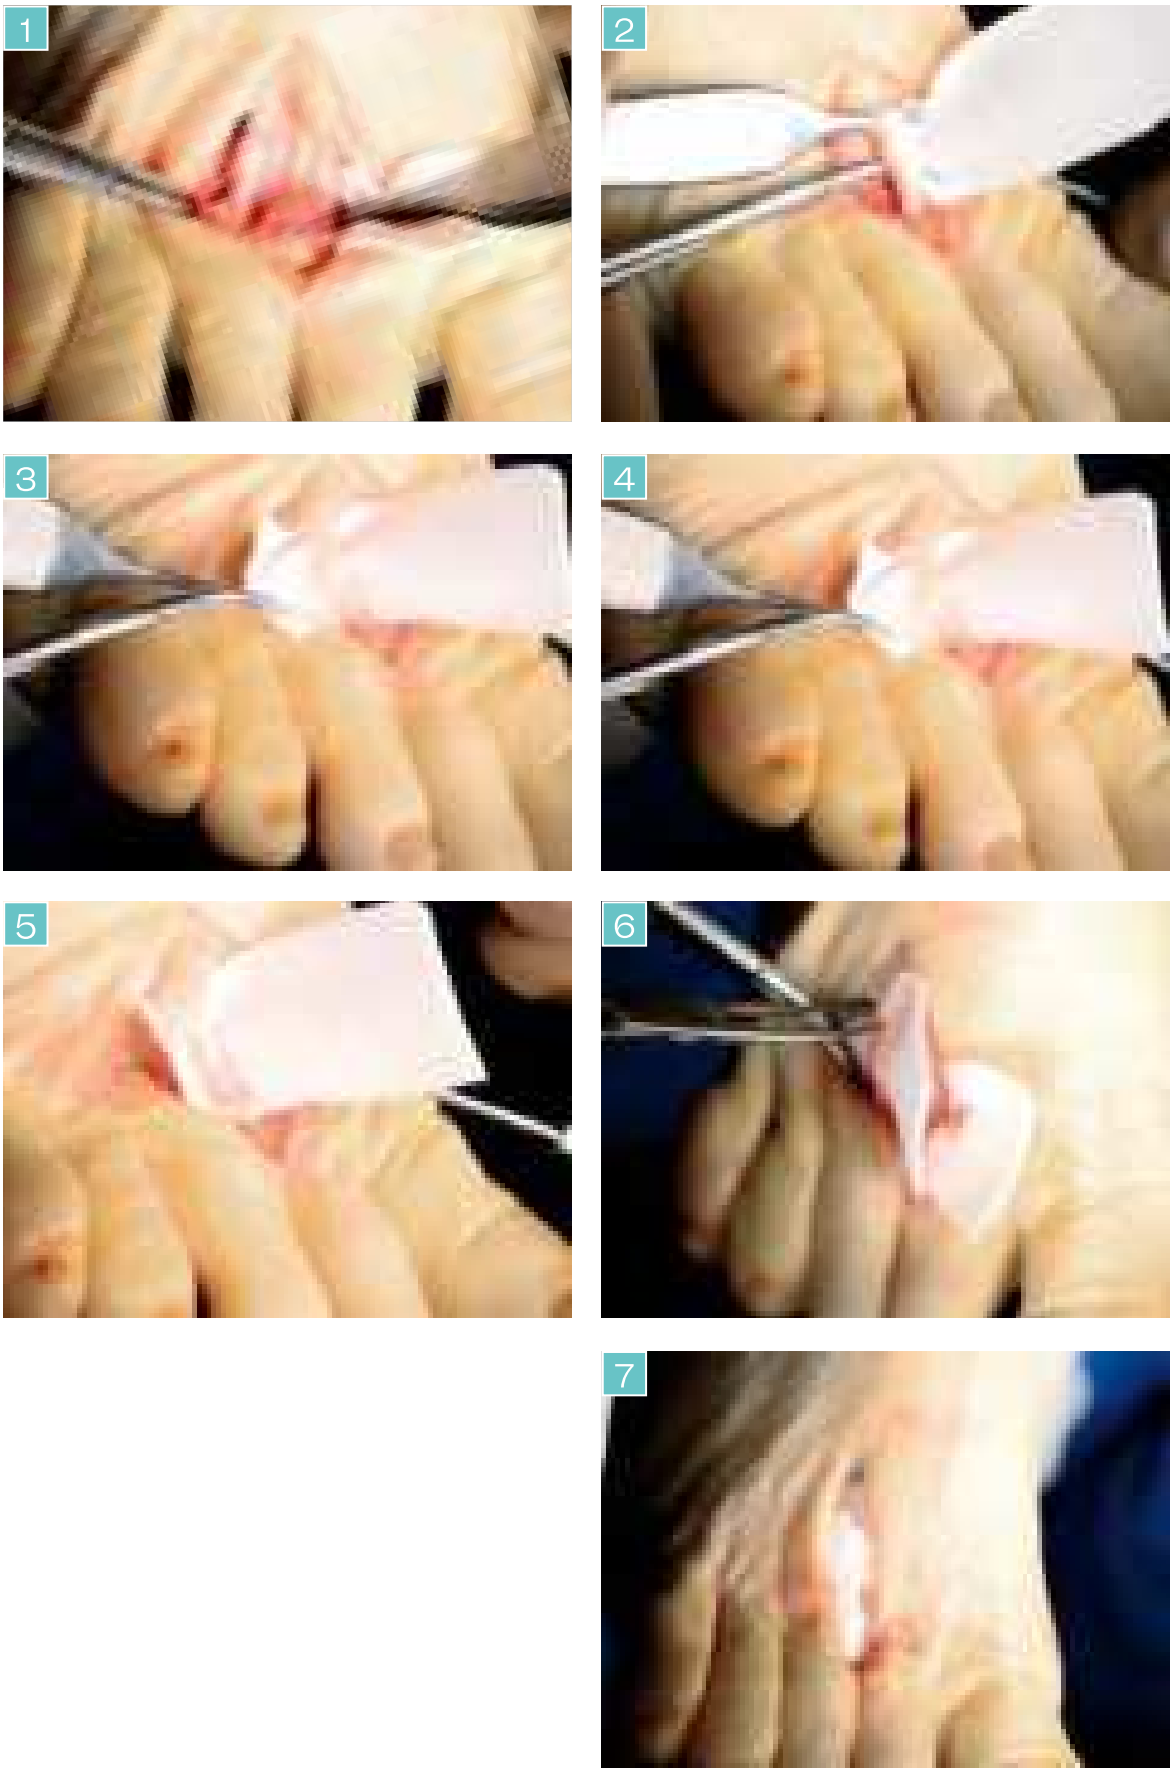
\* Courtesy of U. Graf, MD, Zurich, Switzerland

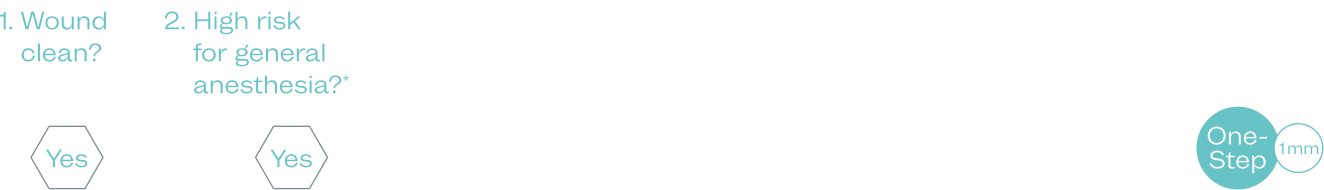
An 80-year-old patient with a history of hypertension, was referred with a suspicious lesion on the dorsum of the left hand, which was confirmed to be a squamous cell carcinoma by histopathological examination.

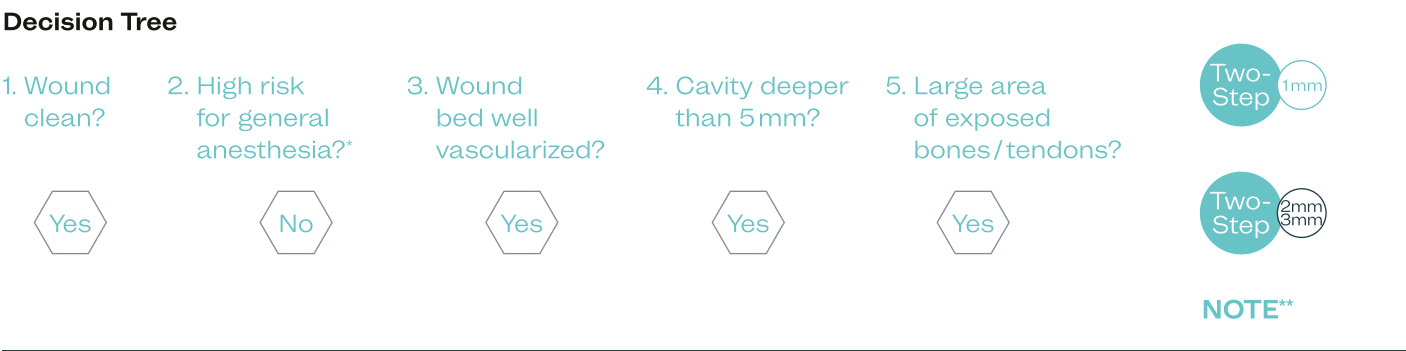
Consecutive patient underwent female-to-male affirming surgery. On the preoperative day, the flap was drawn on the non-dominant hand and an Allen test was performed to confirm vascular support from the ulnar artery. Under a tourniquet, the flap was raised distally to proximally and care was taken to meticulously clip all vessel branches. The radial sensory nerve (asterisk Fig. 1) was identified, dissected, and spared. The flap was raised in a subfascial plane and care was taken to include the proximal sensory nerves, veins and axial pedicle.

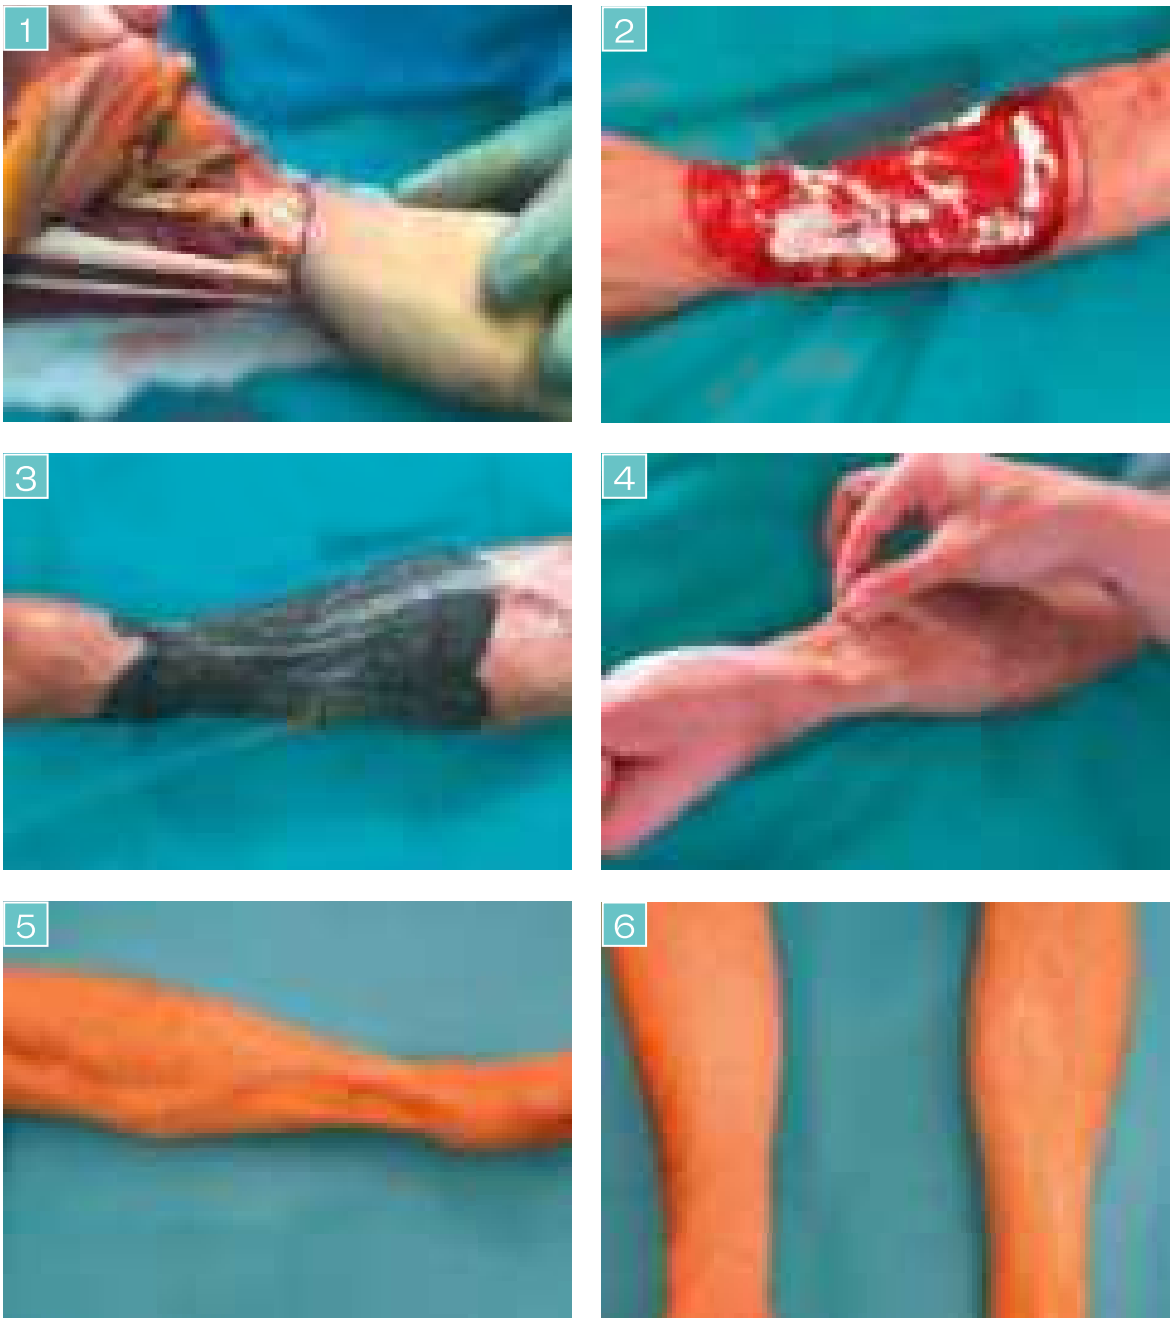
\* Courtesy of W. Watfa, MD, Lausanne, Switzerland. Watfa et al., MatriDerm® Decreases Donor Site Morbidity After Radial Forearm Free Flap Harvest in Transgender Surgery, J Sex Med. 2017 Oct;14(10):1277-1284.

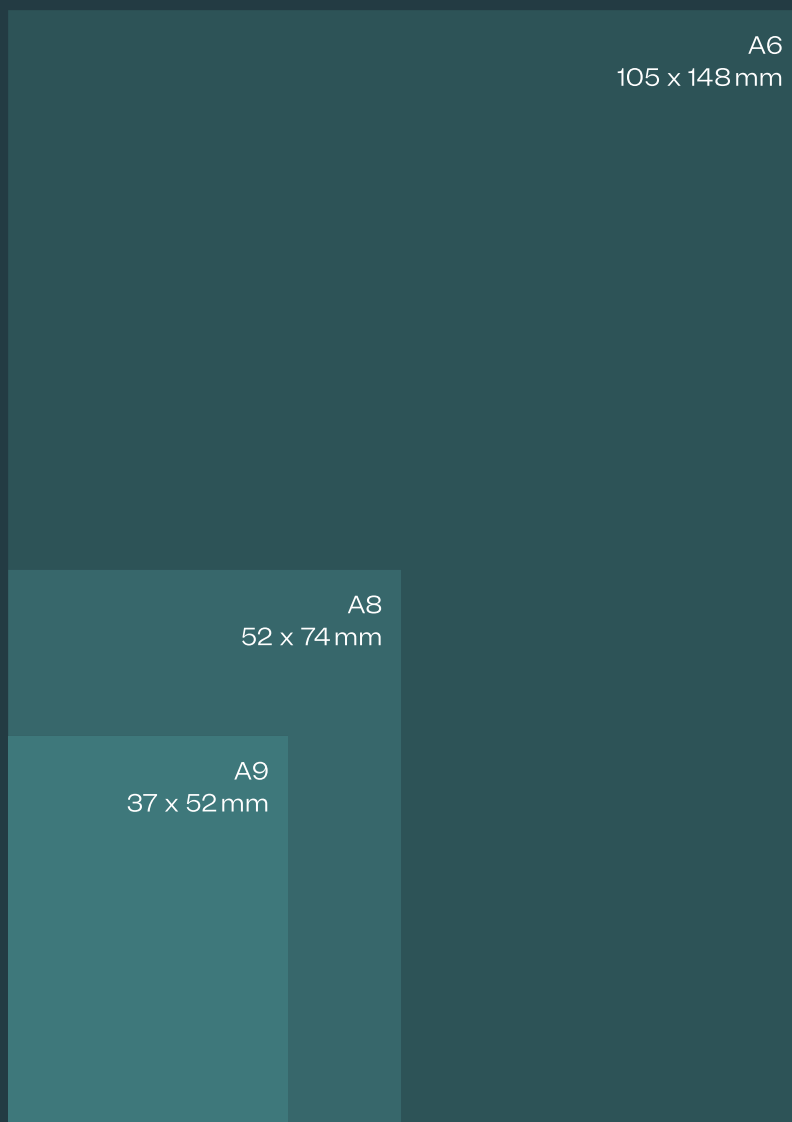
All product and company names are trademarks™ or registered® trademarks of their respective holders. Use of them does not imply any affiliation with or endorsement by them.
