Flexible solutions for **complex** wound reconstruction

Table of contents

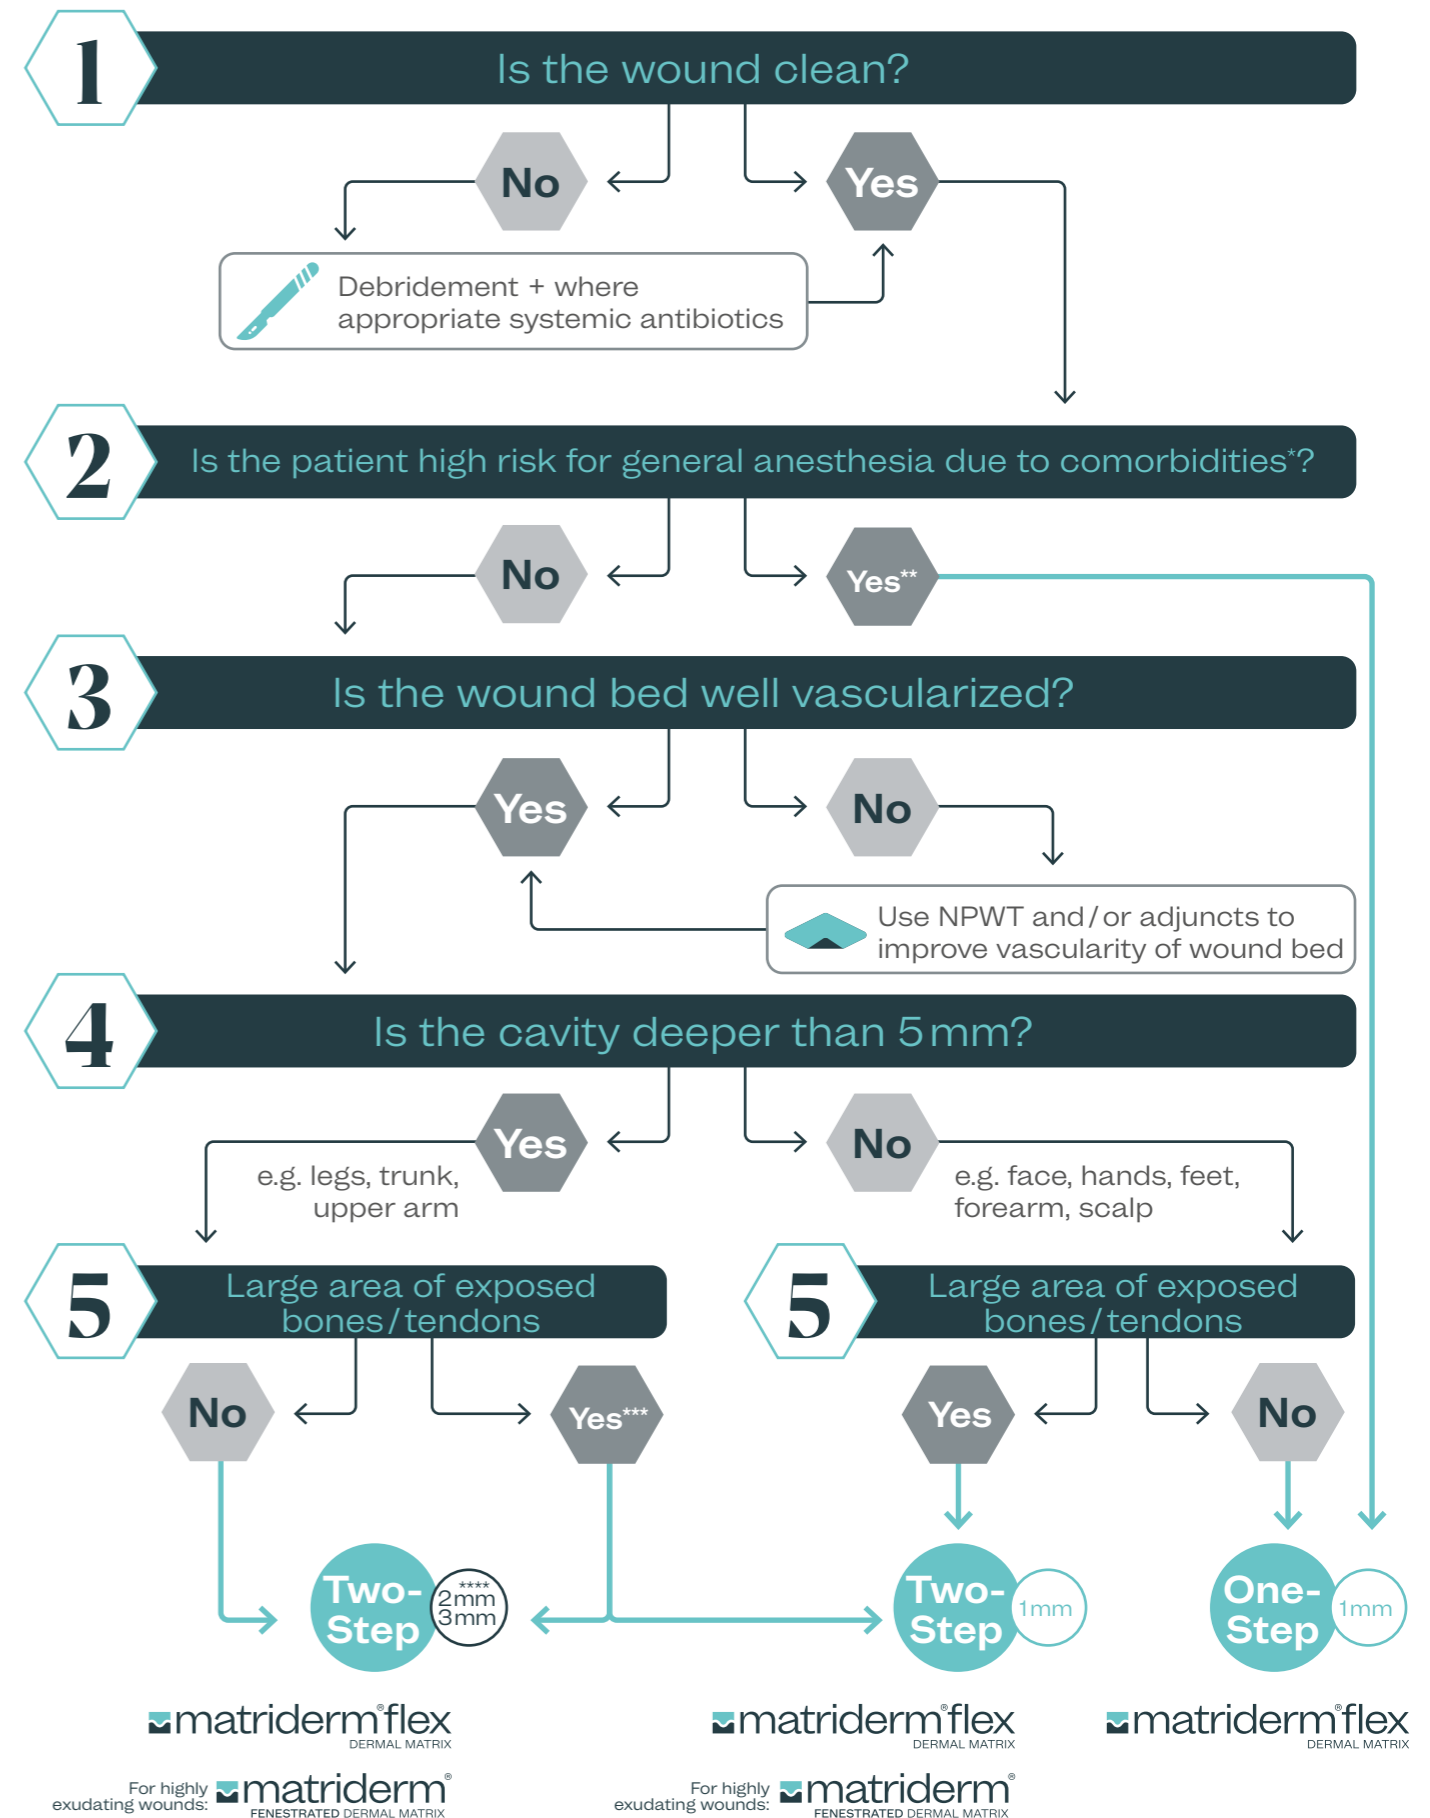
¹ Panayi A. et al. Evidence based review of negative pressure wound therapy, World J Dermatol. Feb 2, 2017; 6(1): 1-16

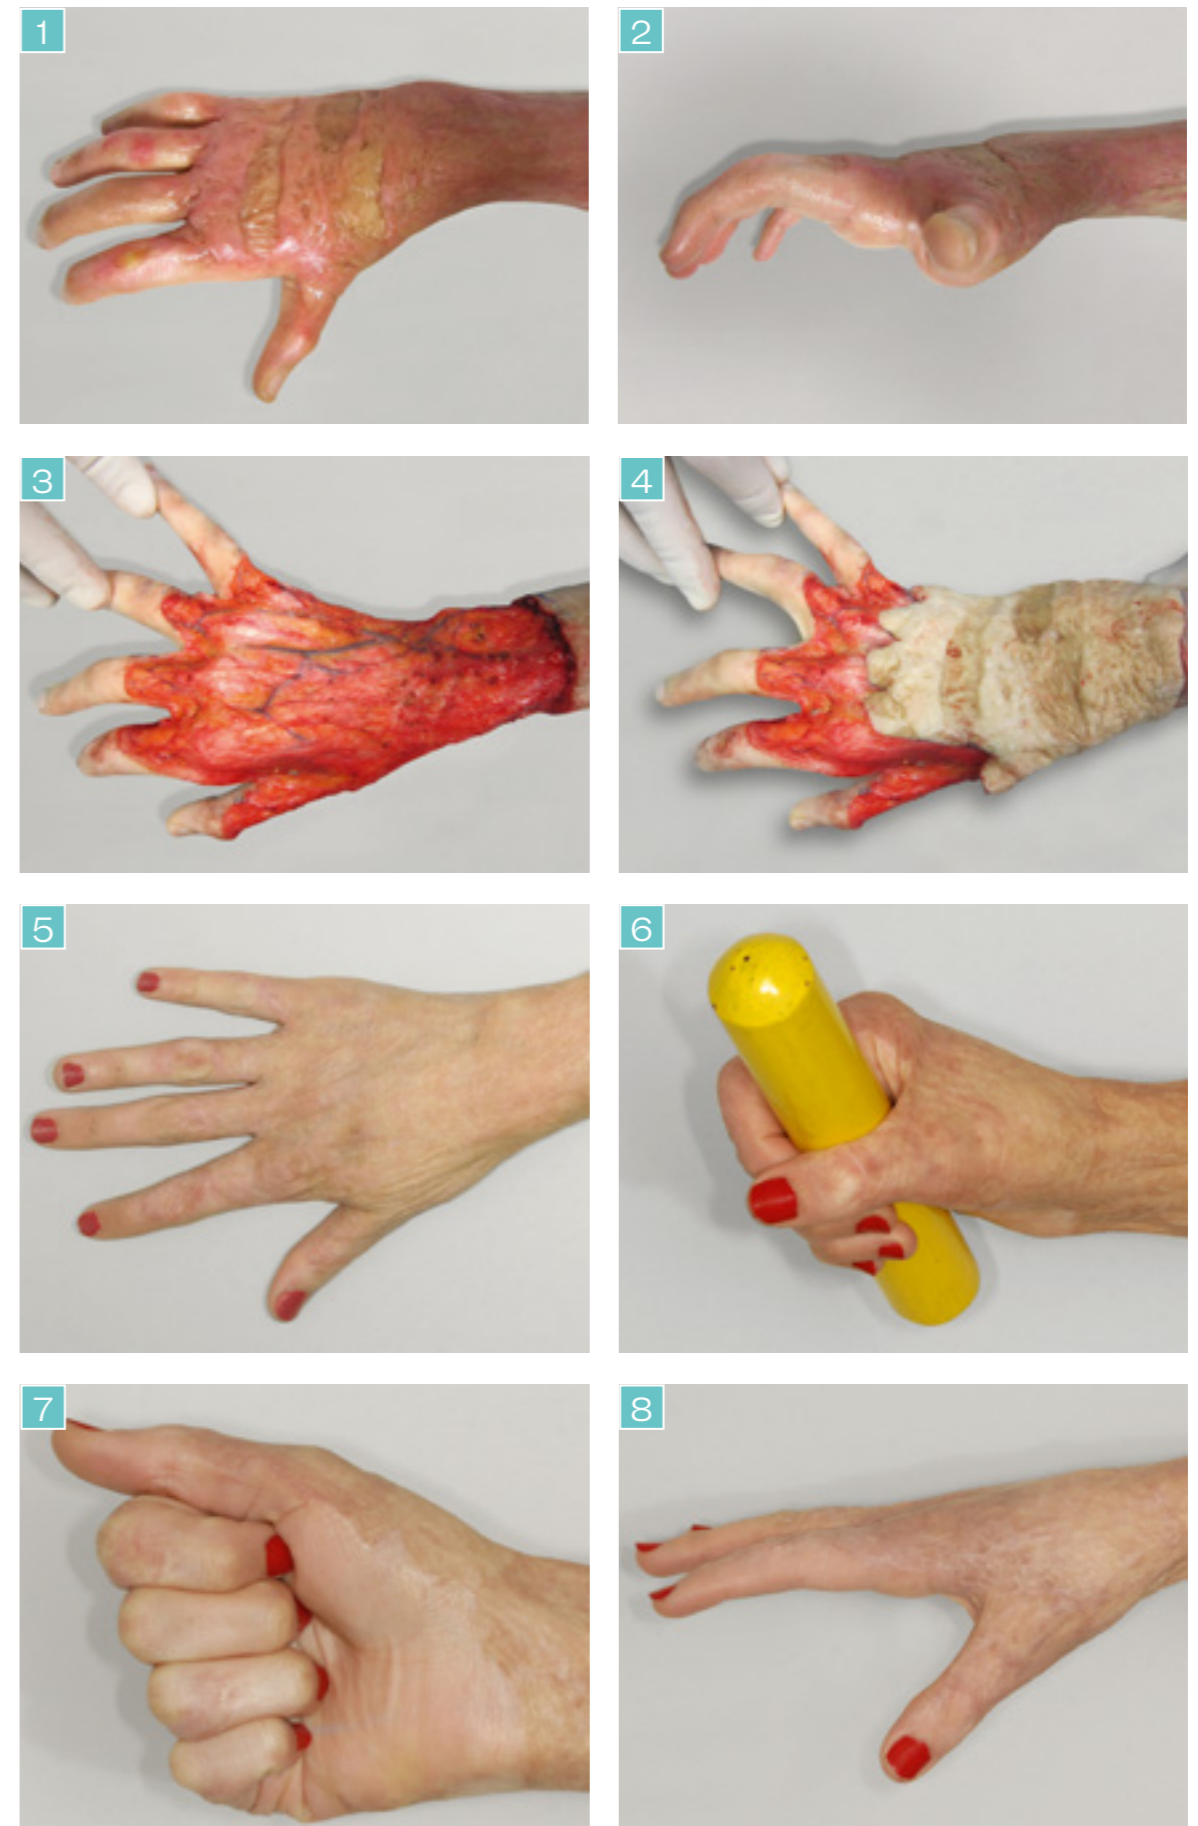
* Courtesy of L. Kamolz, MD, Graz, Austria

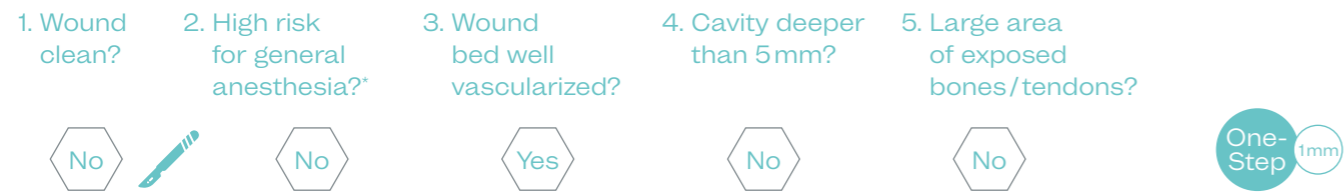
A 2-year-old child presented with a scald burn on the right foot (Fig.1). At the subsequent surgery the wound was carefully debrided (Fig.2). Due to the higher risk of contracture because of the young age of the patient, it was decided to use MatriDerm® in an attempt to prevent scar tissue formation and contracture.

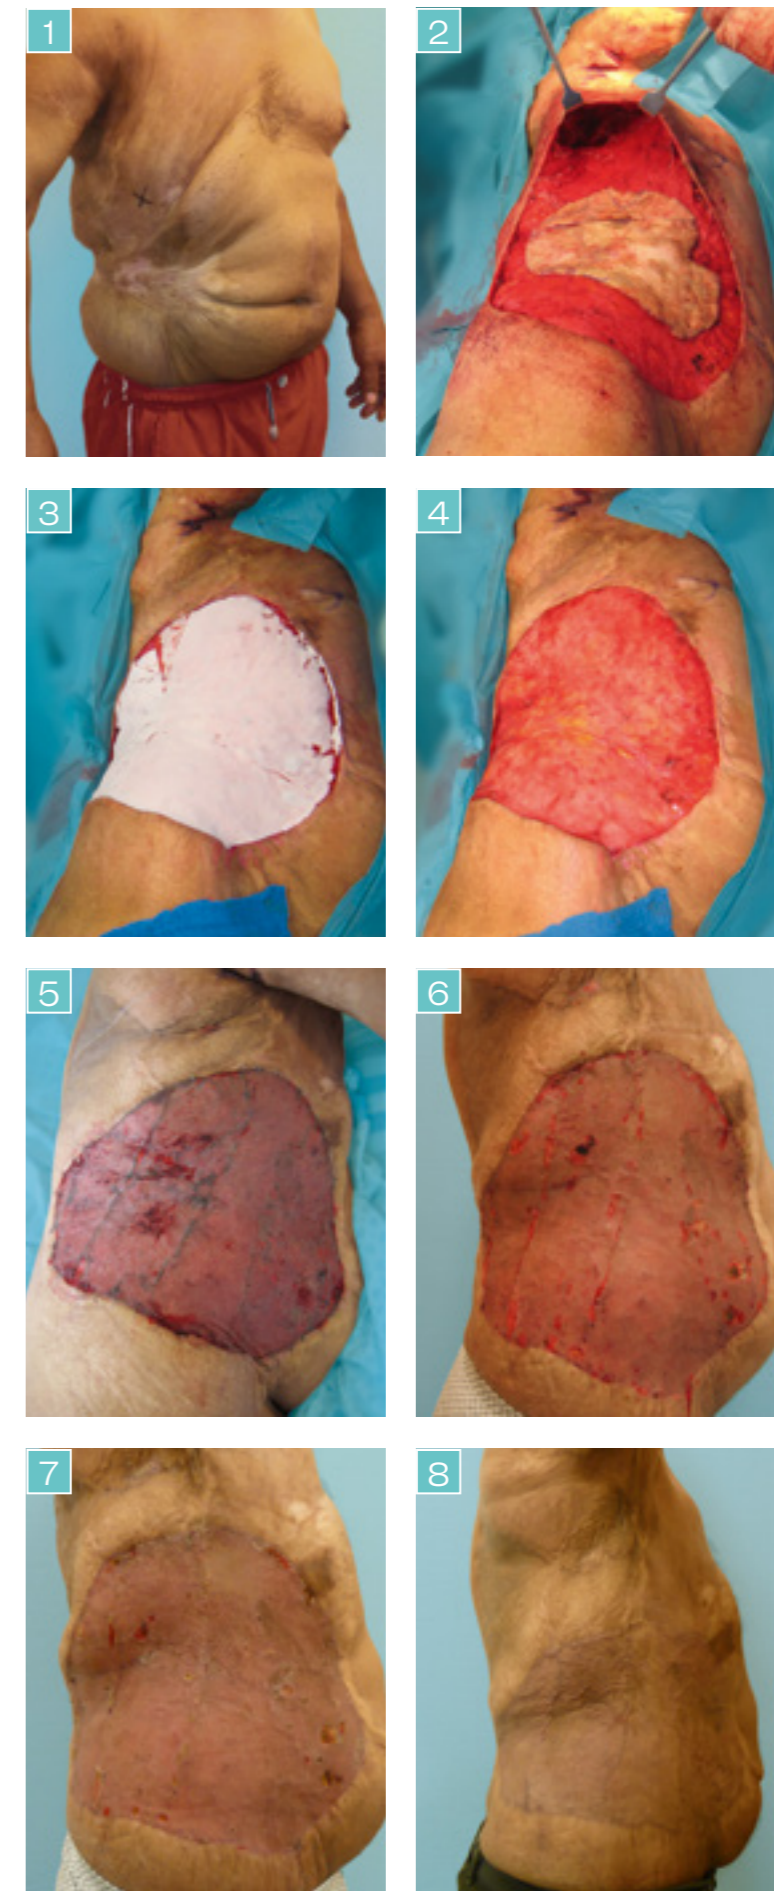
* Courtesy of J. Grünert, MD, St. Gallen, Switzerland

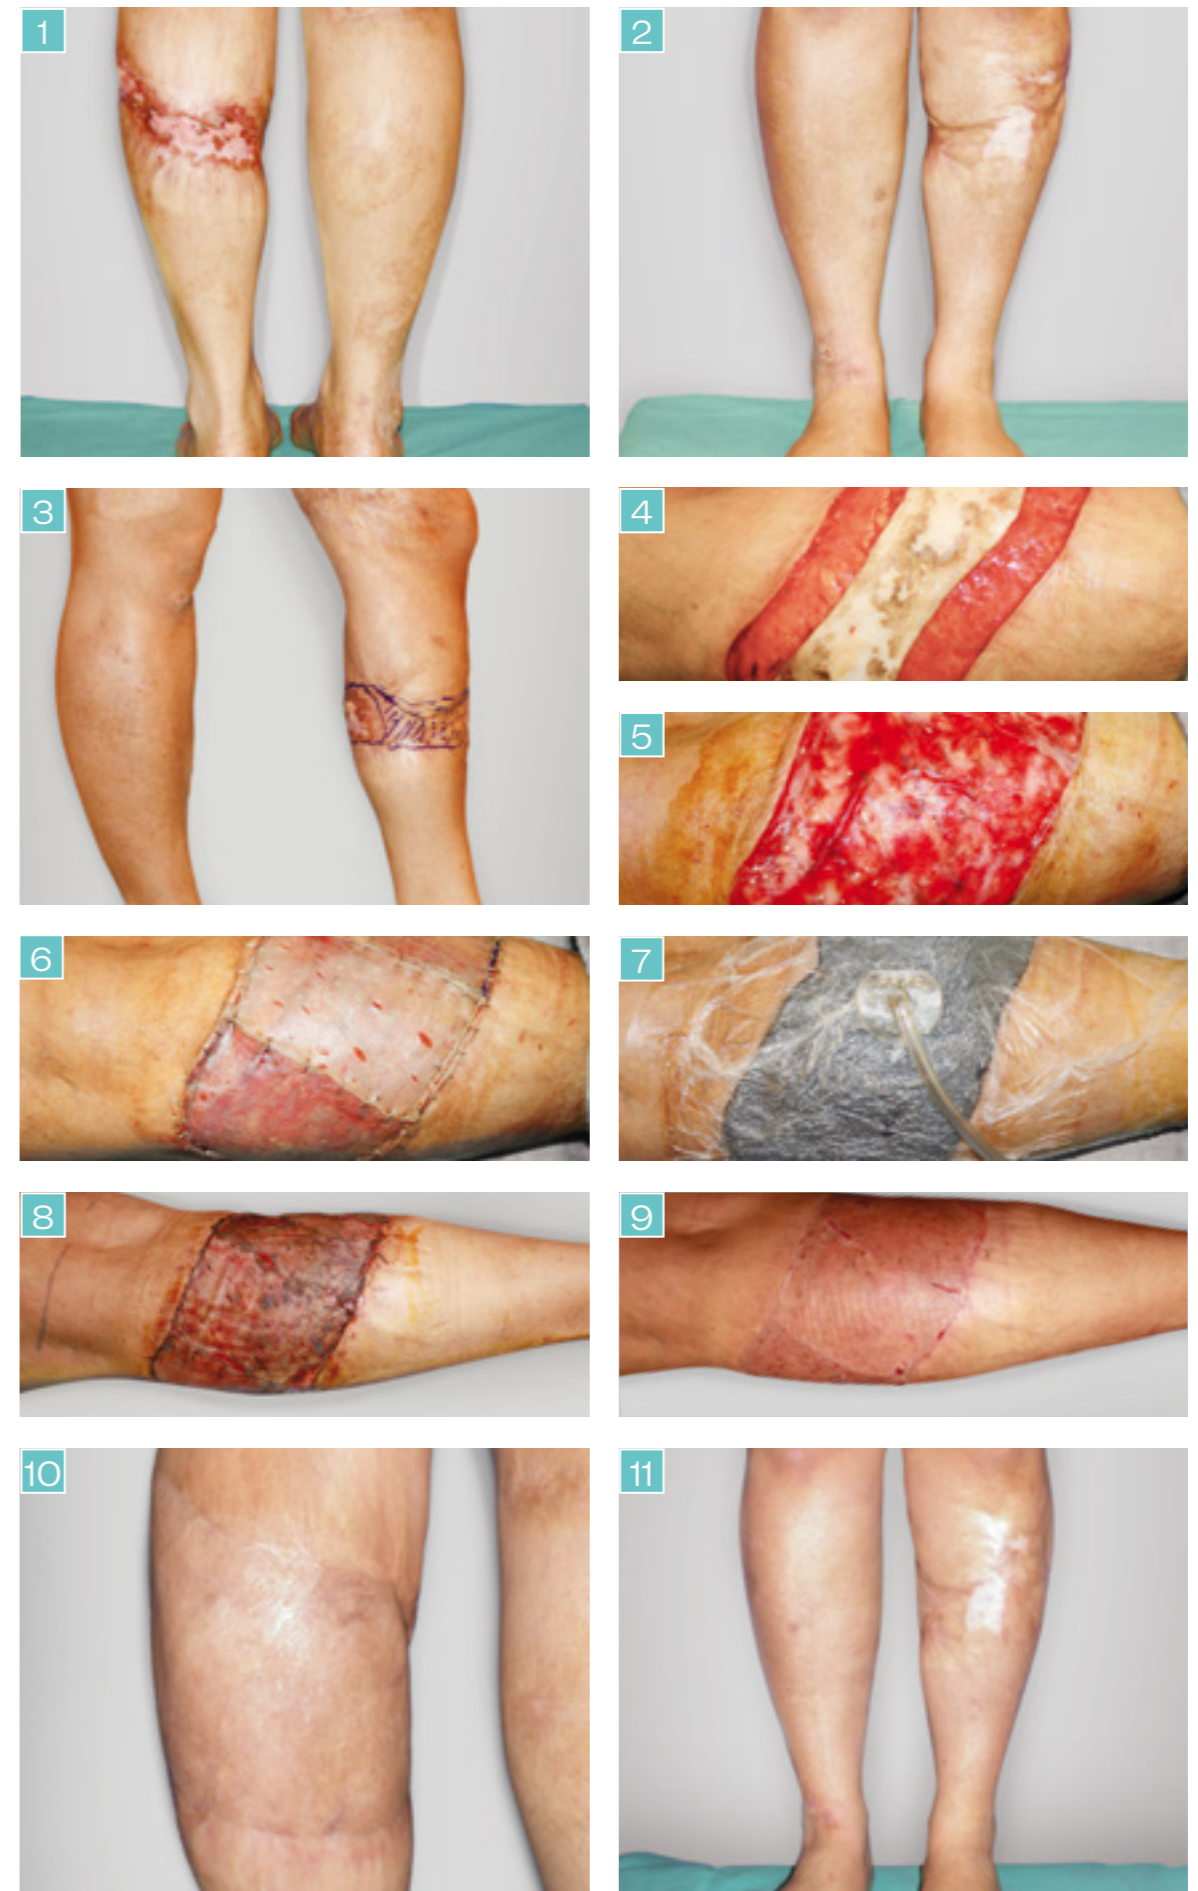
* Courtesy of A. Modarressi, MD, Geneva, Switzerland

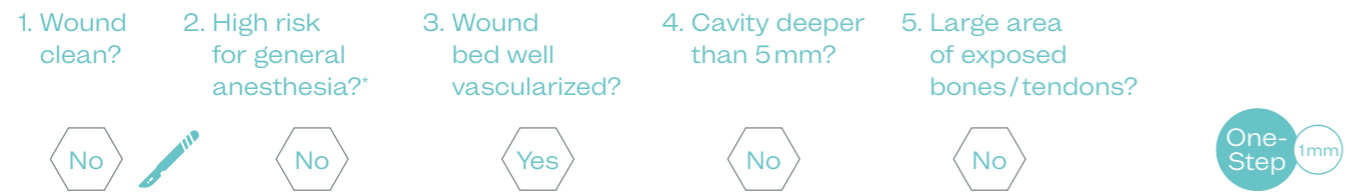
A 42-year old male presented with a flame burn on chest and neck (60% TBSA) (Fig.1). This is a challenging region due to high incidents of contractions, so high elasticity is very important.

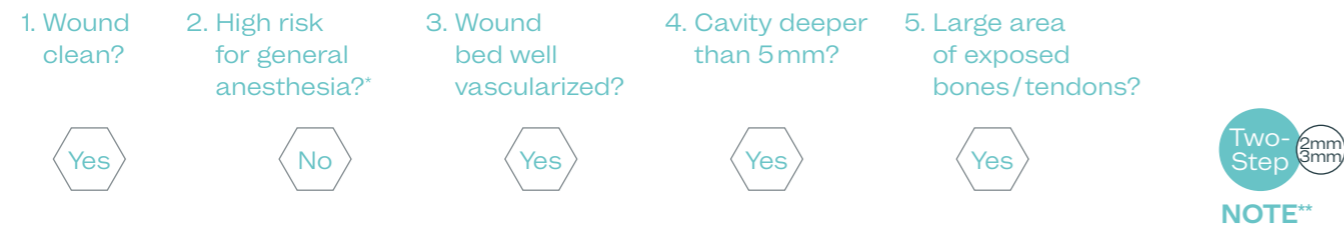
The patient suffered from a work accident where his arm was crushed into an industrial roller, which resulted in multiple bone fractures and degloving of his right arm (Fig. 1).

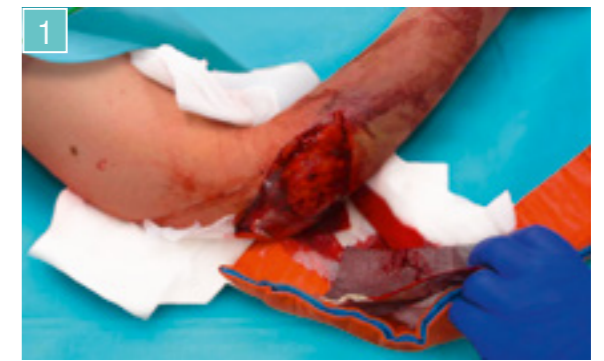
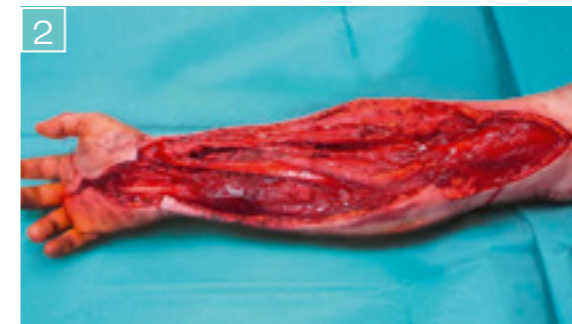
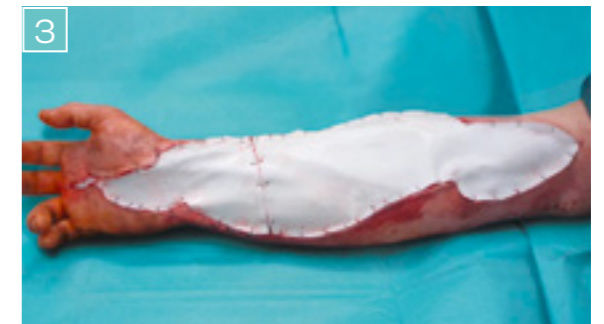
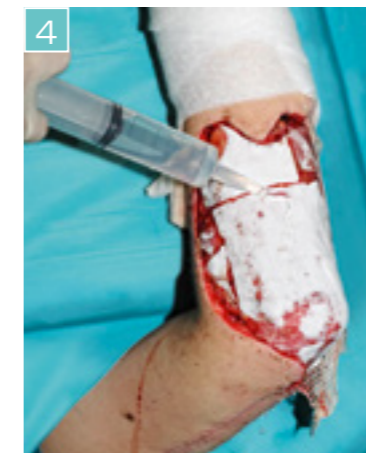
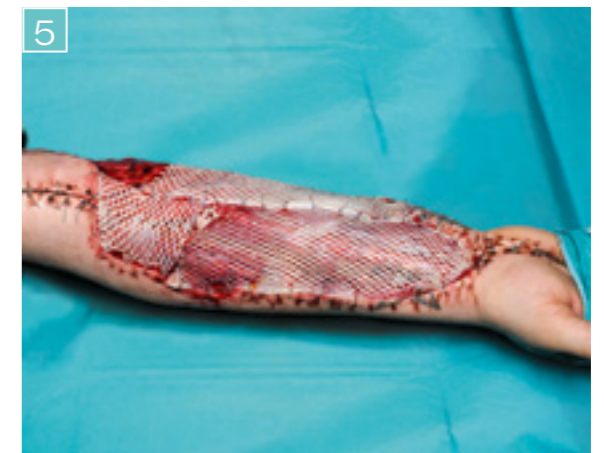
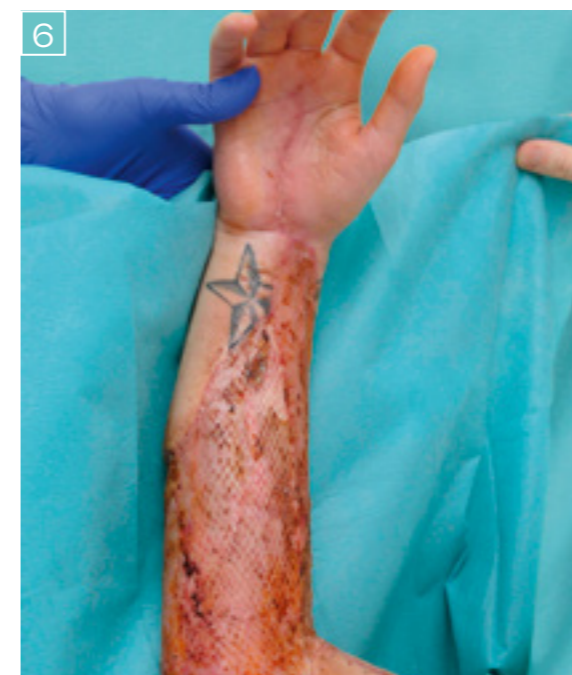
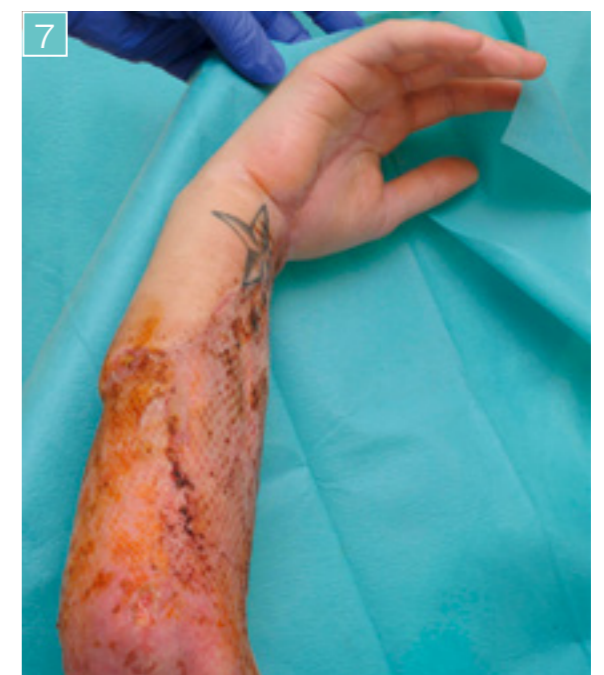
* Courtesy of M. Kerl, MD, Graz, Austria

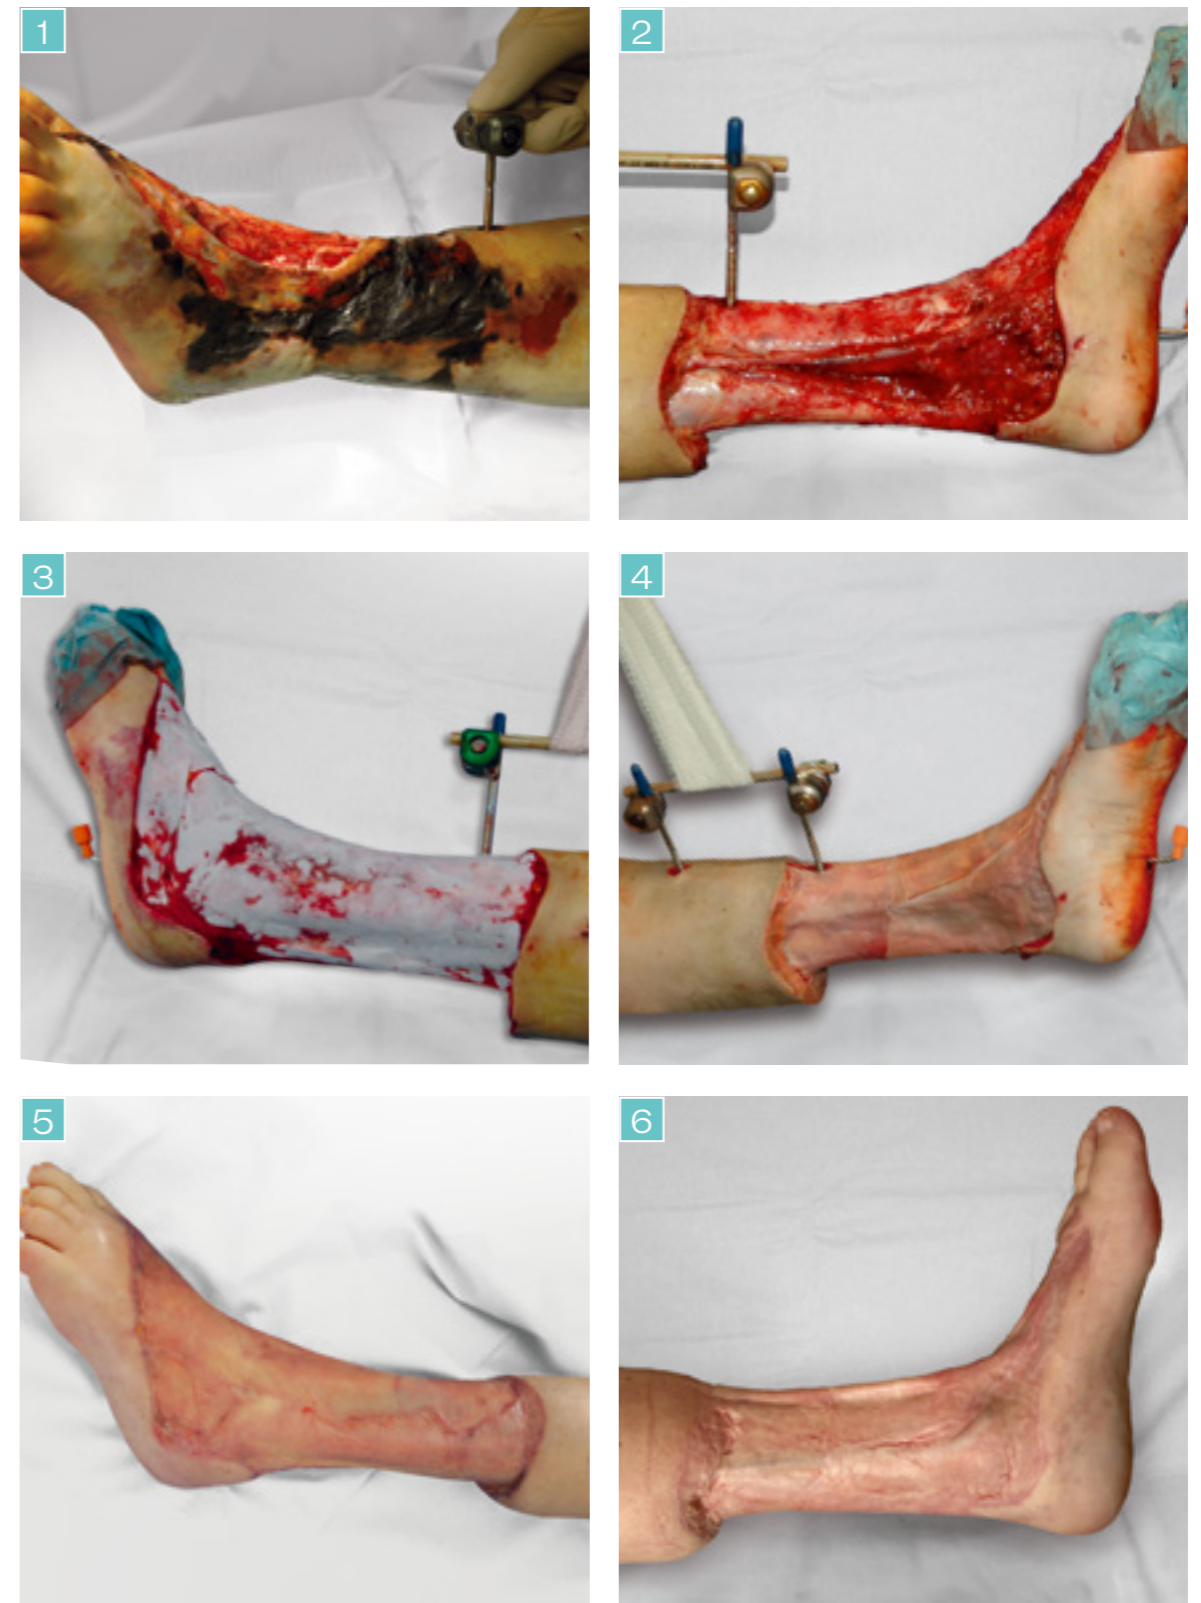
* Courtesy of M. Öhlbauer, MD, Murnau, Germany

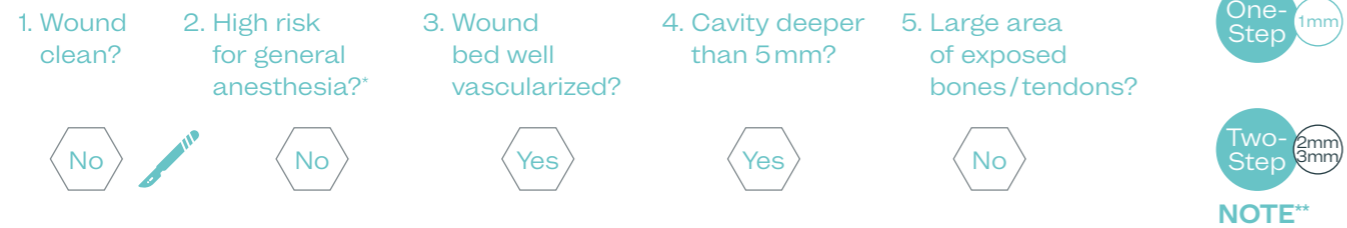
The patient was transferred to a special trauma clinic on day 5 post injury. Two-thirds of the proximal lower leg showed necrotic tissue (Fig.1). Parts of the lower leg fascia were destroyed. After debridement vital paratenon at the tibia was exposed (Fig.2). The tissue defect was covered with 1mm MatriDerm® and unmeshed split-thickness skin graft in a One-Step Procedure (Fig.3,4). Fixation was performed by negative pressure wound therapy for 1 week.

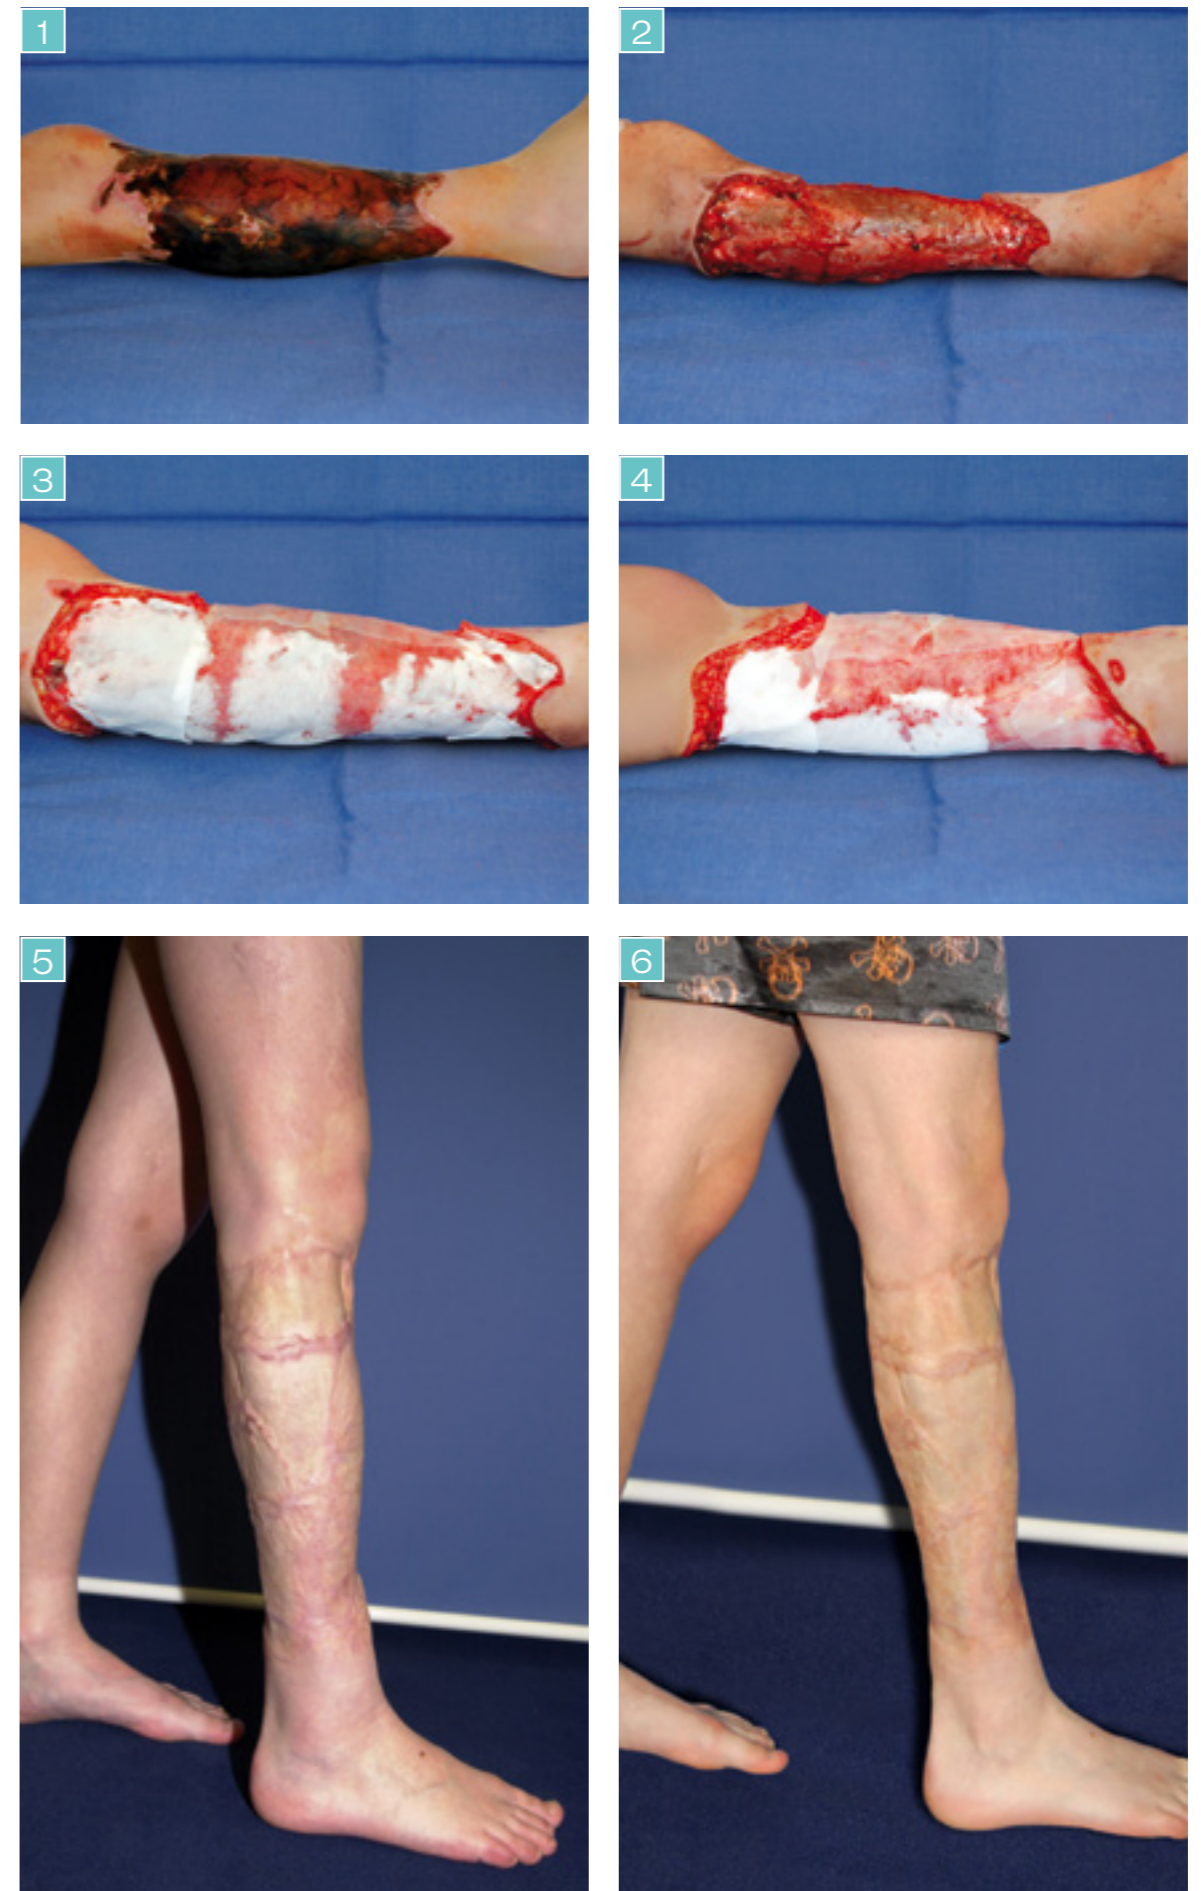
* Courtesy of M. Öhlbauer, B. Wallner and M. Miltz, MD, Murnau, Germany

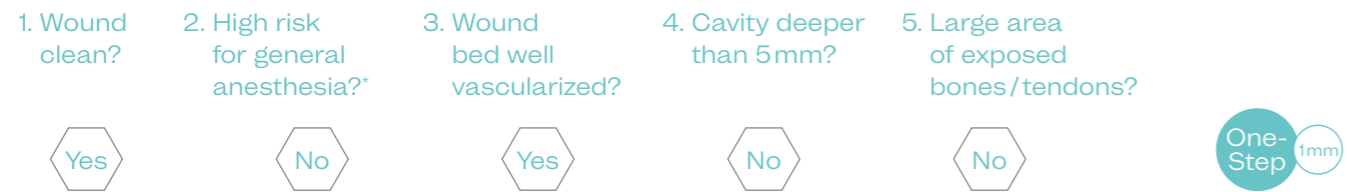
In this case a 60-year-old patient was hospitalized with an acute avulsion after motor-bike injury. The intra-operative view revealed a defect at the heel and a 2cm exposed Achilles tendon (Fig.1). The wound was treated with 1mm MatriDerm® and unmeshed split-thickness skin graft in a One-Step Procedure. 2.5 weeks later the wound area showed a closed skin with good tendency to heal (Fig.2). The physiotherapy started at this stage. A follow up of 5 weeks p. o. demonstrated a good development with a completely stable wound also over the Achilles tendon (Fig.3,4).

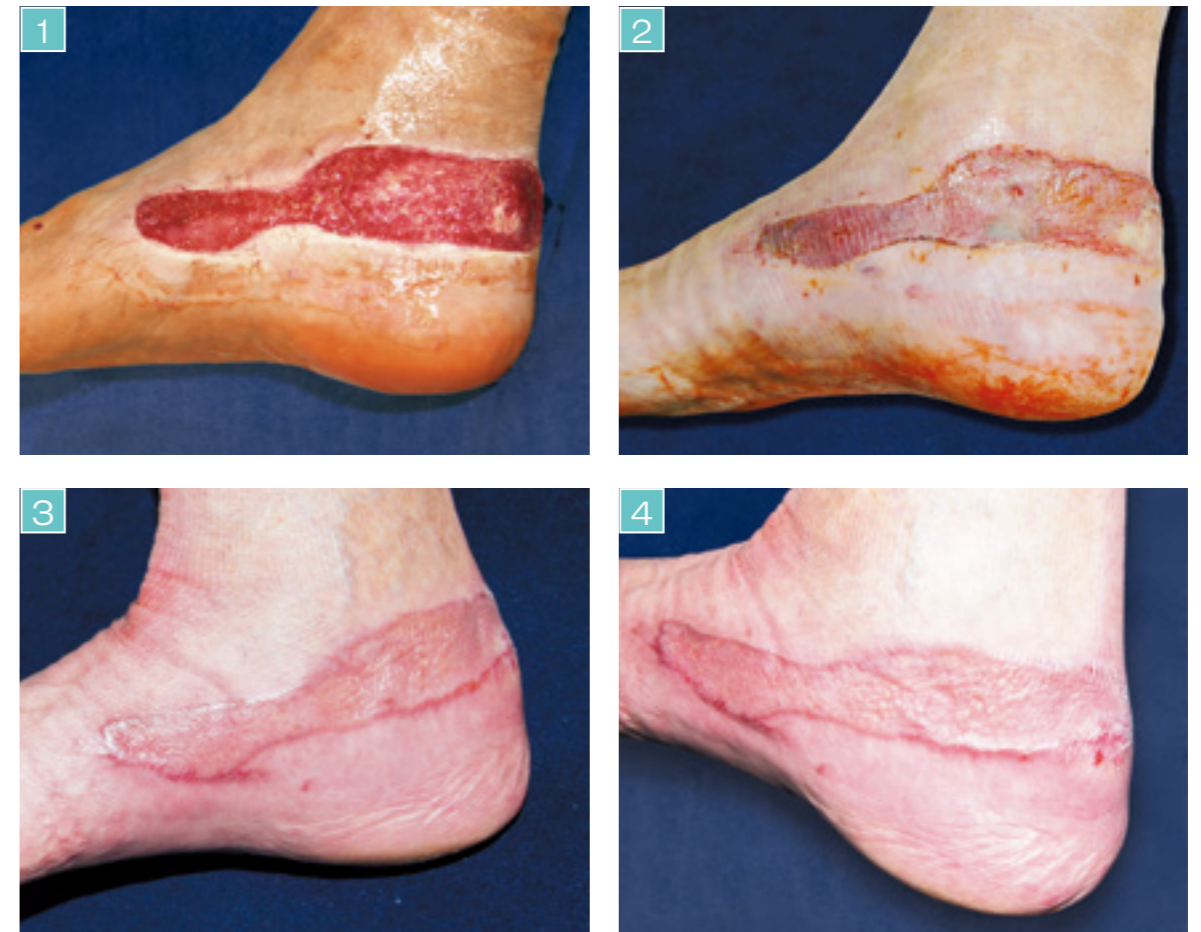
* Courtesy of U. Graf, MD, Zurich, Switzerland

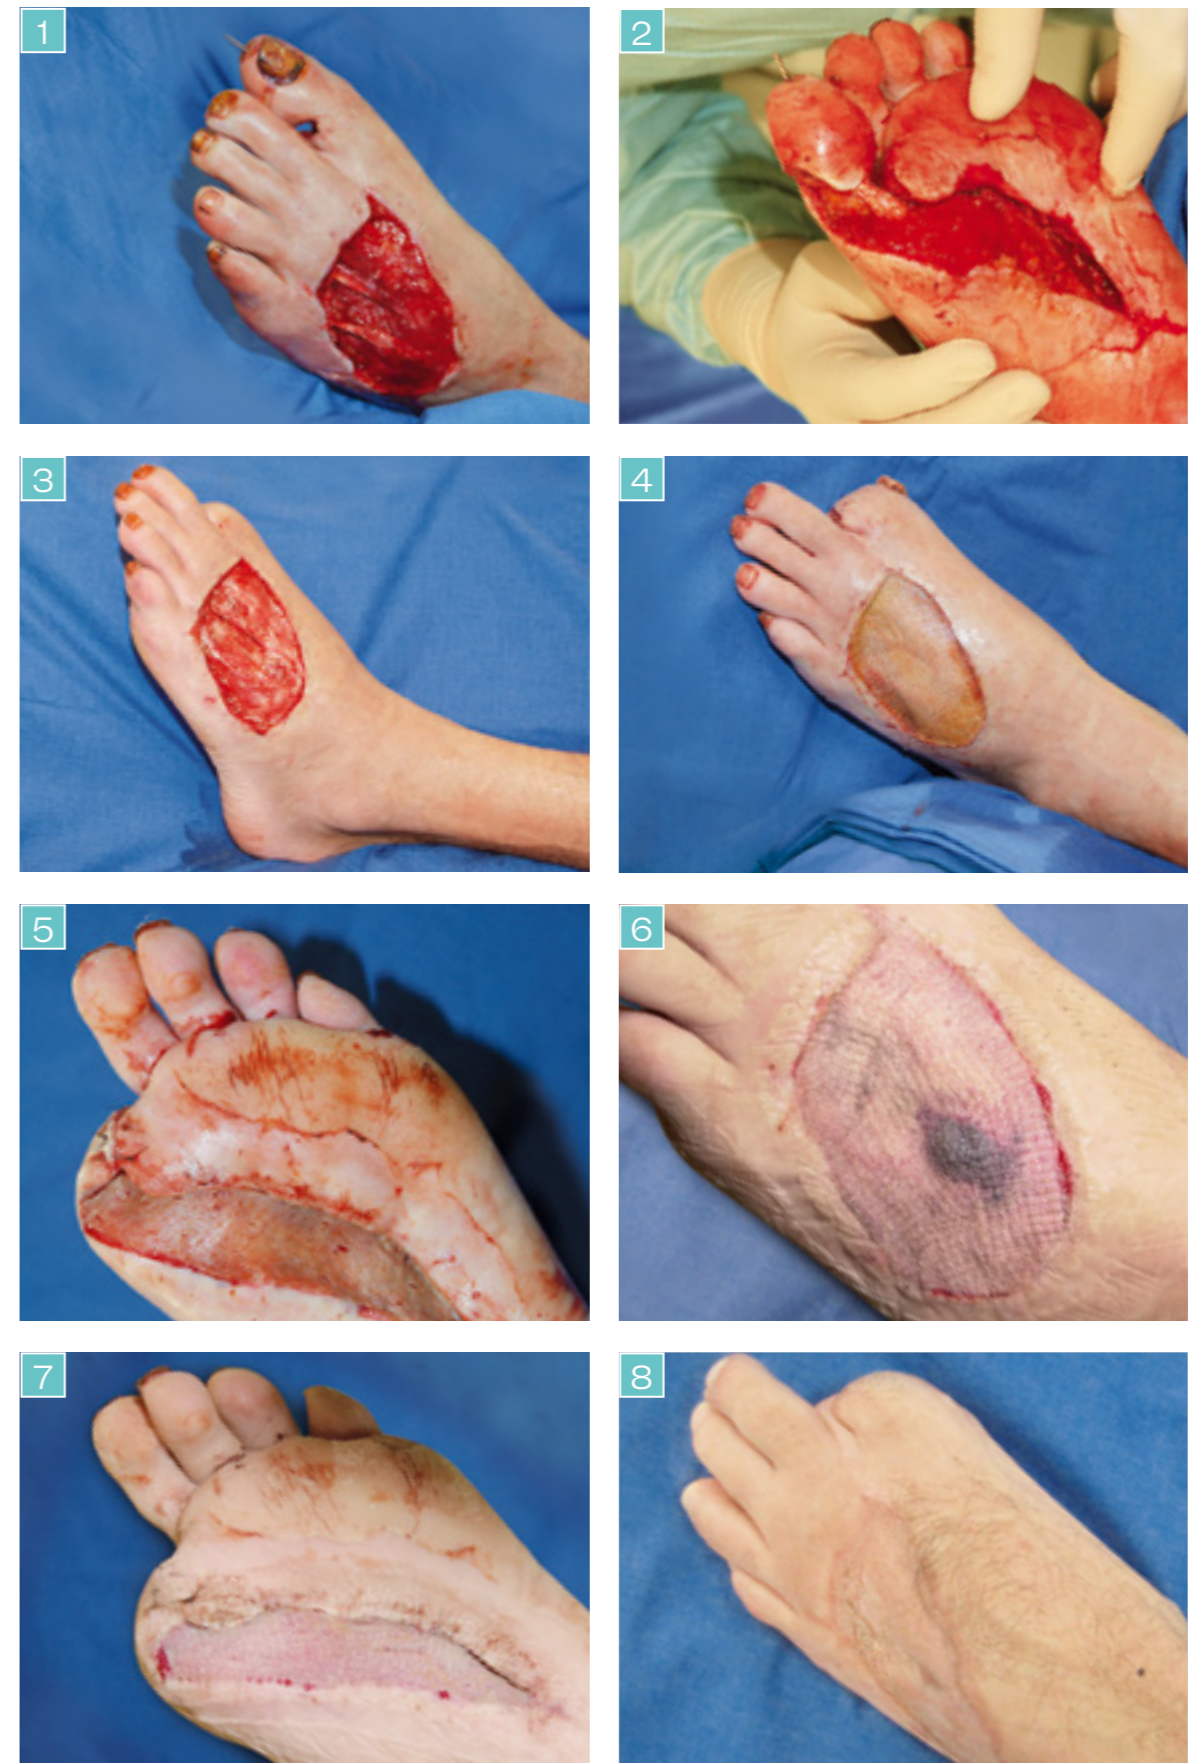
* Courtesy of M. Öhlbauer, B. Wallner and M. Miltz, MD, Murnau, Germany

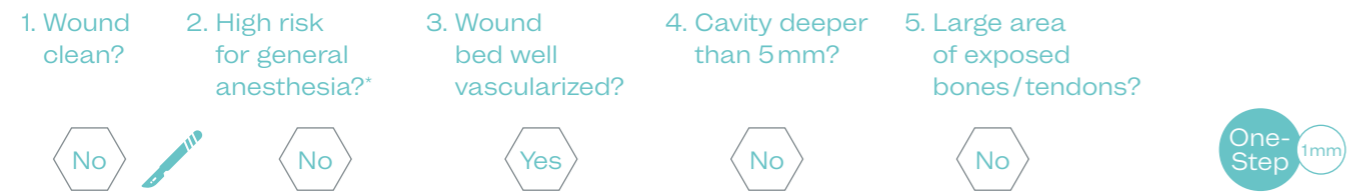
Initial view of the circular saw injury at the hand showing a deep soft tissue defect with involvement of the auricular and the annular finger (Fig.1). Based on the bone status a partial amputation to the mid-joint of the auricular finger was necessary. The wound closure was done with a retrograde pedicular forearm flap. Three days later the flap suffered from a necrosis caused by a septal vascular anomaly (Fig.2). 13 days after injury: Second surgery was required due to the flap loss.

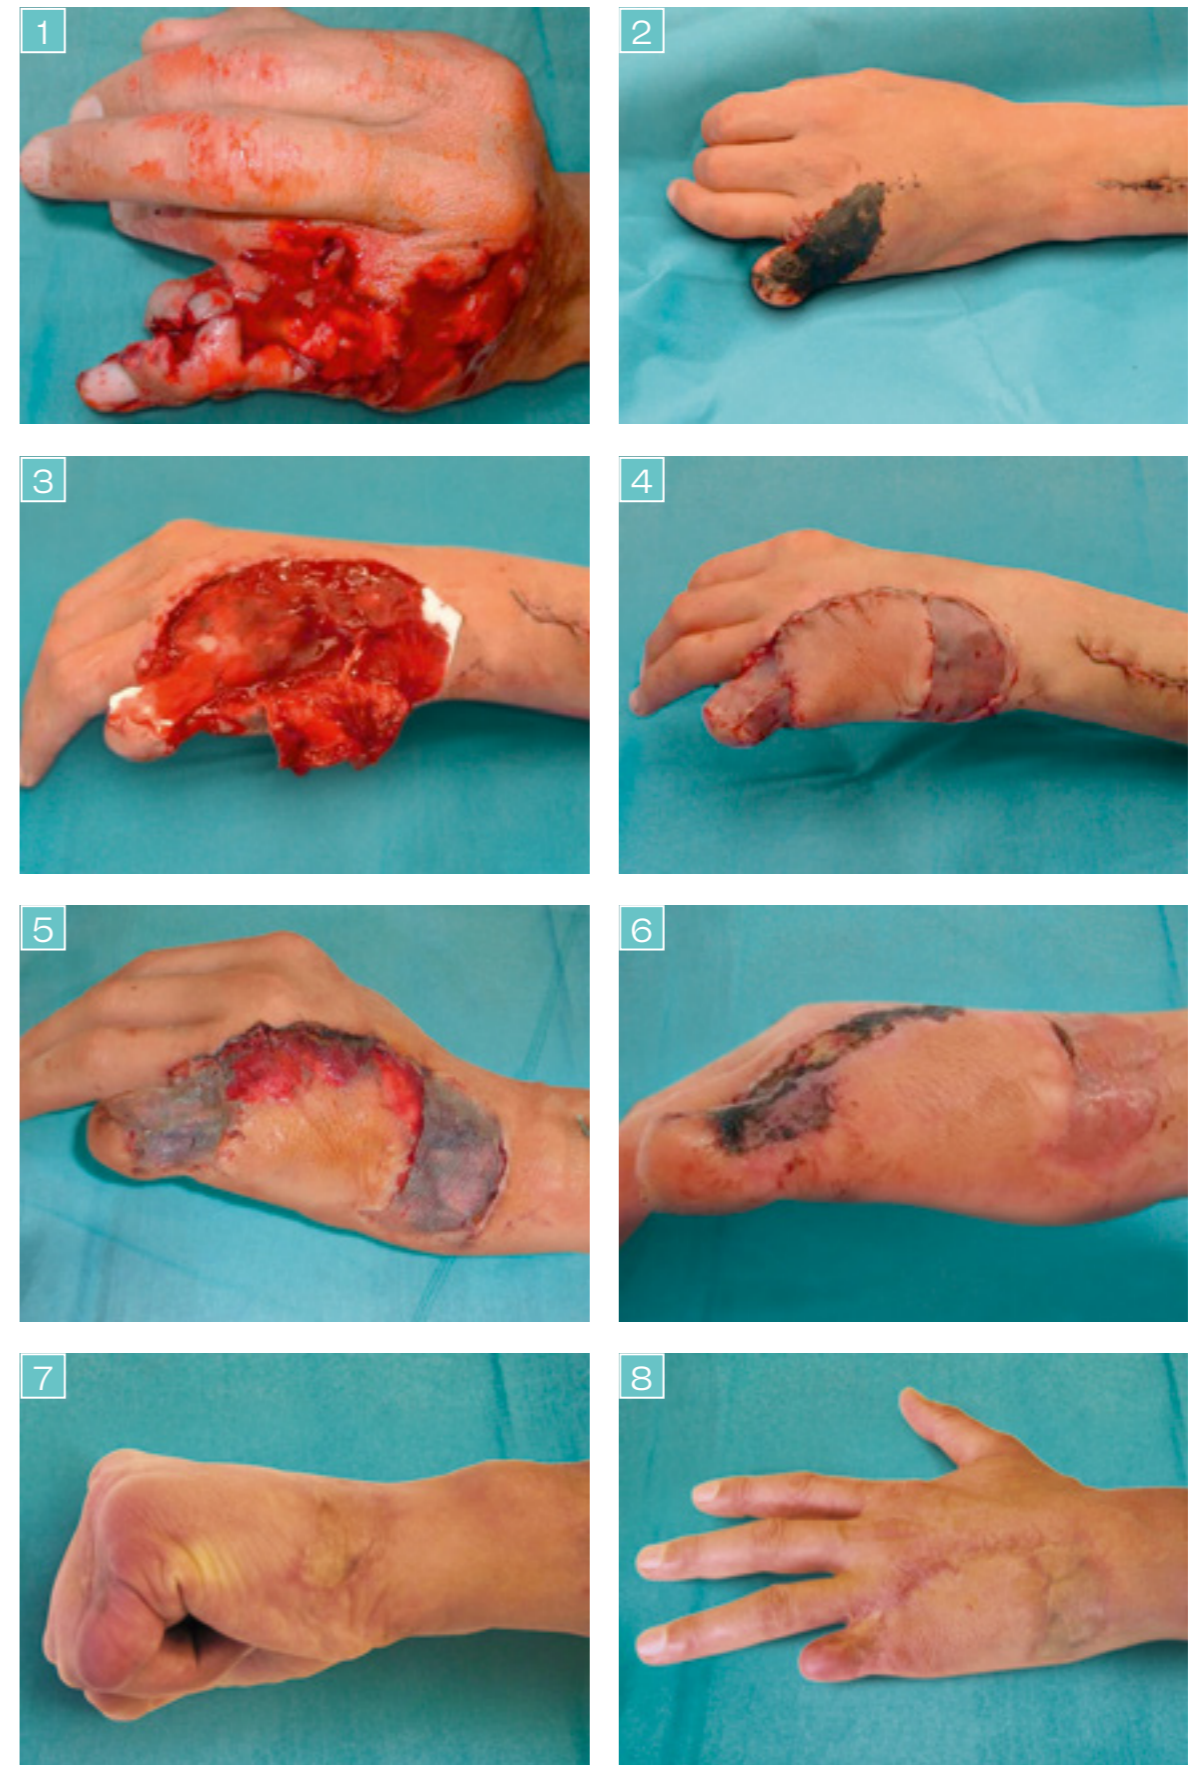
* Courtesy of L. Mathys, MD, Bern, Switzerland

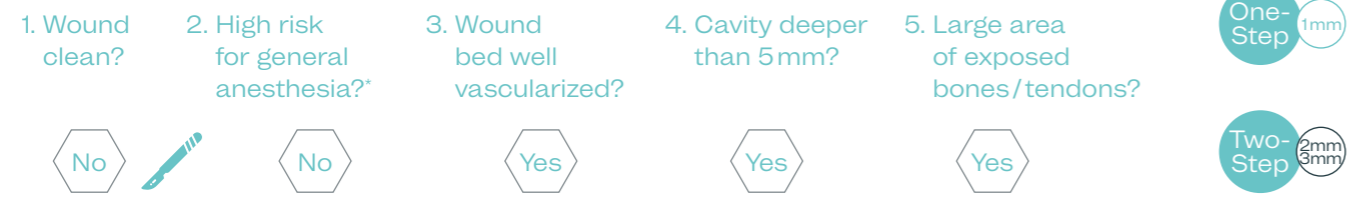
This 55-year-old patient suffered a laceration of the left lower leg and foot (Fig.1). After operative debridement, there was significant soft tissue loss (Fig.2). Defect coverage was performed with a free latissimus dorsi-serratus flap to replace the soft tissue loss. On top of the muscle flap a dry MatriDerm® (1mm) was placed (Fig.3) and rehydrated in situ. A meshed split-skin graft (meshed 1:1.5) was placed on top of the rehydrated MatriDerm® in a One-Step Procedure.
