Flexible solutions for **complex** wound reconstruction

Table of contents

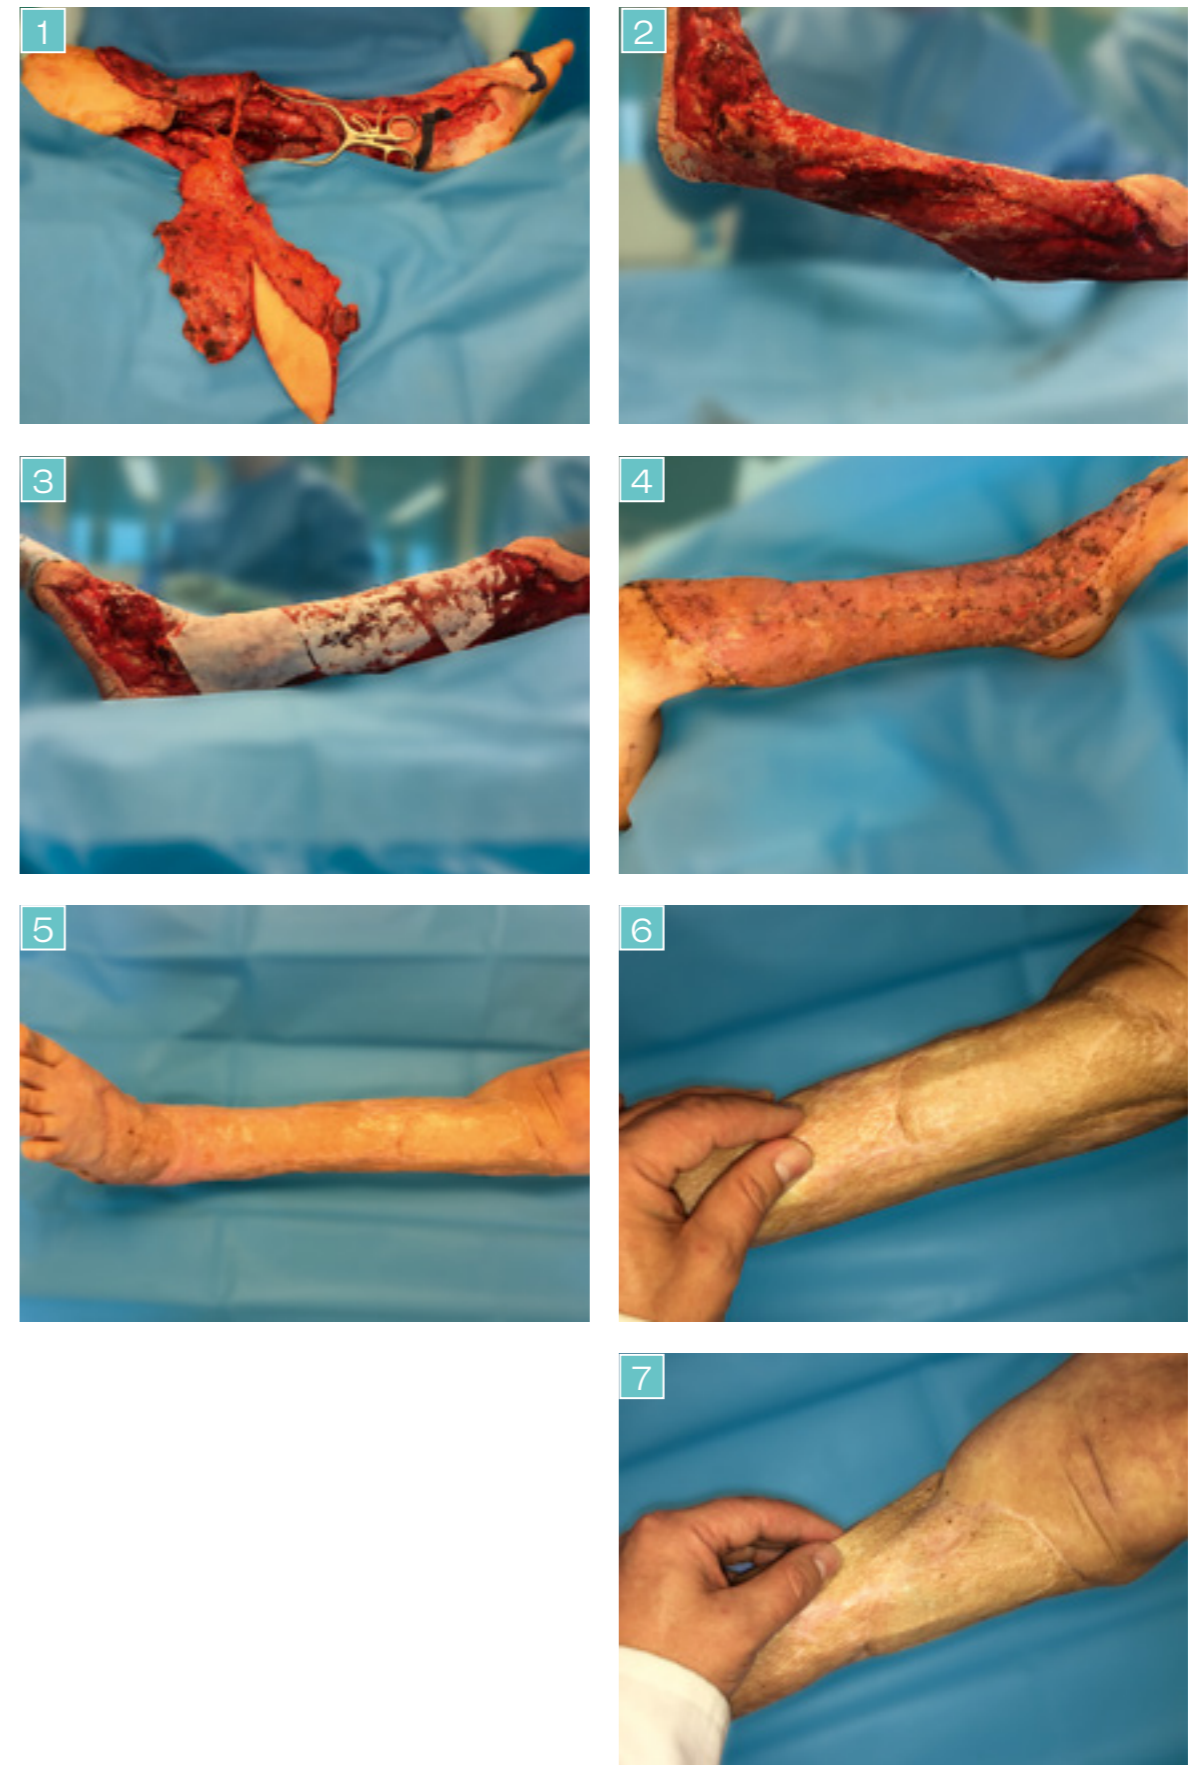
* Courtesy of D. F. Kalbermatten, MD, Basel, Switzerland

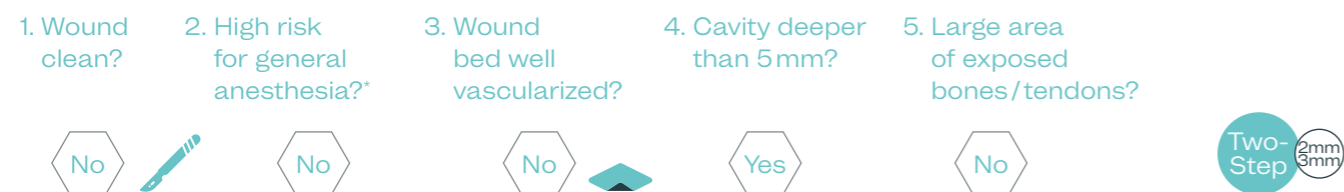
This patient required extensive life saving abdominal wall debridement after developing necrotizing fasciitis following ovarian cancer surgery. After debridement, she was admitted to the intensive care unit for several weeks with an 'open abdomen' measuring 34x33cm. There was exposed bowel covered by a fragile layer of granulation tissue and yellow slough with discharging cavities under the skin flaps laterally (Fig.1). The rectus muscles had retracted laterally and, therefore, it was inappropriate and unsafe to attempt an abdominal wall reconstruction using mesh and/or advancement techniques at that stage. The objective was to get the wound healed in a timely manner with as much protection and padding over the bowel so the patient could commence the rest of her oncologic treatment that included chemotherapy.

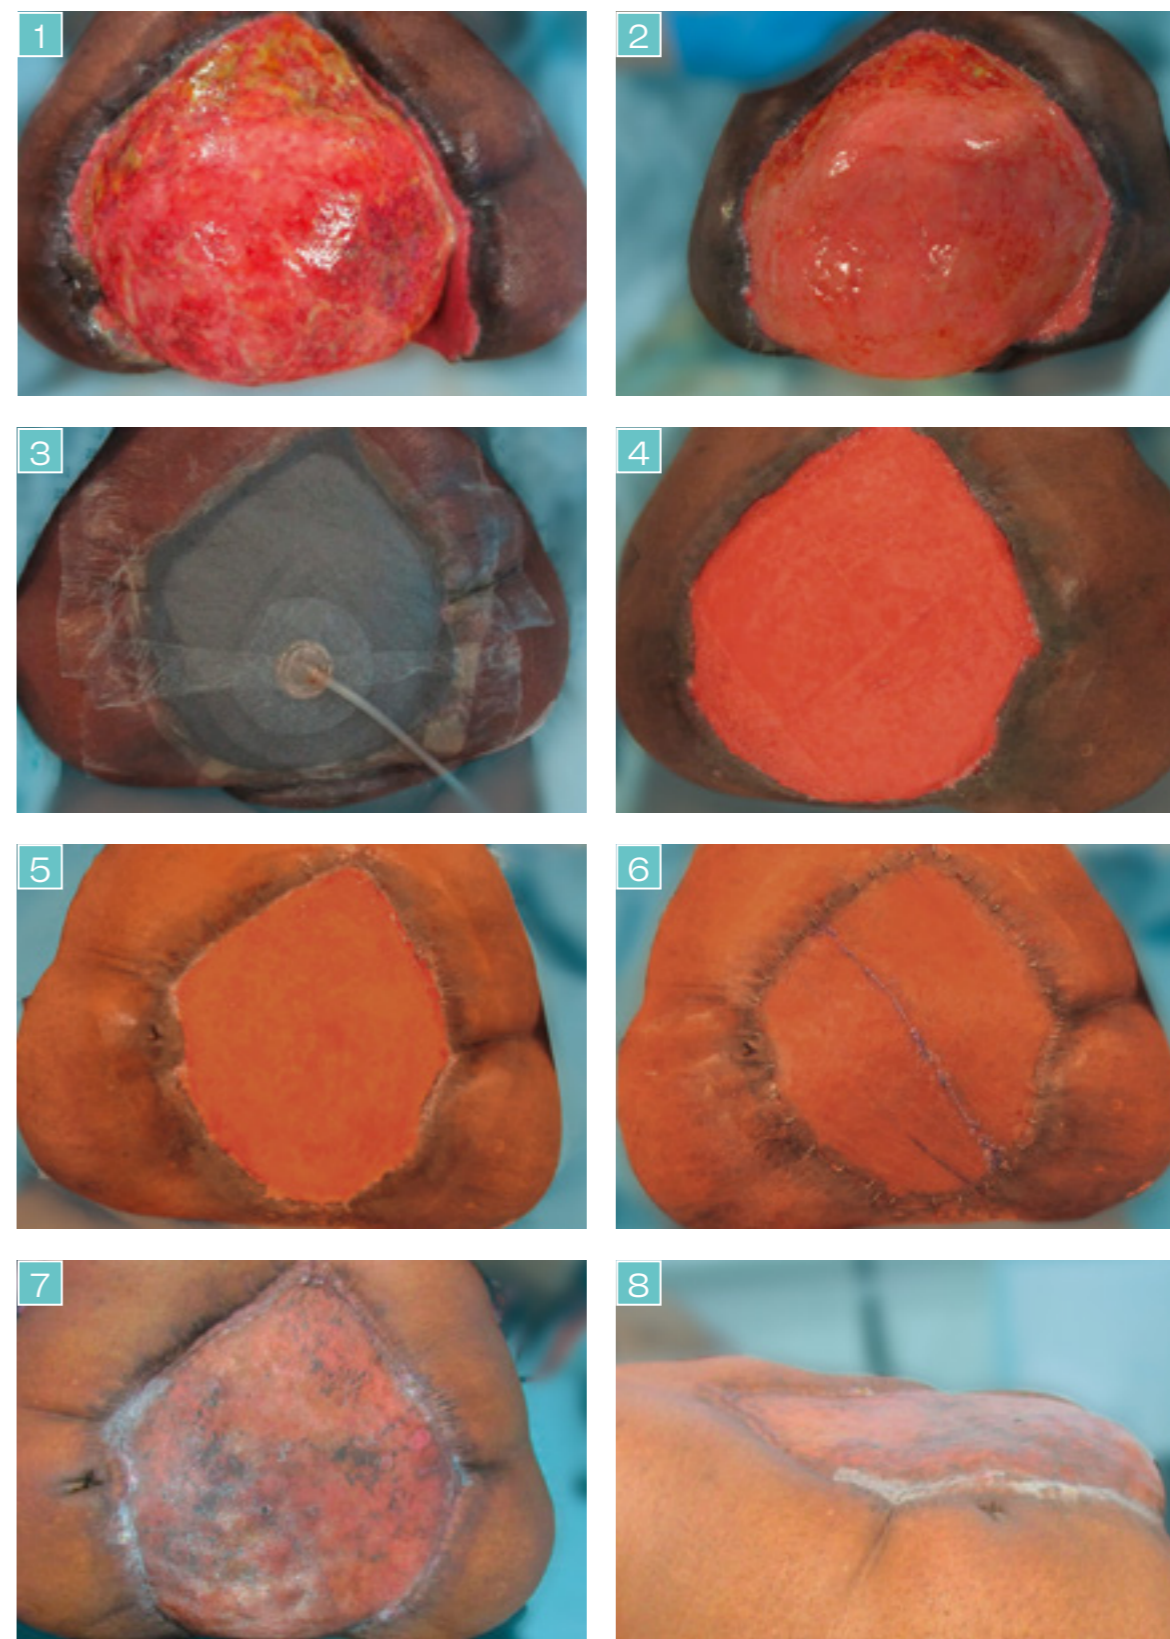
* Courtesy of I. Younis, MBBCh, MRCS (Eng), MSc, FRCS (Plast), London, UK

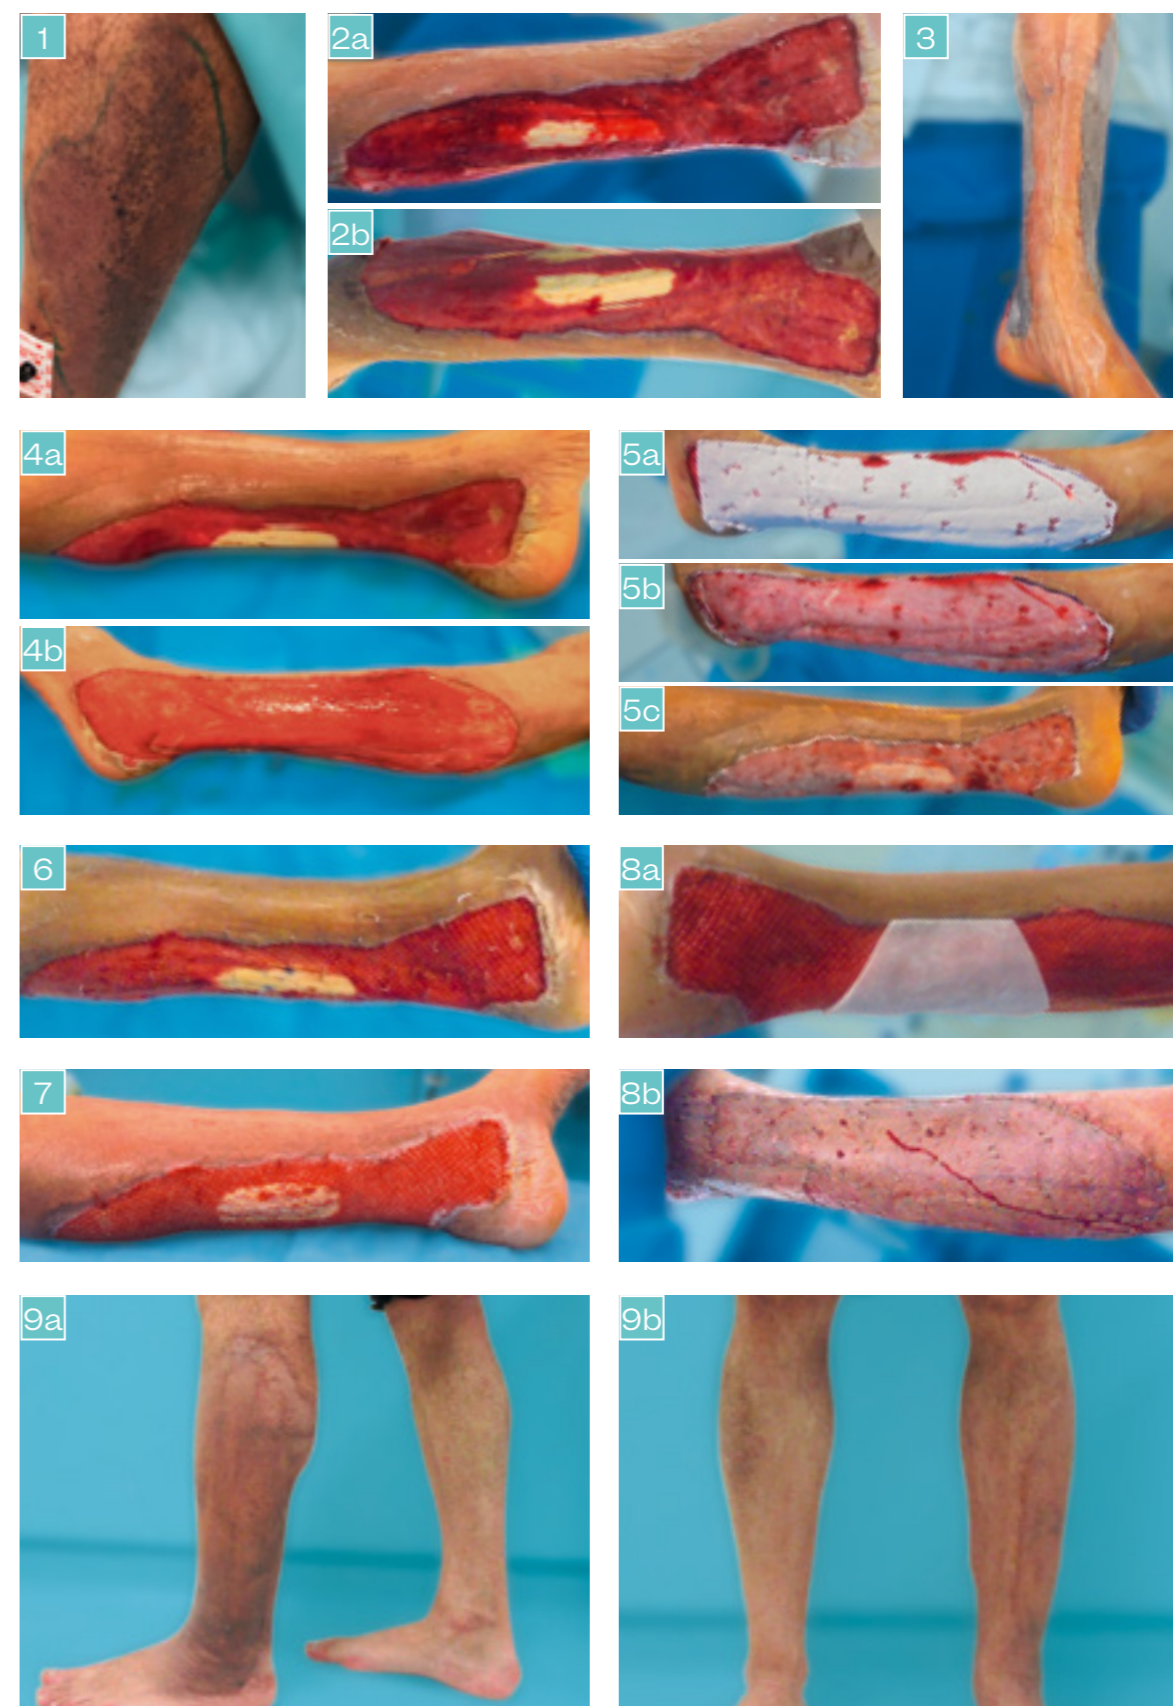
* Courtesy of I. Younis, MBBCh, MRCS (Eng), MSc, FRCS (Plast), London, UK

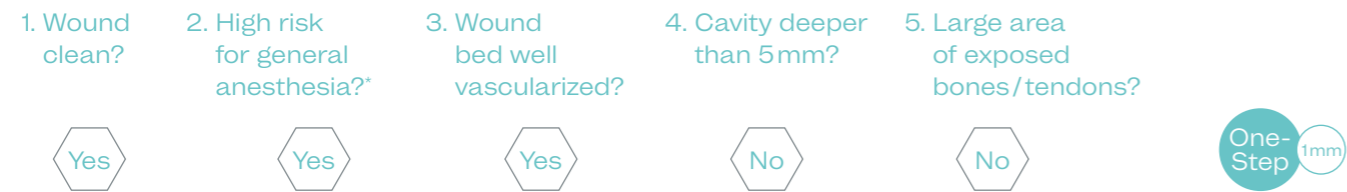
This patient with a neuropathic cavoid foot and an idiopathic clubfoot has a 4-year history of infected ulcerations on the plantar and lateral dorsal side of the foot. In the weeks prior to the reconstructive surgery, the Pseudomonas-infected ulcer was treated with MediHoney to control the infection. The wound bed was optimized with Hyiodine.

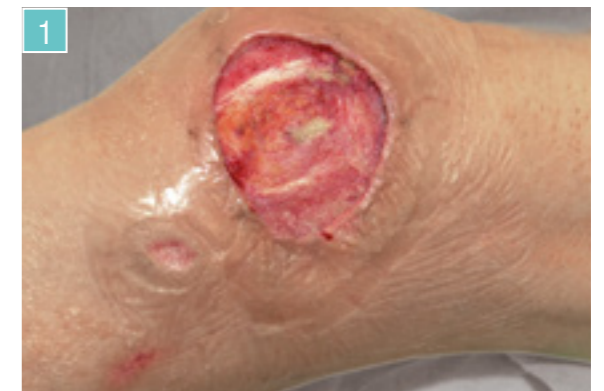
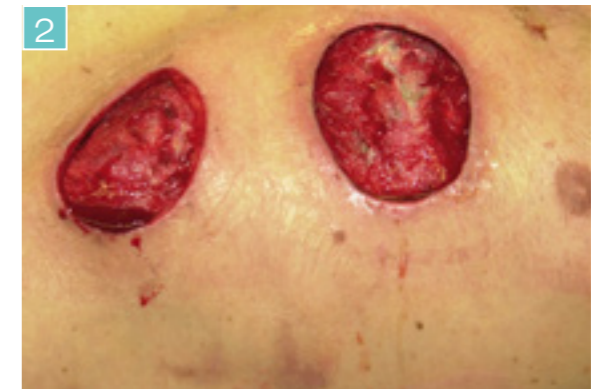
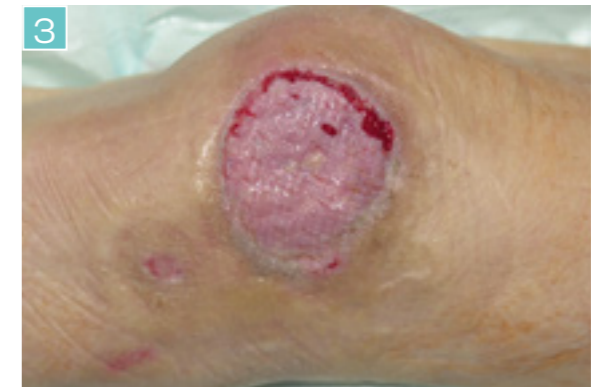
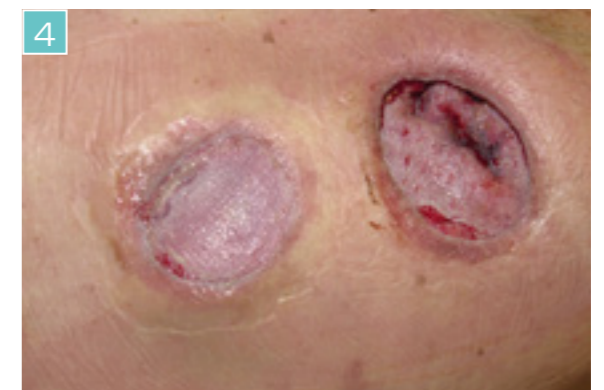
* Courtesy of M. Öhlbauer, MD, Murnau, Germany

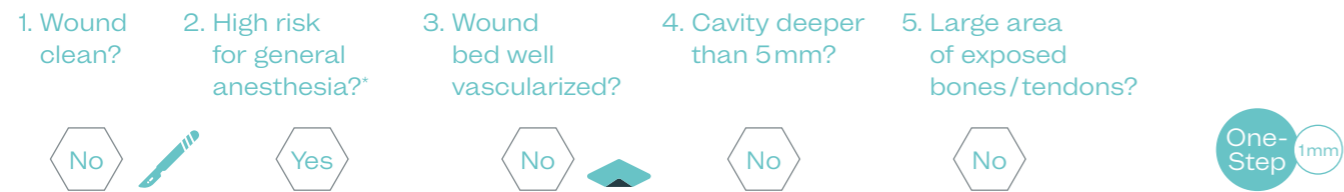
An 81-year-old male patient presented with a squamous cell carcinoma in the left popliteal fossa. The ulceration was growing already for 5 years.

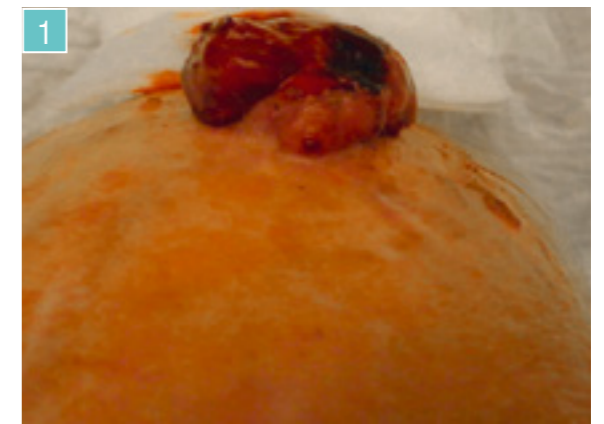
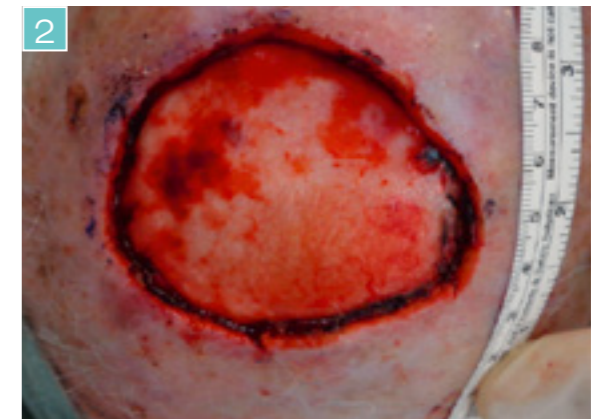
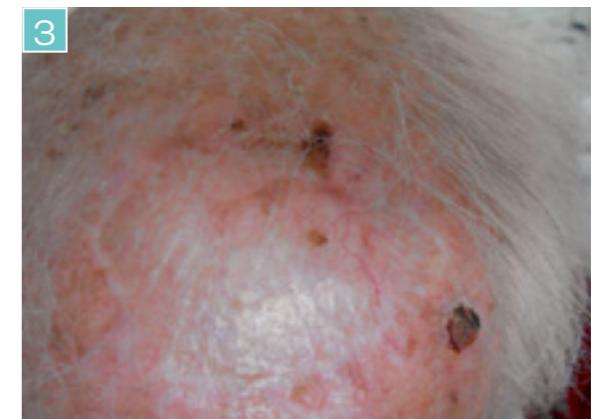
* Courtesy of V. Wedler, MD, Frauenfeld, Switzerland

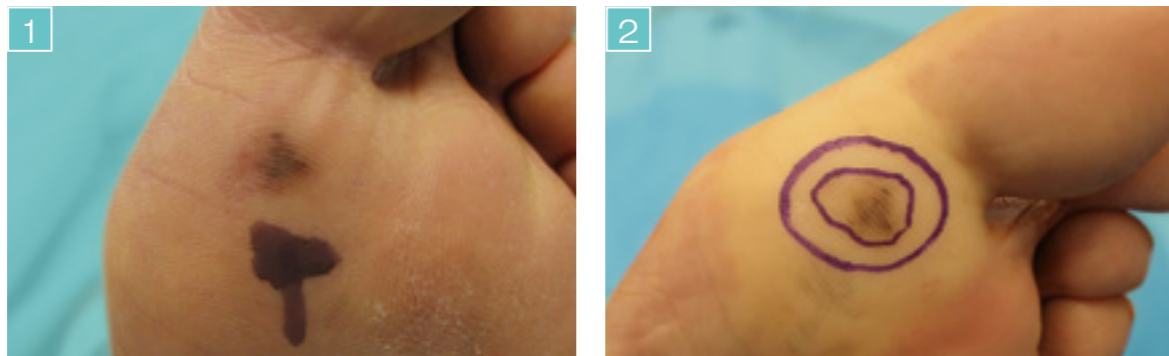
After 14 days post surgery MatriDerm® had not only integrated well but interestingly the peripheral 5mm had started epithelialising (Fig.6-7) with no contour defect (Fig.8). At 21 days there was further progression of epithelialisation centrally (Fig.9). As over 50% of the MatriDerm® had epithelialised really well, we saw no reason to undertake a split thickness graft. At six weeks post surgery the wound had not only fully epithelialised but had remodelled with no tethering, instability or contour defect (Fig.10-11). The patient was able to fully weight bear and undertake all normal every activities including sports such as football.

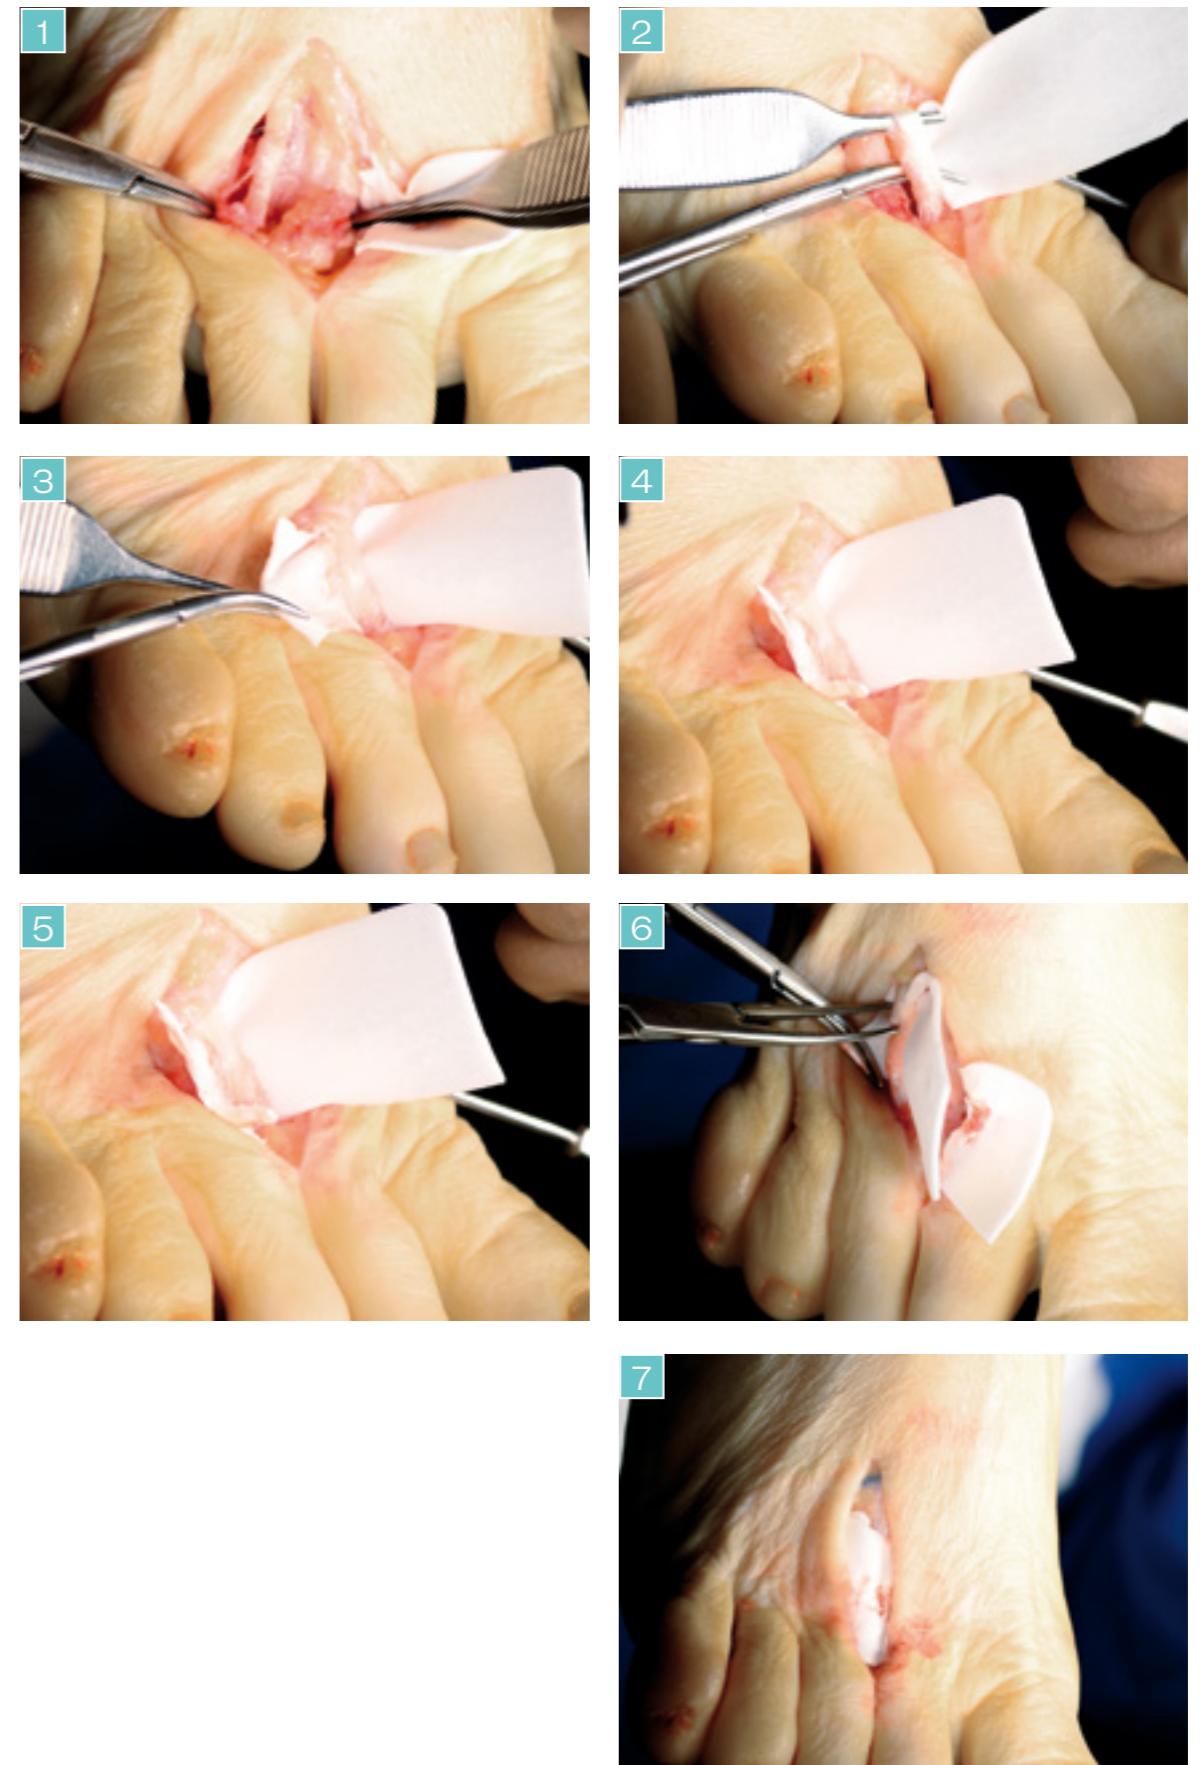
* Courtesy of U. Graf, MD, Zurich, Switzerland

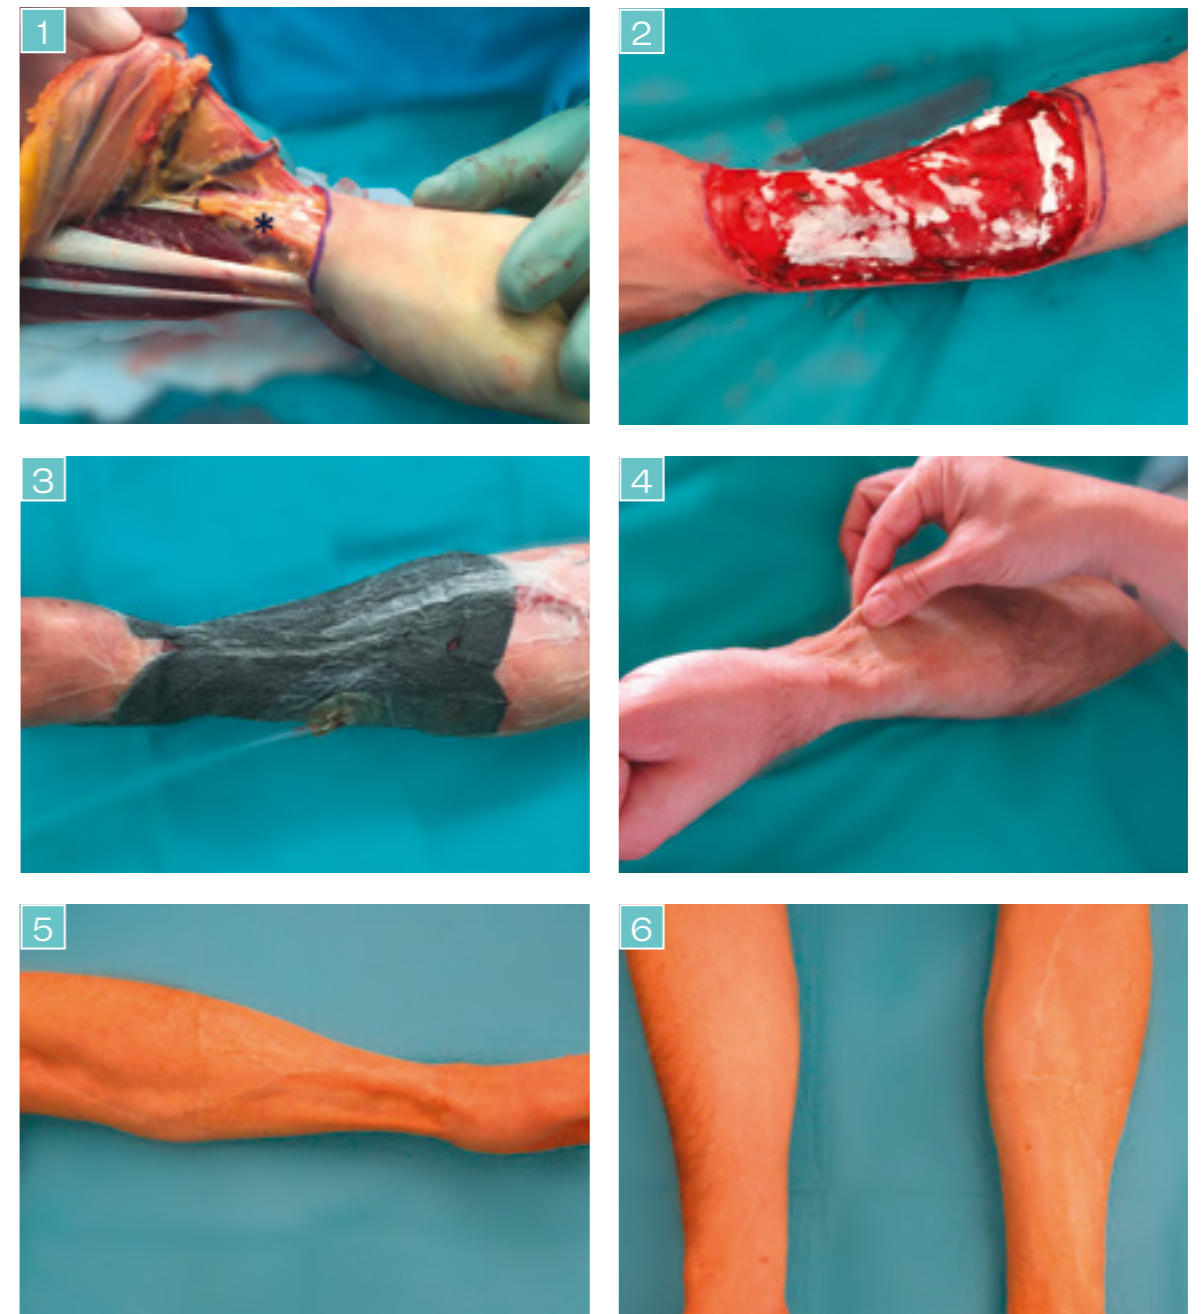
* Courtesy of W. Watfa, MD, Lausanne, Switzerland. Watfa et al., MatriDerm® Decreases Donor Site Morbidity After Radial Forearm Free Flap Harvest in Transgender Surgery, J Sex Med. 2017 Oct;14(10):1277-1284.
